**Appendix I-2**  
**Ahart Campground**  
**Photographs**

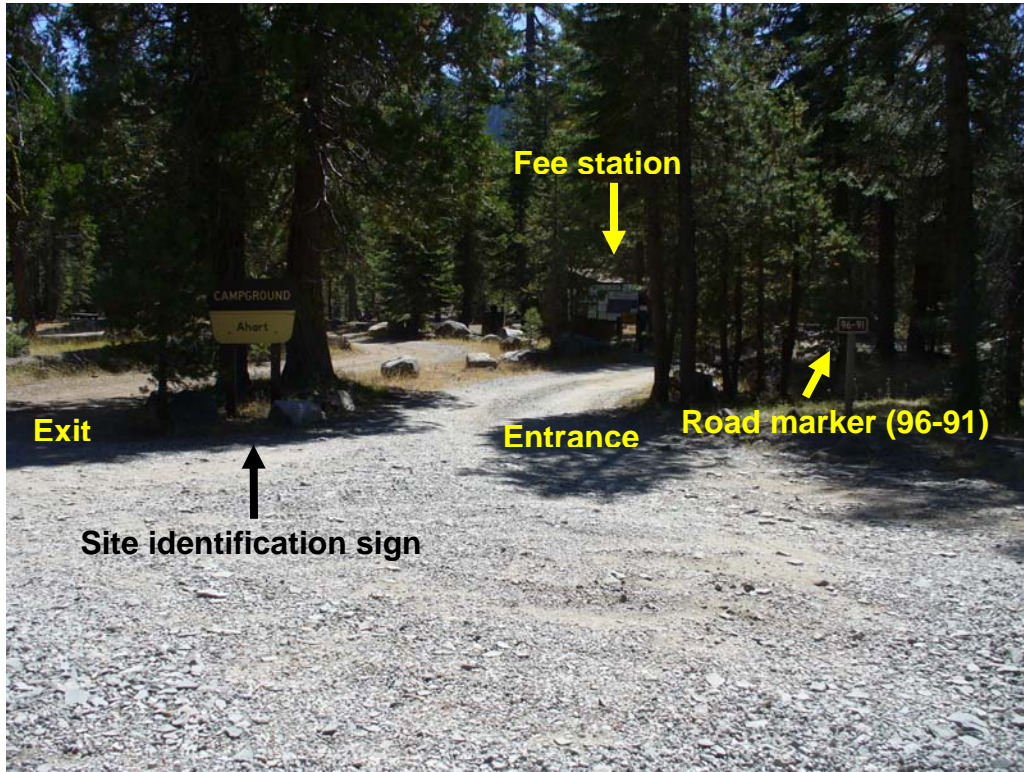
Photo I-2-1. Entrance/exit area at Ahart Campground. (9/04/08)

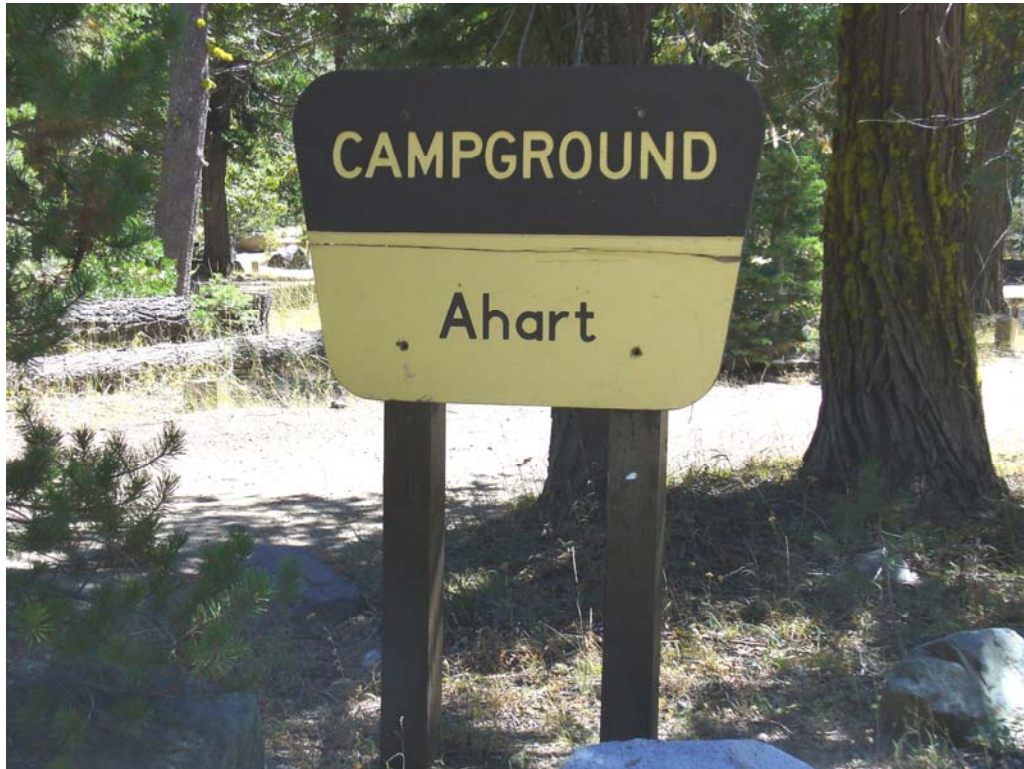
Photo I-2-2. Site identification sign at entrance to Ahart Campground. This site is in fair condition due to the large crack. (9/04/08)

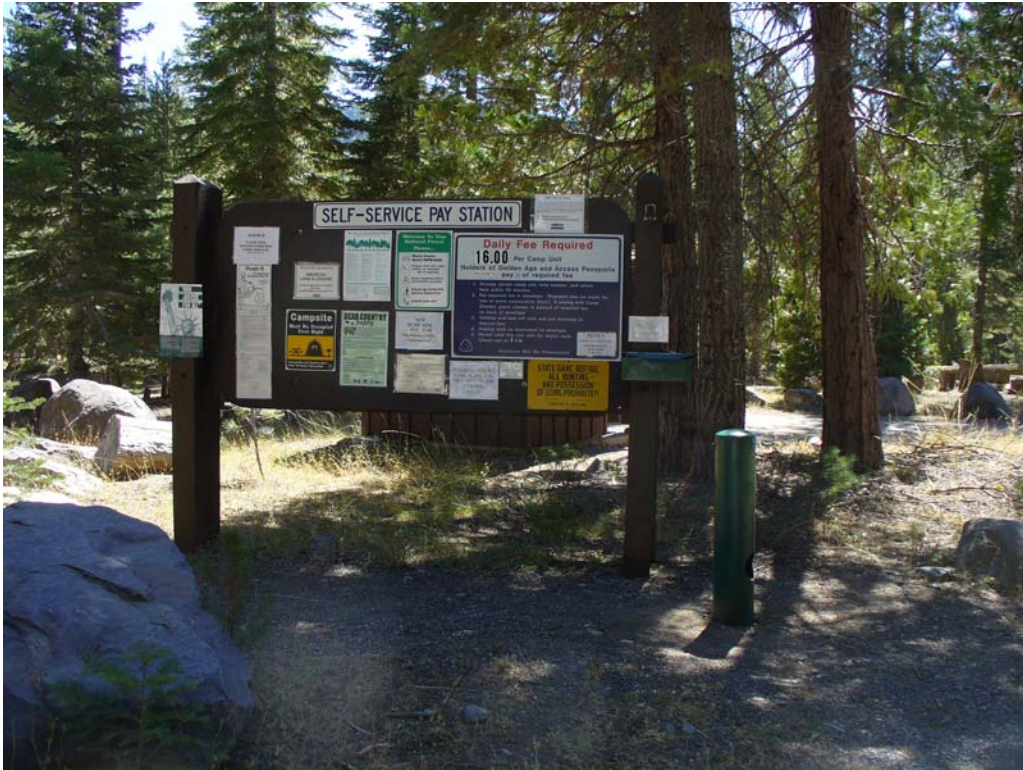
**Photo I-2-3. Fee station near entrance to Ahart Campground. Fee tube to right of information board. (9/04/08)**

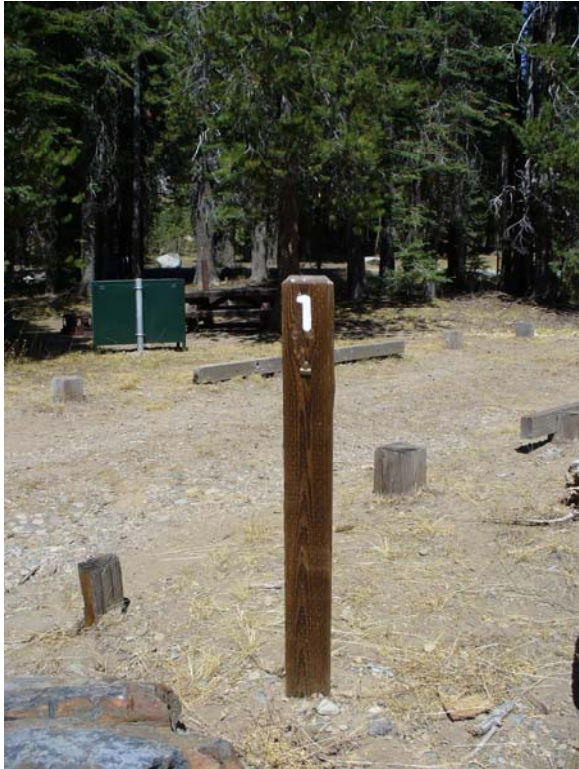
**Photo I-2-4. Typical site (unit) marker. (9/04/08)**

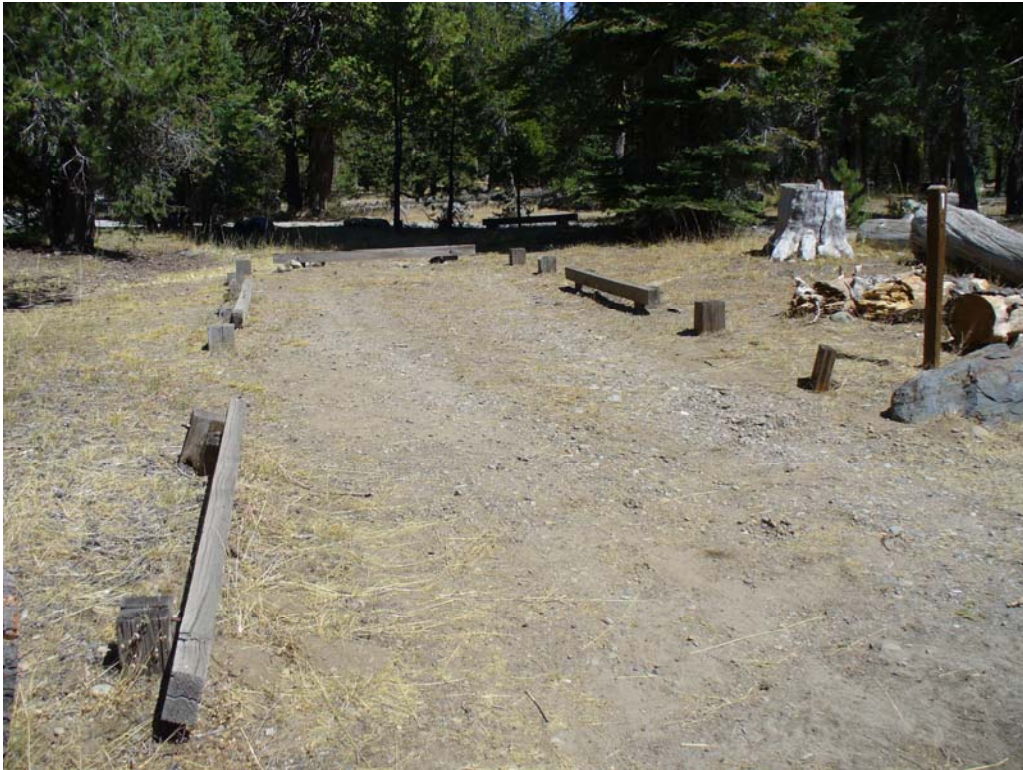
**Photo I-2-5. Typical parking spur delineated with wood posts and barriers. Note native surface. (9/4/08)**

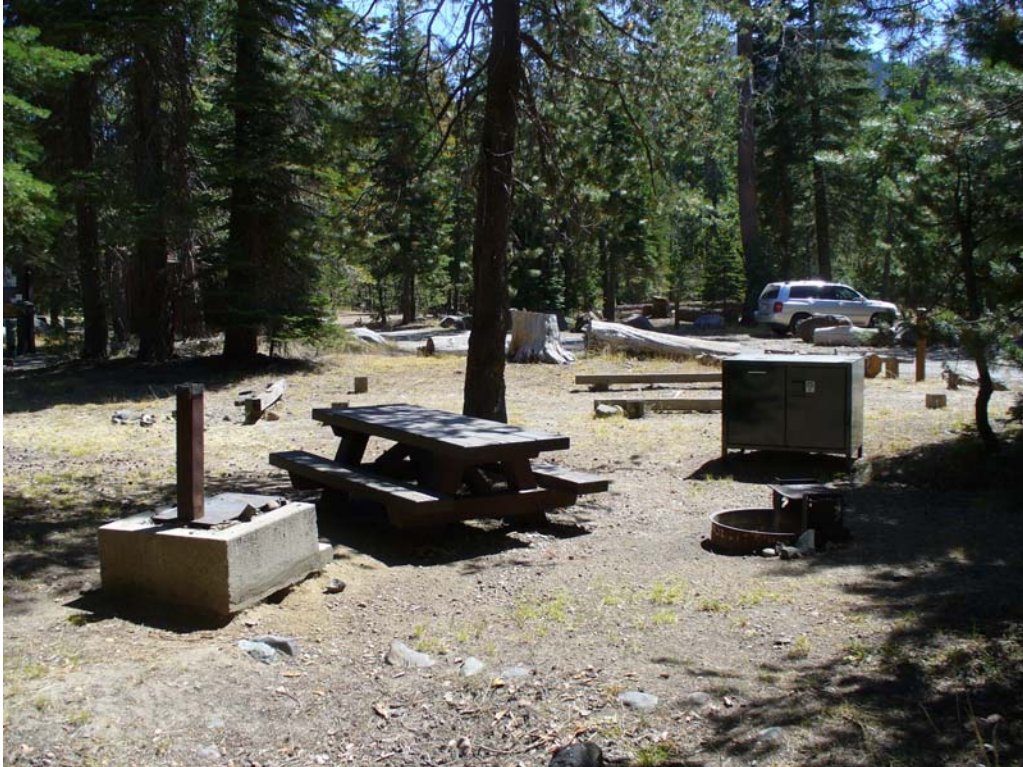
**Photo I-2-6. Typical site at Ahart Campground. (9/04/08)**

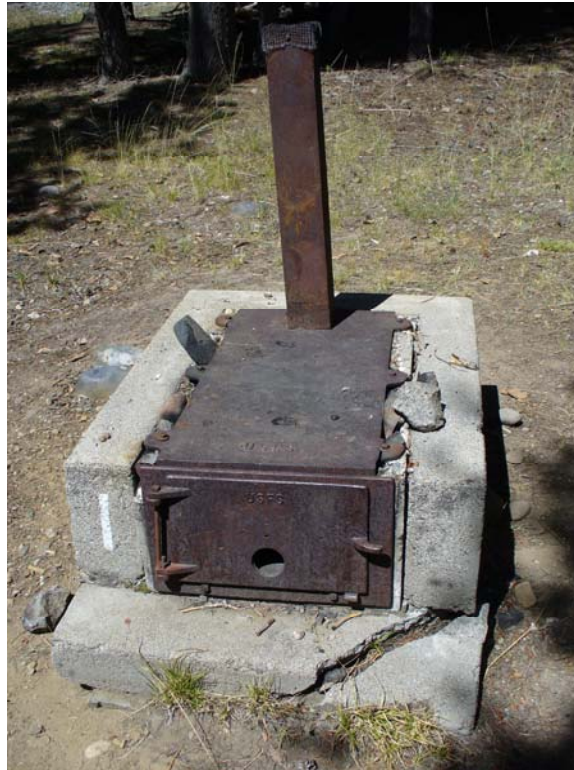
**Photo I-2-7. Concrete and steel stove at site 1, poor condition. (9/04/08)**

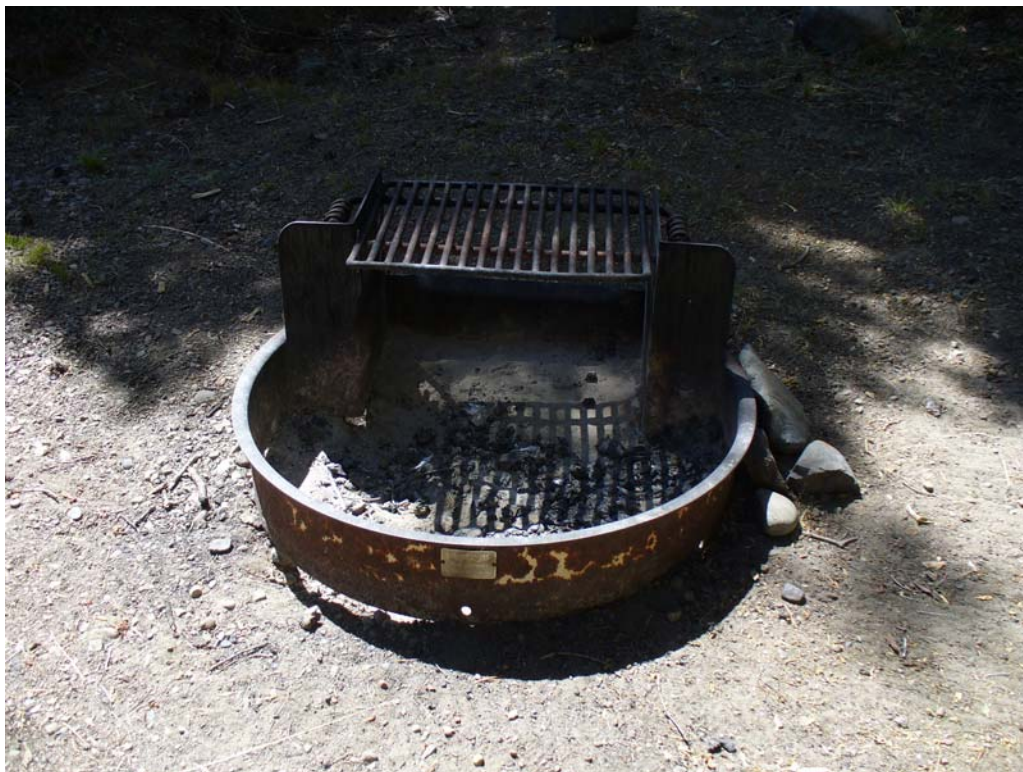
**Photo I-2-8. Typical steel fire ring with grill, not accessible. (9/04/08)**

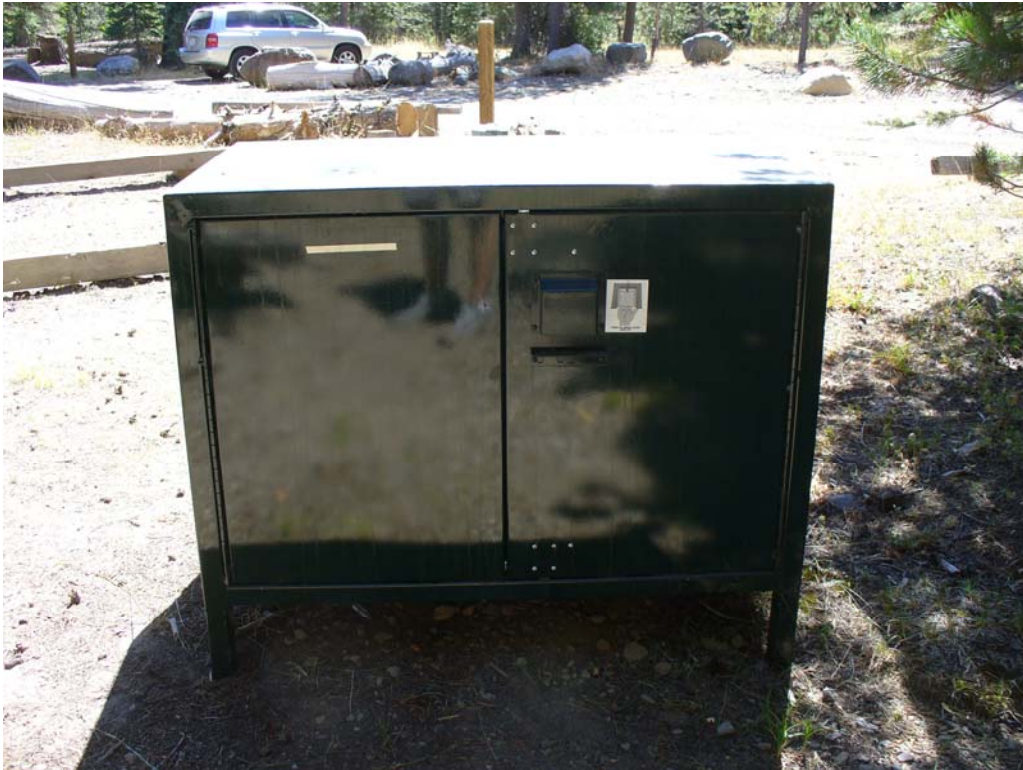
**Photo I-2-9. Typical bear-proof food storage locker (bear box), new and in good condition. (9/04/08)**

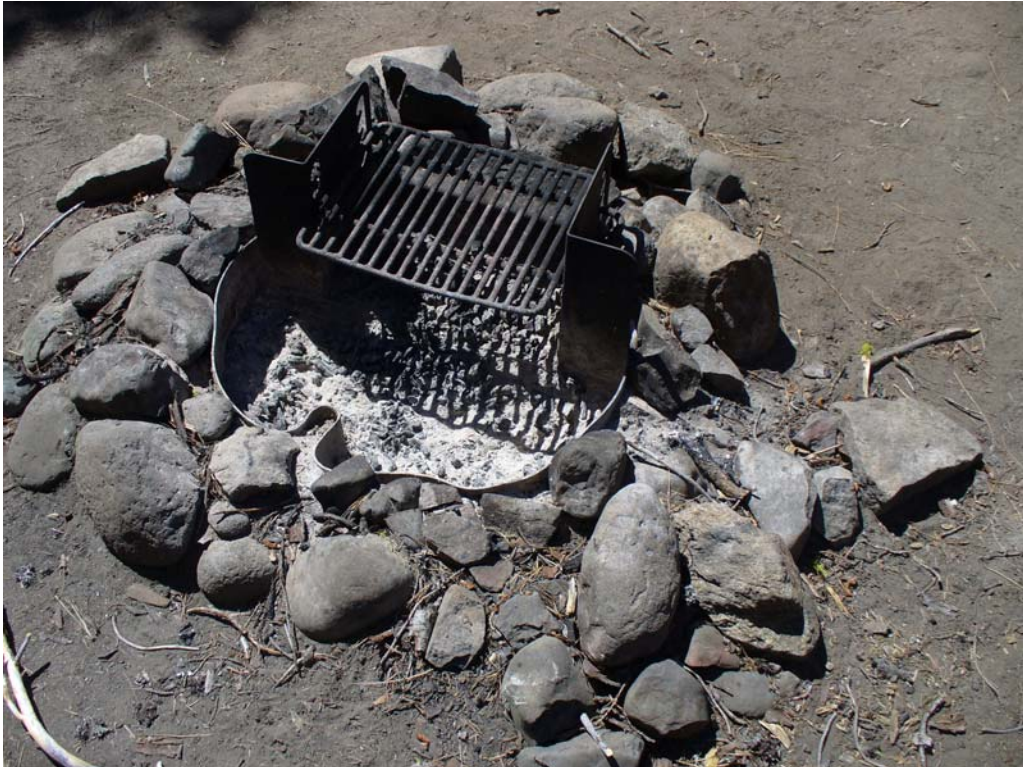
**Photo I-2-10. Steel fire ring and grill, poor condition. (9/04/08)**

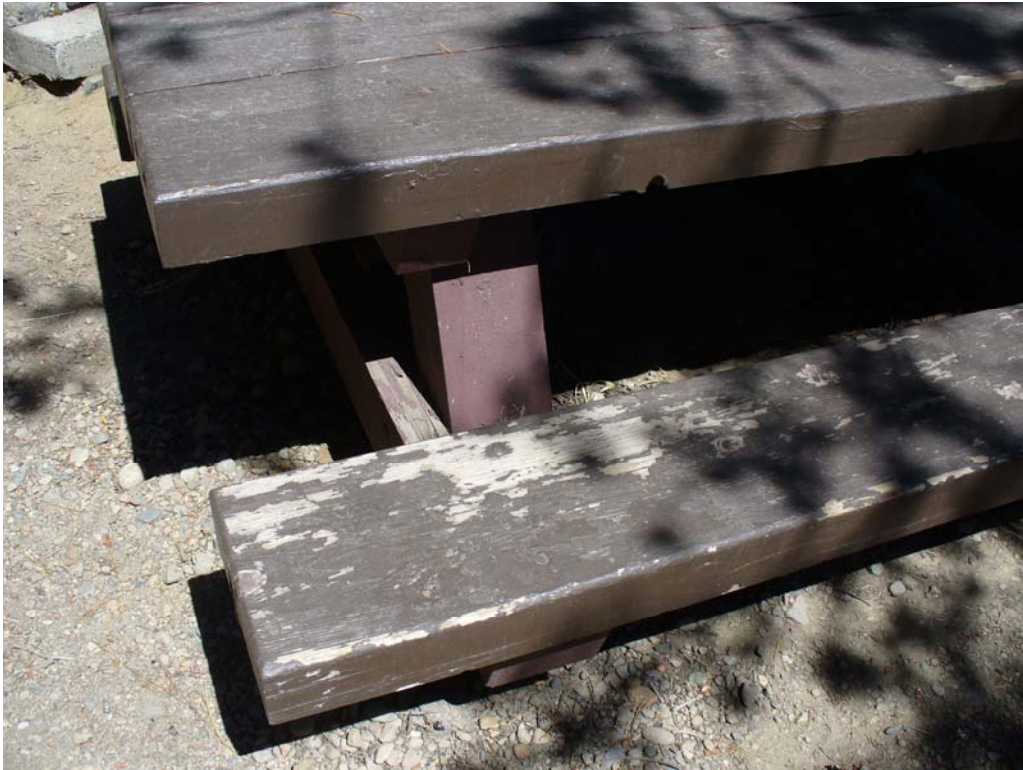
**Photo I-2-11. Typical heavy wood table showing flaking paint. (9/04/08)**

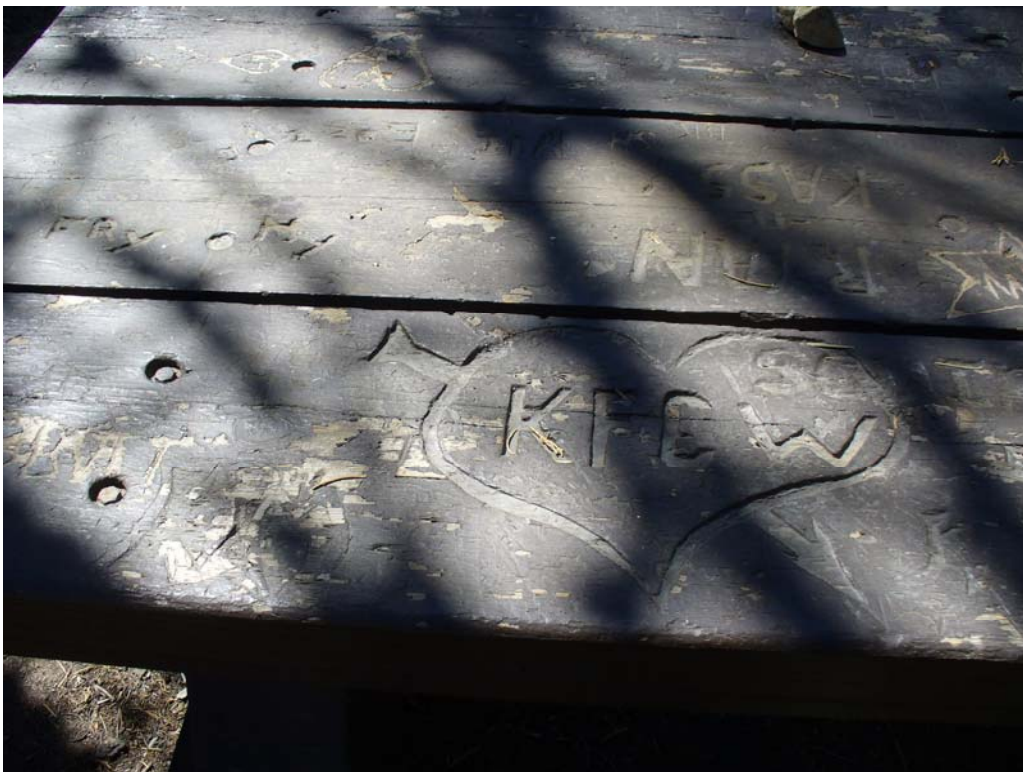
**Photo I-2-12. Typical heavy wood table with graffiti. (9/04/08)**

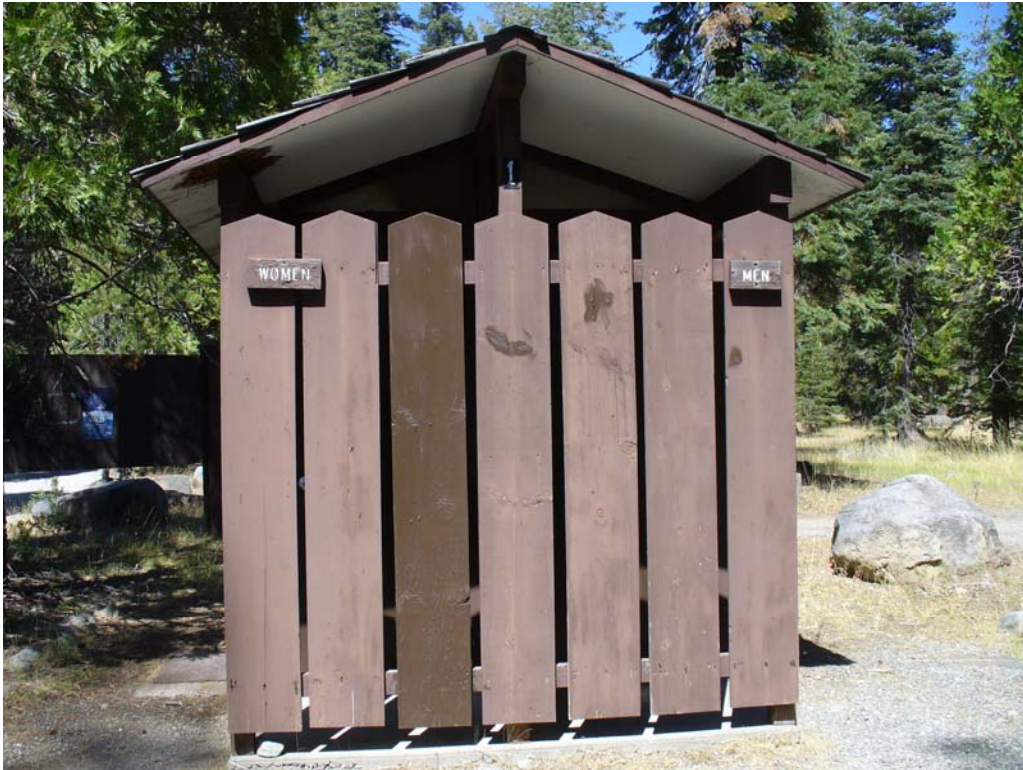
**Photo I-2-13. Double-unit, vault toilet building (No. 1). (9/04/08)**

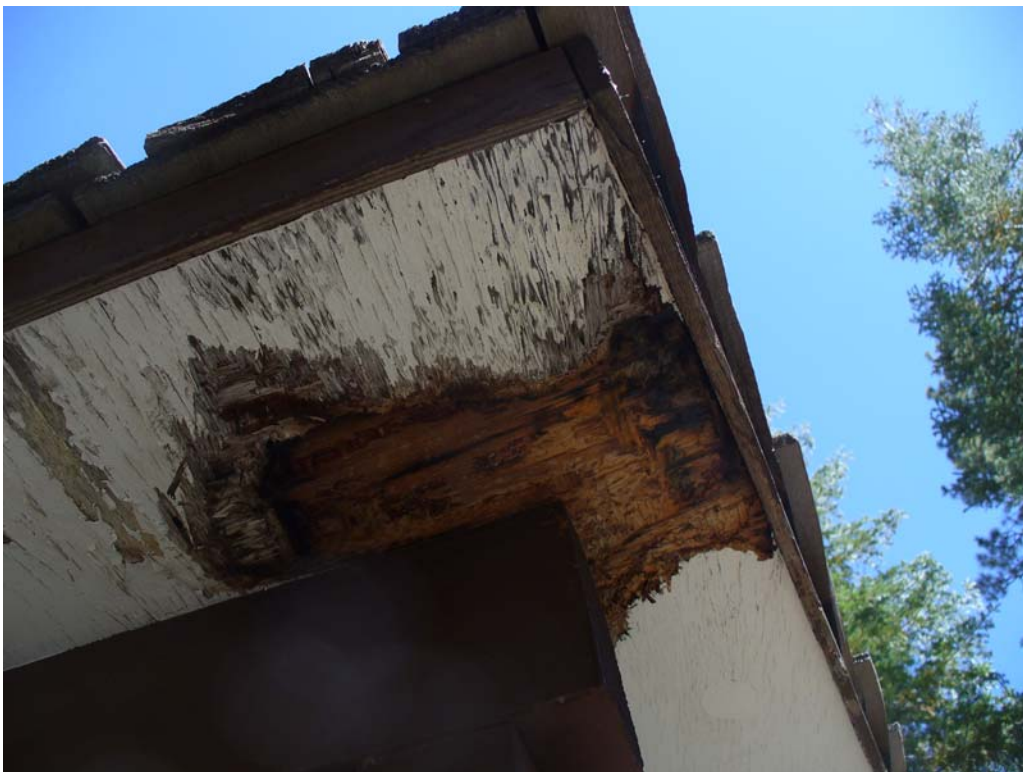
**Photo I-2-14. Dry rot on roof and frame of toilet building No. 1. (9/0408)**

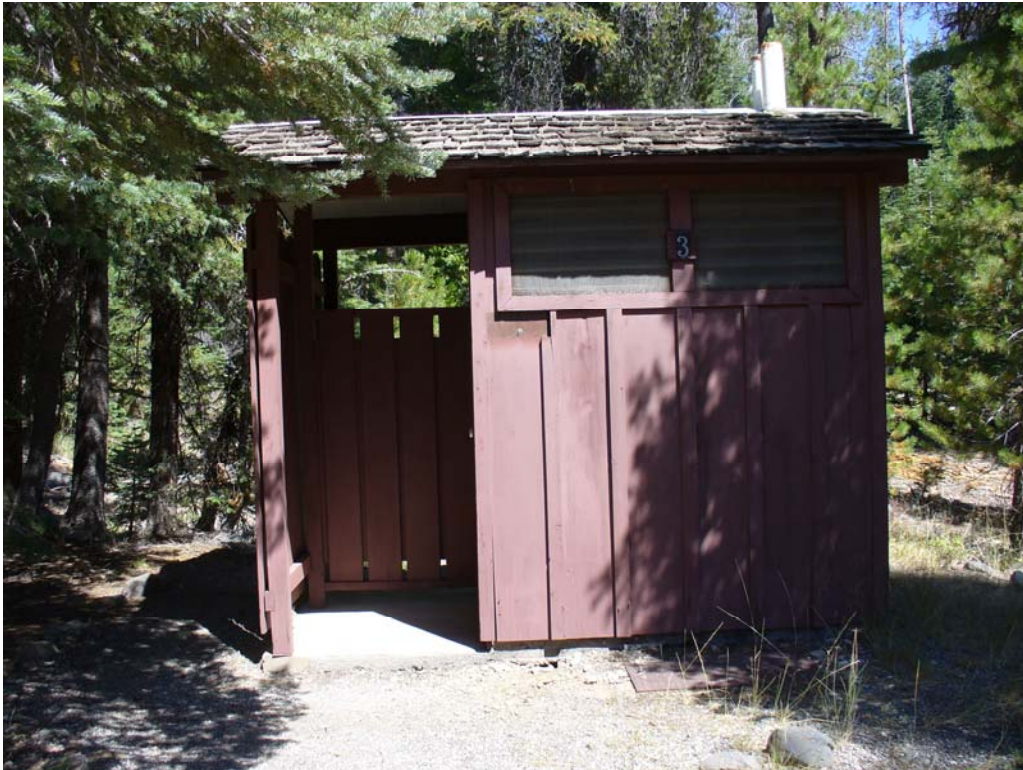
**Photo I-2-15. Toilet building No. 3. (9/04/09)**

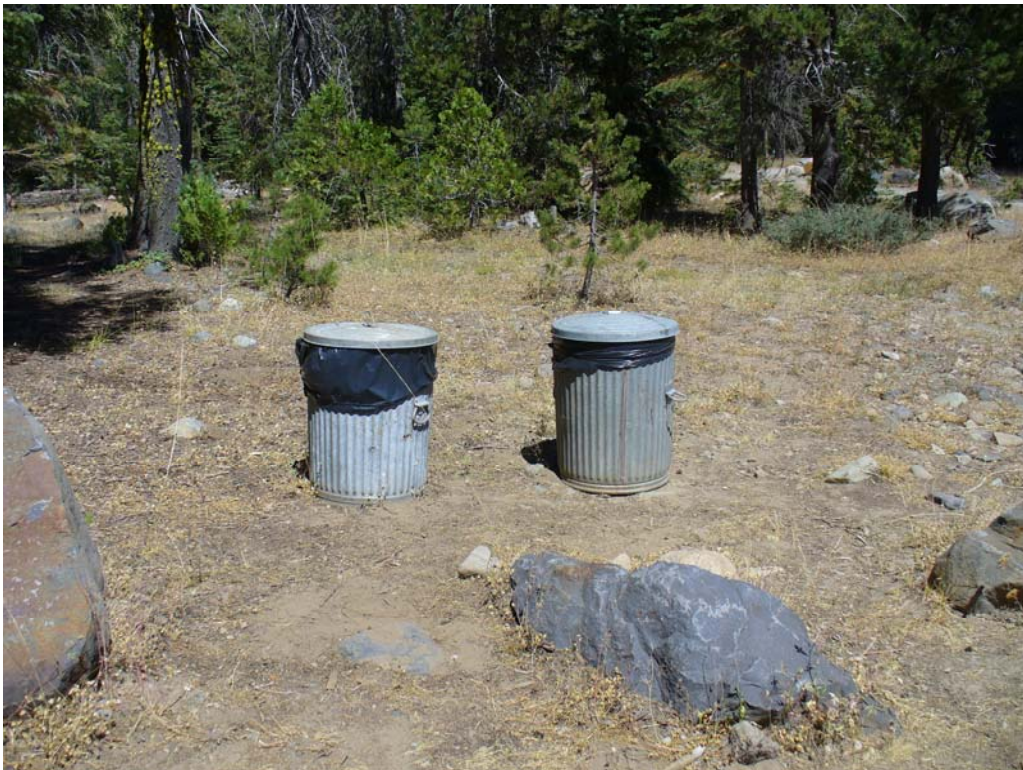
**Photo I-2-16. Garbage bins. (9/04/08)**
