**Appendix O-2**  
**French Meadows Boat Ramp**  
**Photographs**

**French Meadows Boat Ramp Parking Area**

**French Meadows Picnic Area**

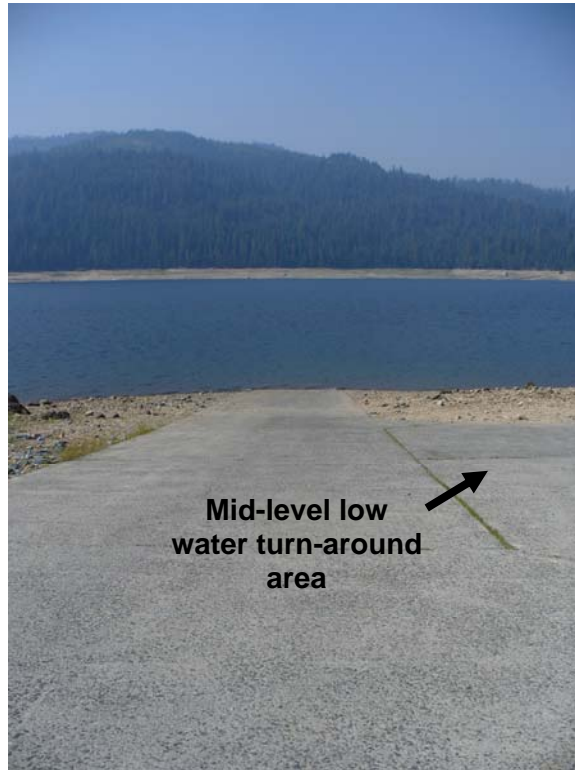
**Photo O-2-1. French Meadows Boat Ramp on July 23, 2008 (WSE = 5,220 ft).**

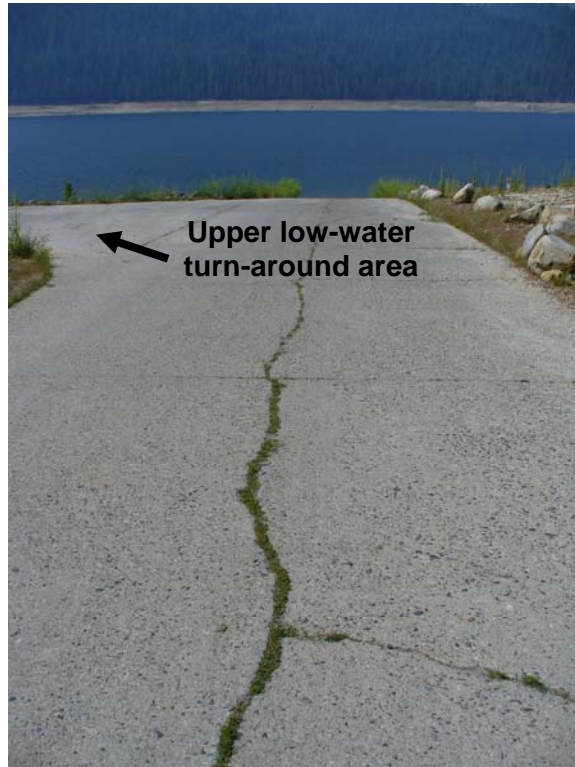
**Photo O-2-2. Cracking in-filled with vegetation along French Meadows Boat Ramp, upper section. (7/23/08)**

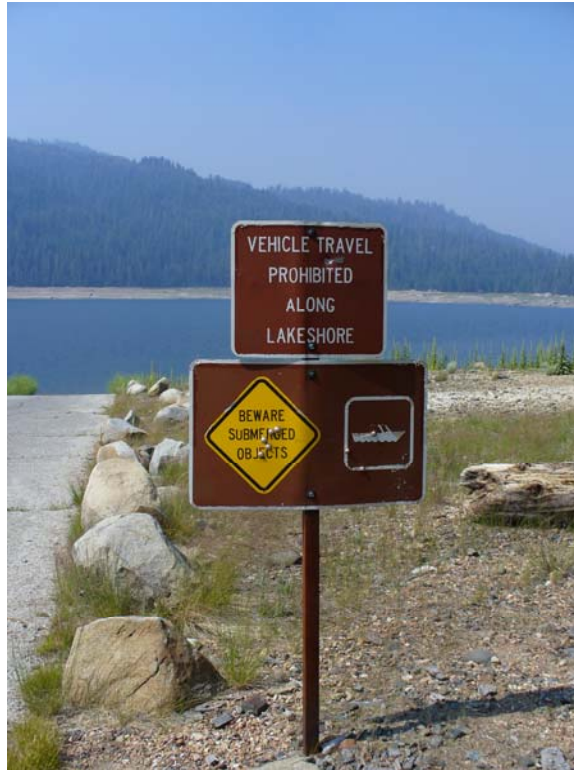
**Photo O-2-3. Sign at upper end of French Meadows Boat Ramp. Sign is in good condition but paint is flaking. (7/23/08)**

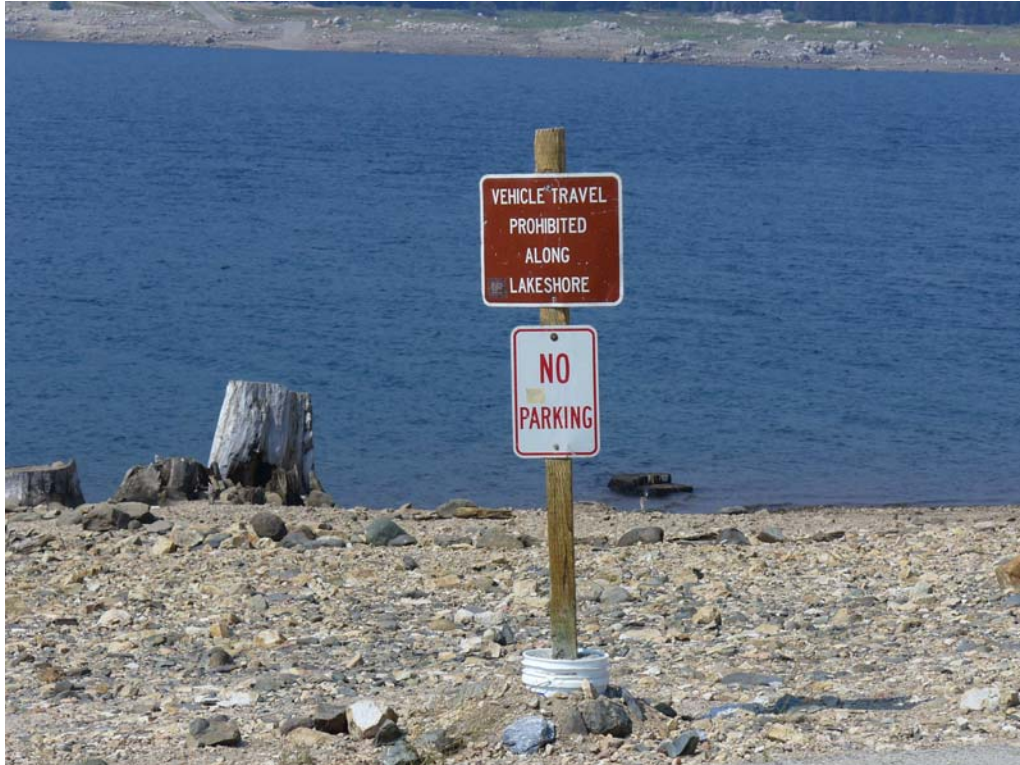
**Photo O-2-4. Temporary sign located in middle low-water turn around area. This sign may be moved as water levels fluctuate. (7/23/08)**

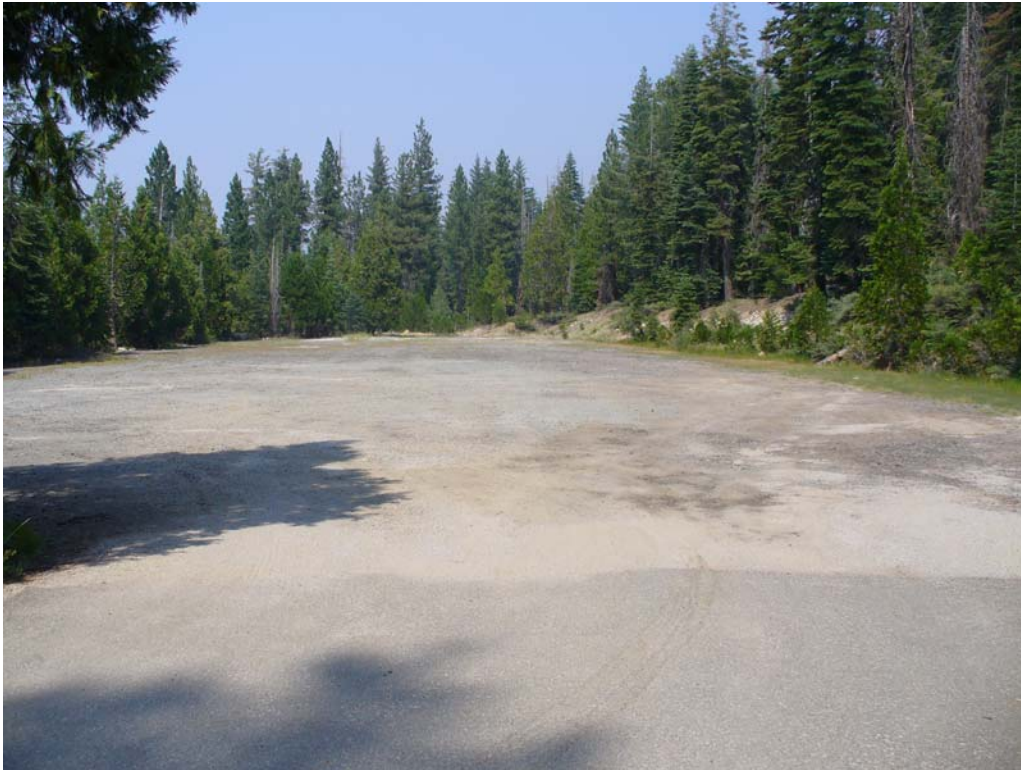
**Photo O-2-5. French Meadows Boat Ramp Parking Area. Surface has deteriorated to aggregate base rock. (7/23/08)**

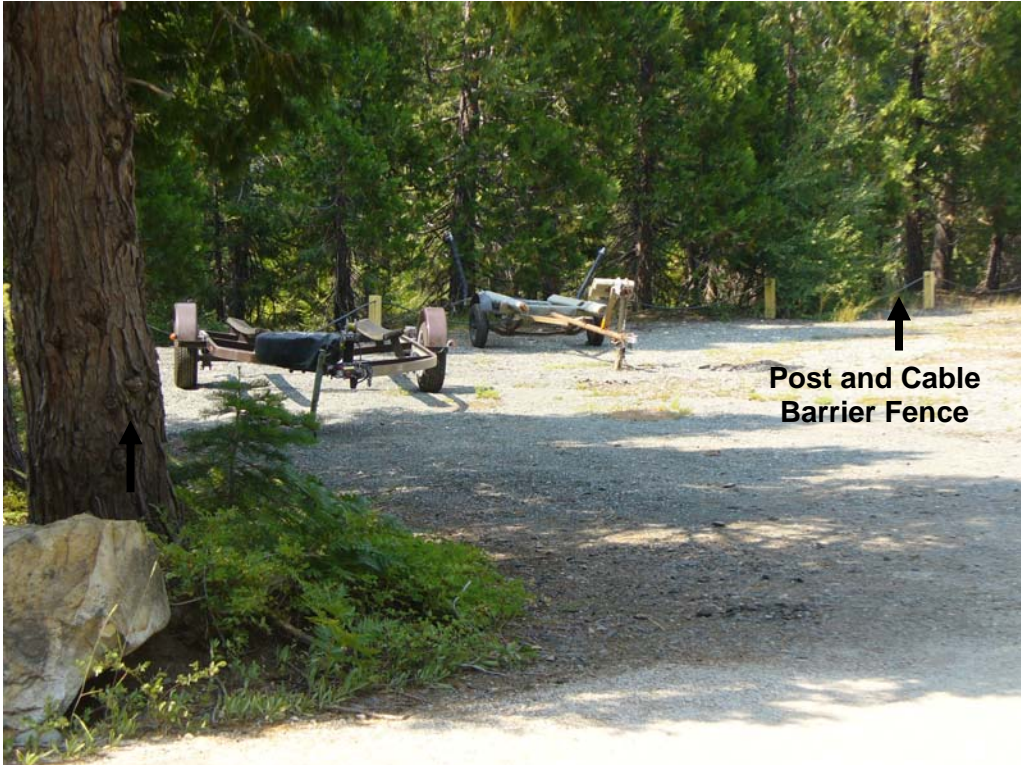
**Photo O-2-6. French Meadows Boat Ramp Parking Area. Note post and cable barrier fence. (7/23/08)**

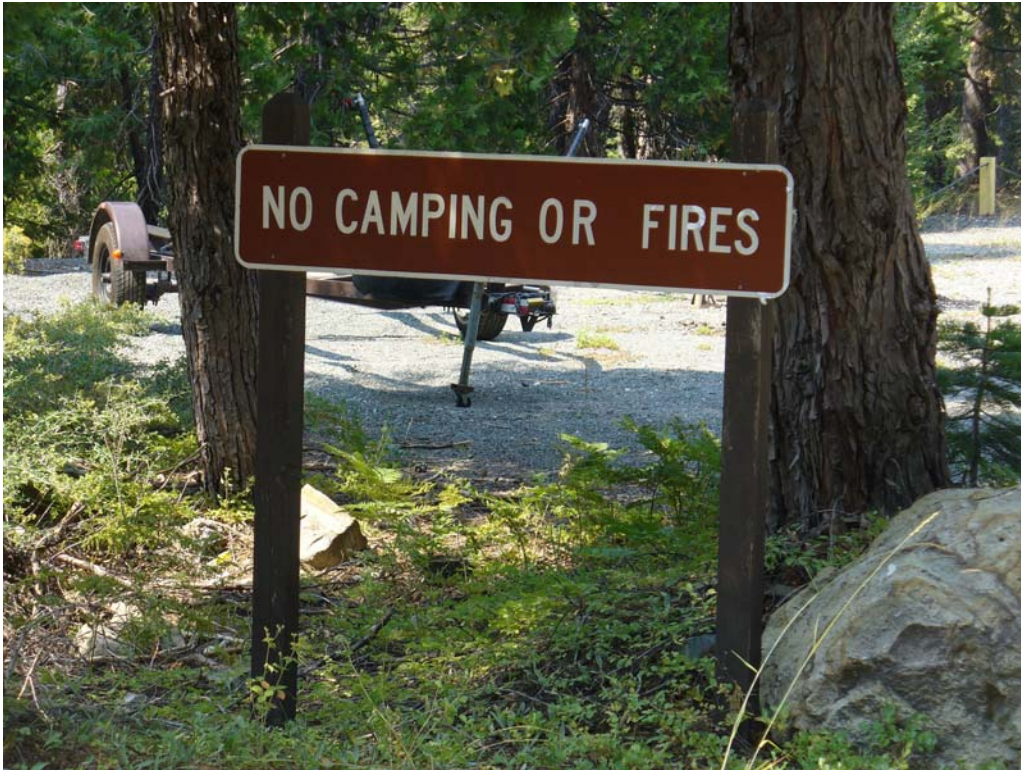
**Photo O-2-7. Sign at entrance to French Meadows Boat Ramp Parking Area. Sign is in good condition. (7/23/08)**

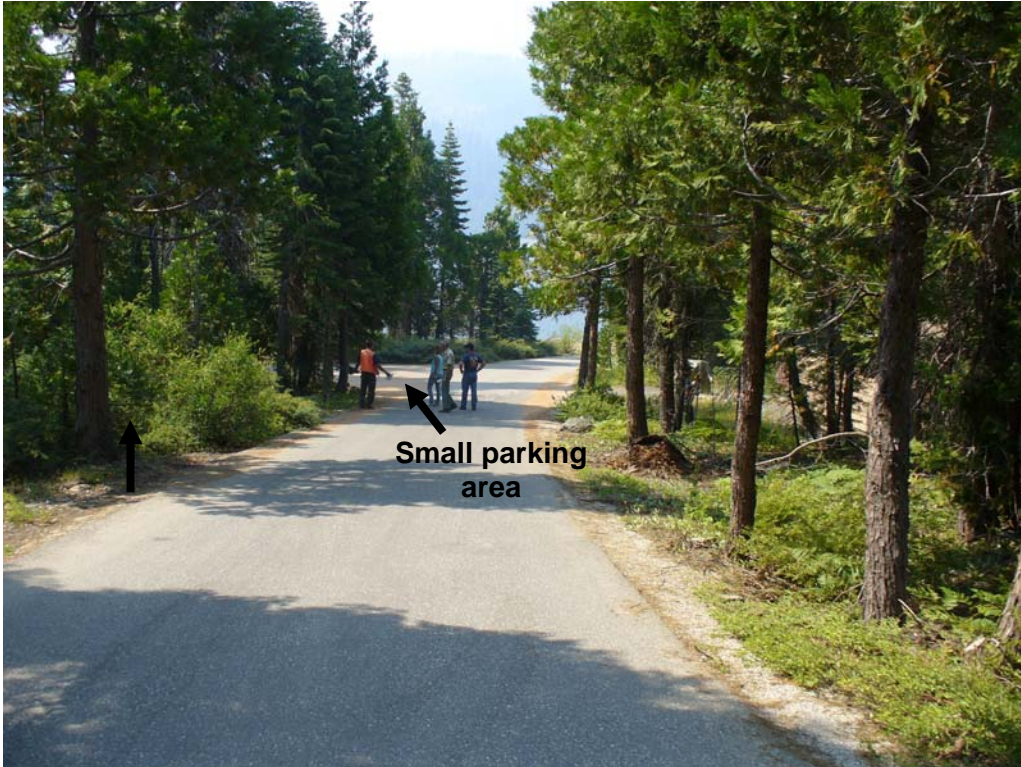
**Photo O-2-8. Paved road extending from French Meadows Boat Ramp Parking Area to French Meadows Boat Ramp. Note small parking area on left side of road. This area also functions as a high water turn-around at max WSE. (7/23/08)**

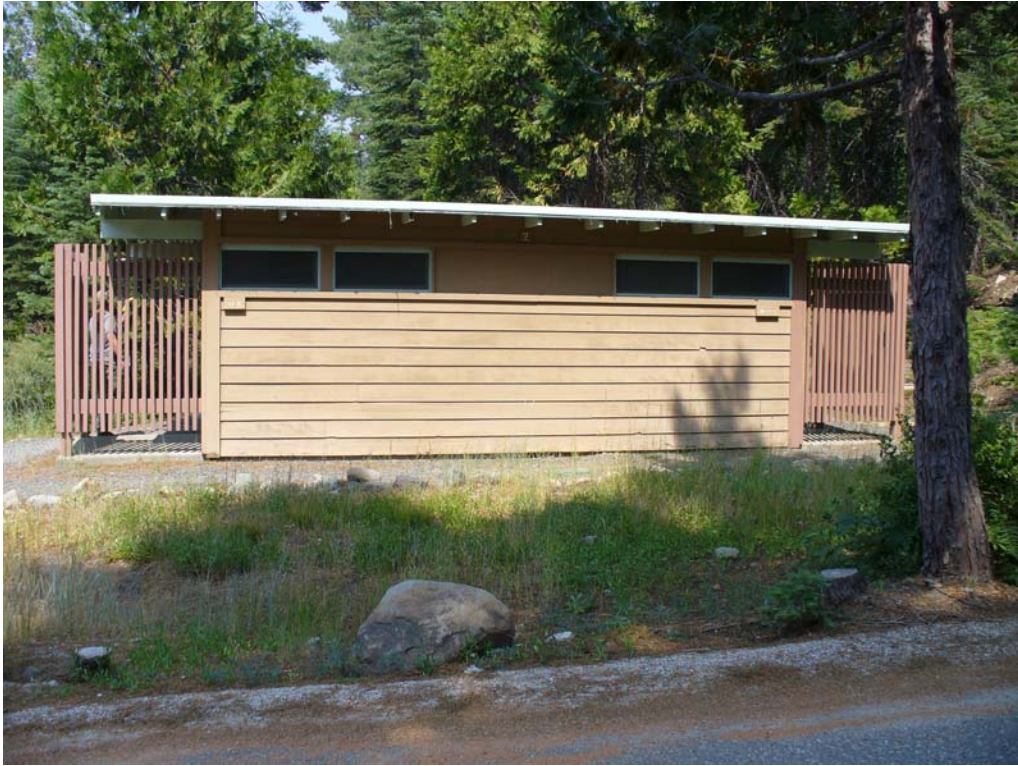
**Photo O-2-9. Bathroom located along access road to French Meadows Boat Ramp. This bathroom has flush toilets and sinks but does not meet current USDA-FS condition or accessibility standards. (7/23/08)**

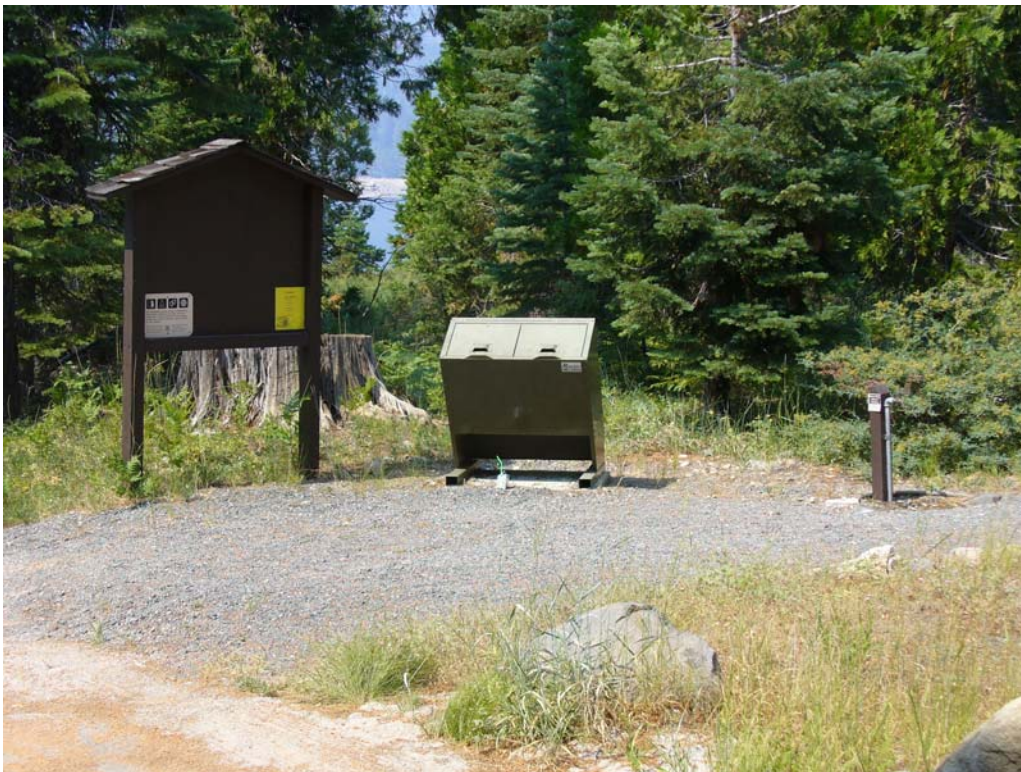
**Photo O-2-10. Information board, bear-proof garbage container, and water faucet located adjacent to bathroom. (7/23/08)**

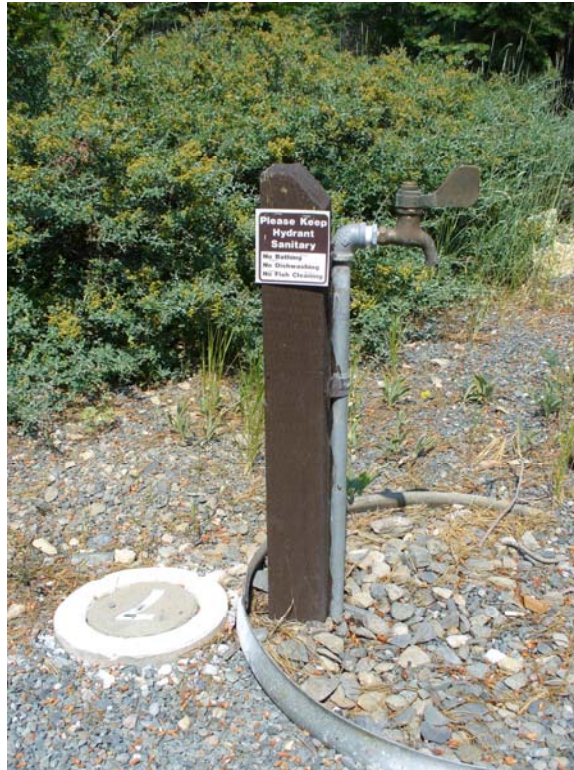
**Photo O-2-11. Water faucet located adjacent to bathroom. Handle is considered disabled accessible. Approach is not disabled accessible due to insufficient clear space and changes in surface level. (7/23/08)**

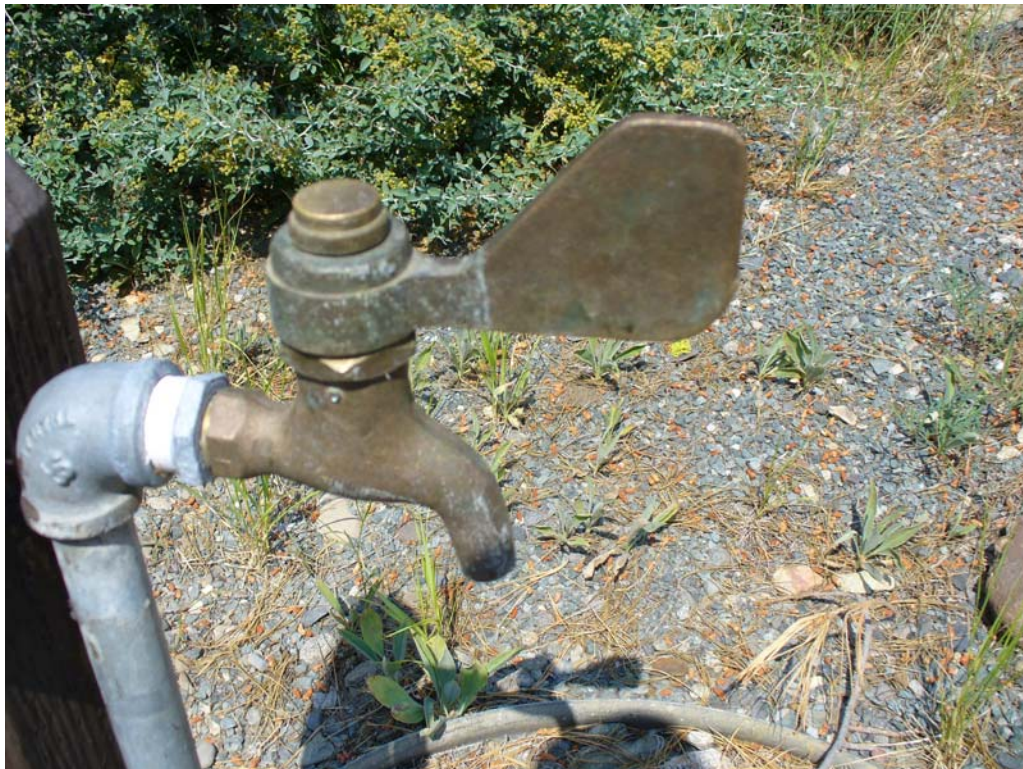
**Photo O-2-12. Example of disabled accessible faucet handle.**

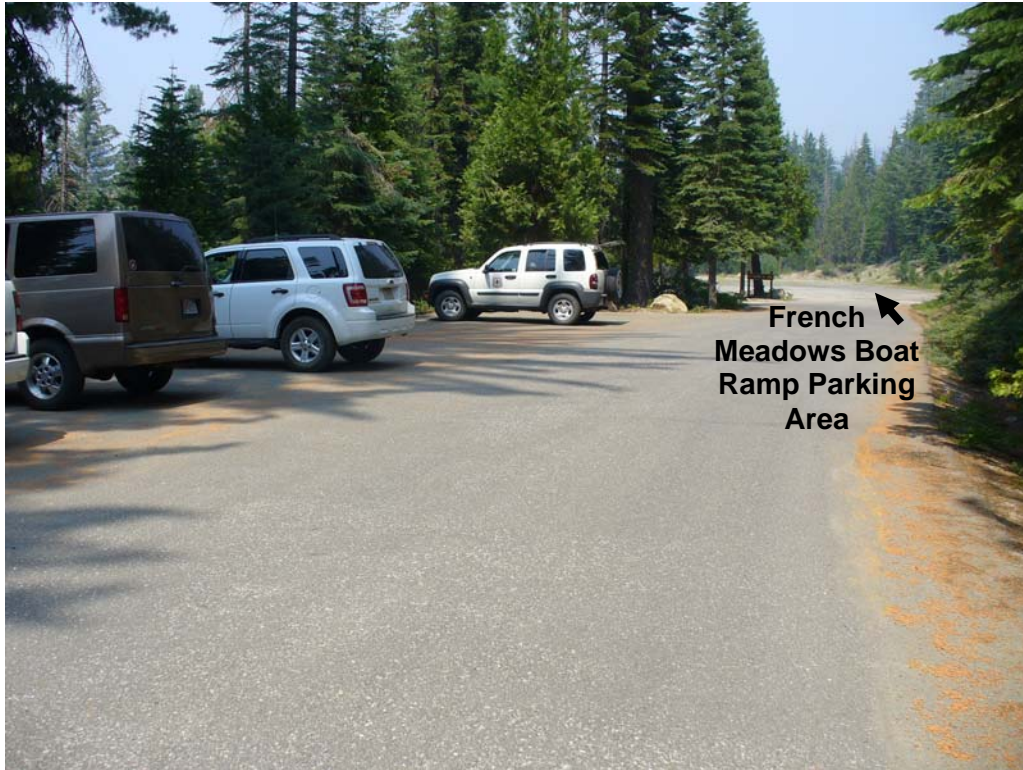
**Photo O-2-13. French Meadows Picnic Area Parking. Parking and roadway surfaces are in good condition. Note Boat Ramp Parking Area in background. (7/23/08)**

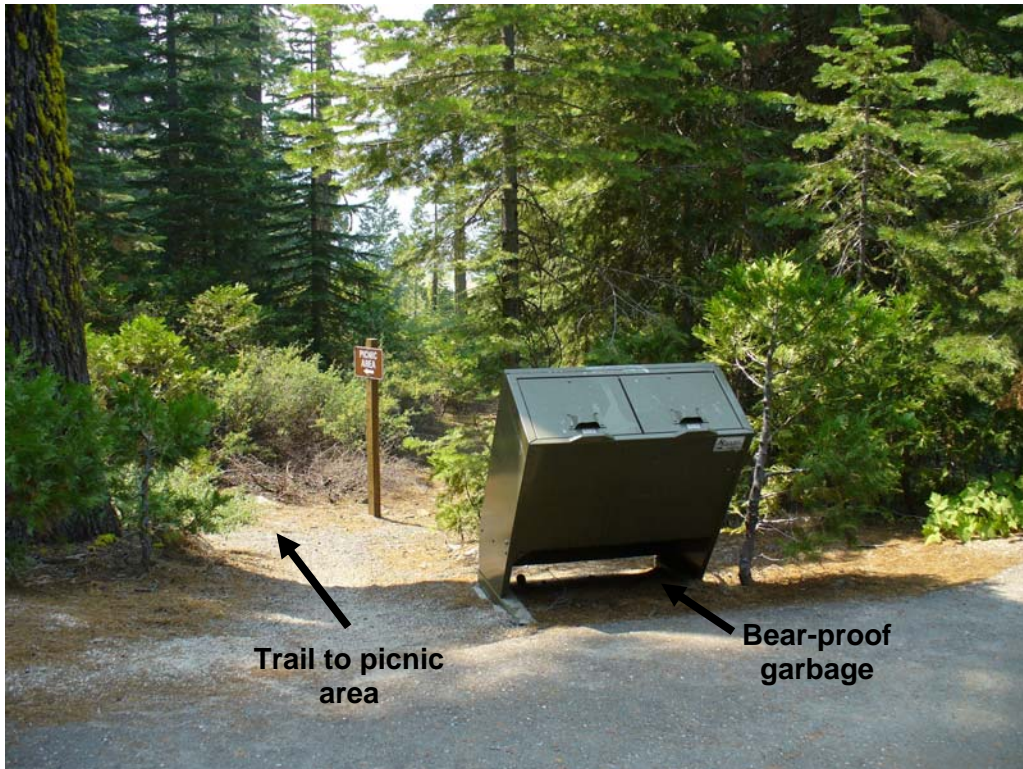
**Photo O-2-14. Entrance to French Meadows Picnic Area. (7/23/08)**

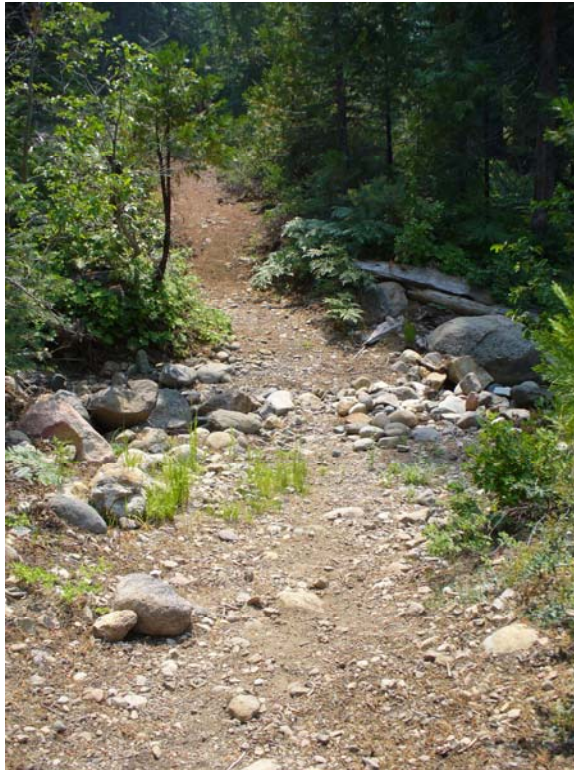
**Photo O-2-15. Trail to French Meadows Parking Area. Trail is not considered disable accessible due to obstacles, level changes, excessive slope, and narrow width. (7/23/08)**

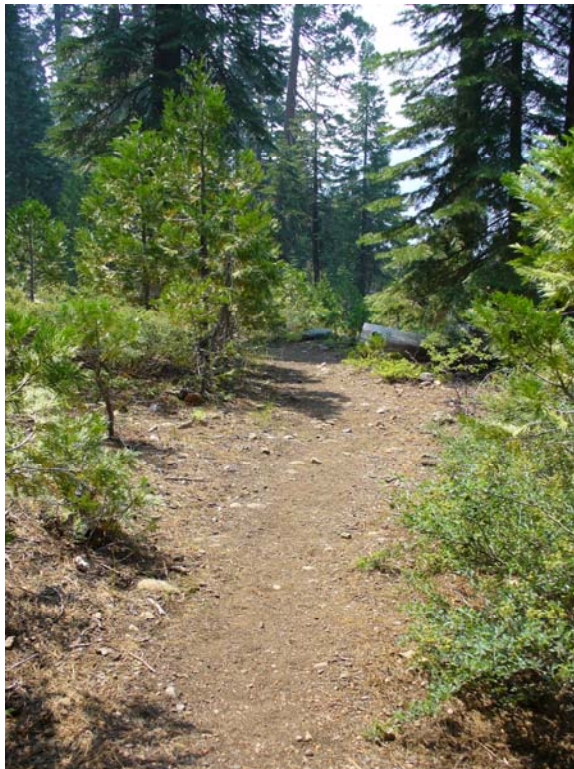
**Photo O-2-16. Trail to French Meadows Parking Area. (7/23/08)**

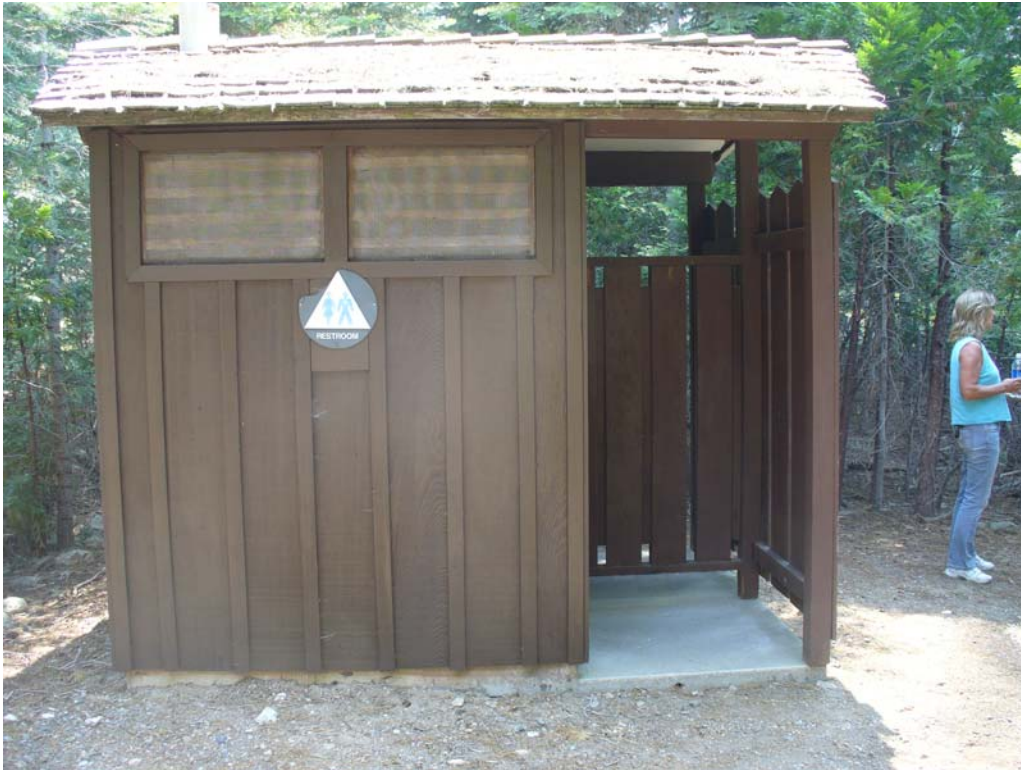
**Photo O-2-17. Two-unit vault toilet located in French Meadows Picnic Area. This toilet does not meet accessibility standards due to narrow entrance width, level changes (e.g., concrete lip) and absence of hand rails. (7/23/08)**

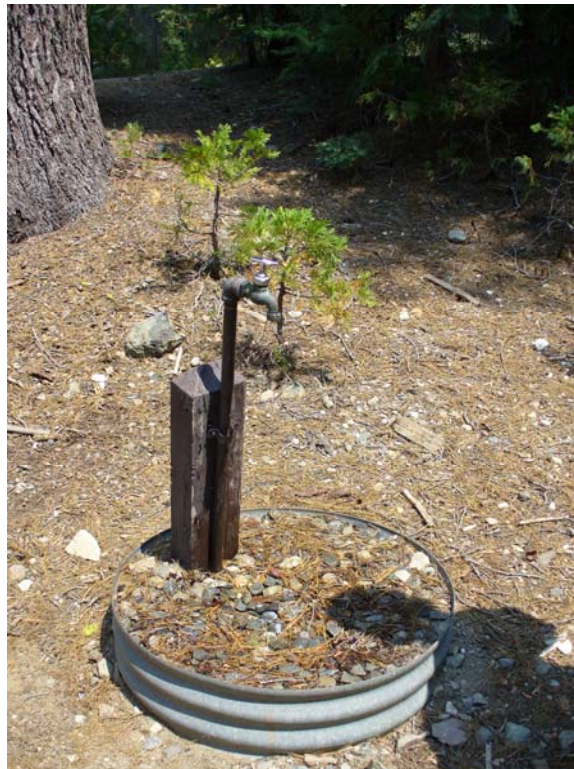
**Photo O-2-18. Water faucet near vault toilet. Does not meet accessibility standards due to handle design, obstacles, and level changes. (7/23/08)**

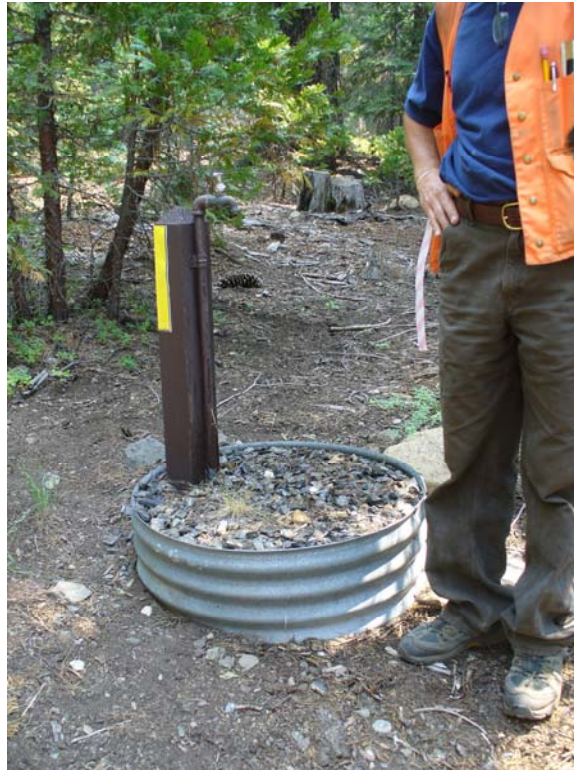
**Photo O-2-19. Water faucet in picnic area. Does not meet accessibility standards due to handle design and level changes. (7/23/08)**

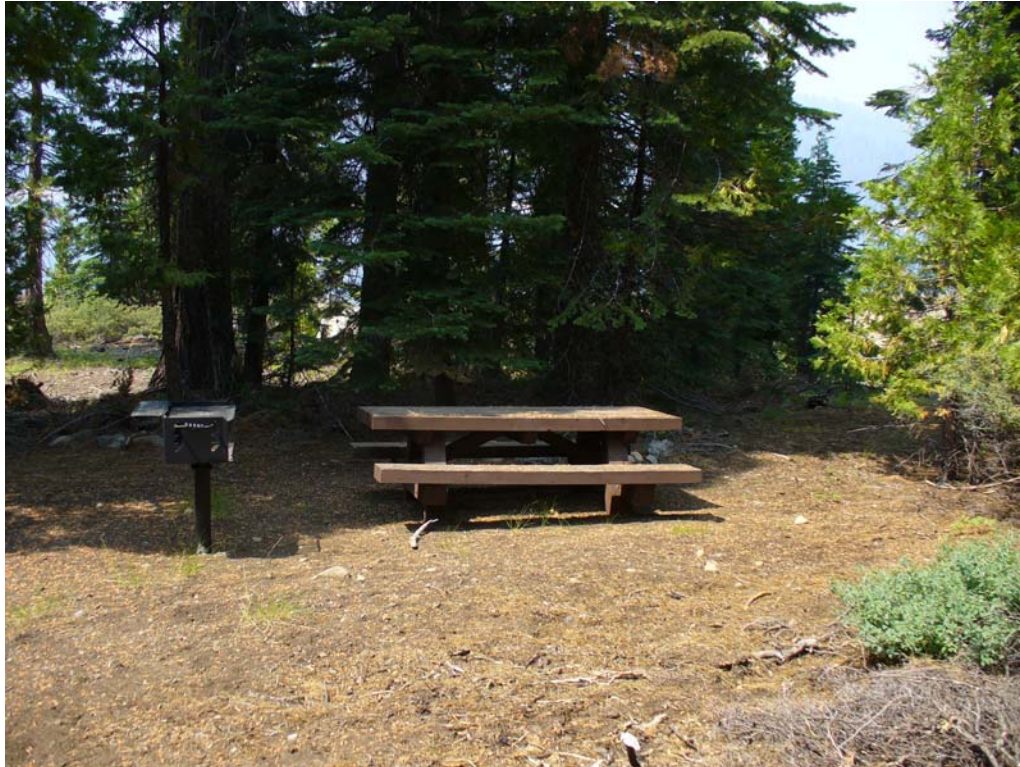
**Photo O-2-20. Typical picnic site in the French Meadows Picnic Area. Note the pedestal grill and wood picnic table. Neither are disabled accessible. (7/23/09)**
