**Placer County Water Agency
Middle Fork American River Project
(FERC No. 2079)**

**REC 1 – RECREATION USE AND FACILITIES
TECHNICAL STUDY REPORT**

Placer County Water Agency
P.O. Box 6570
Auburn, CA 95604

May 2010

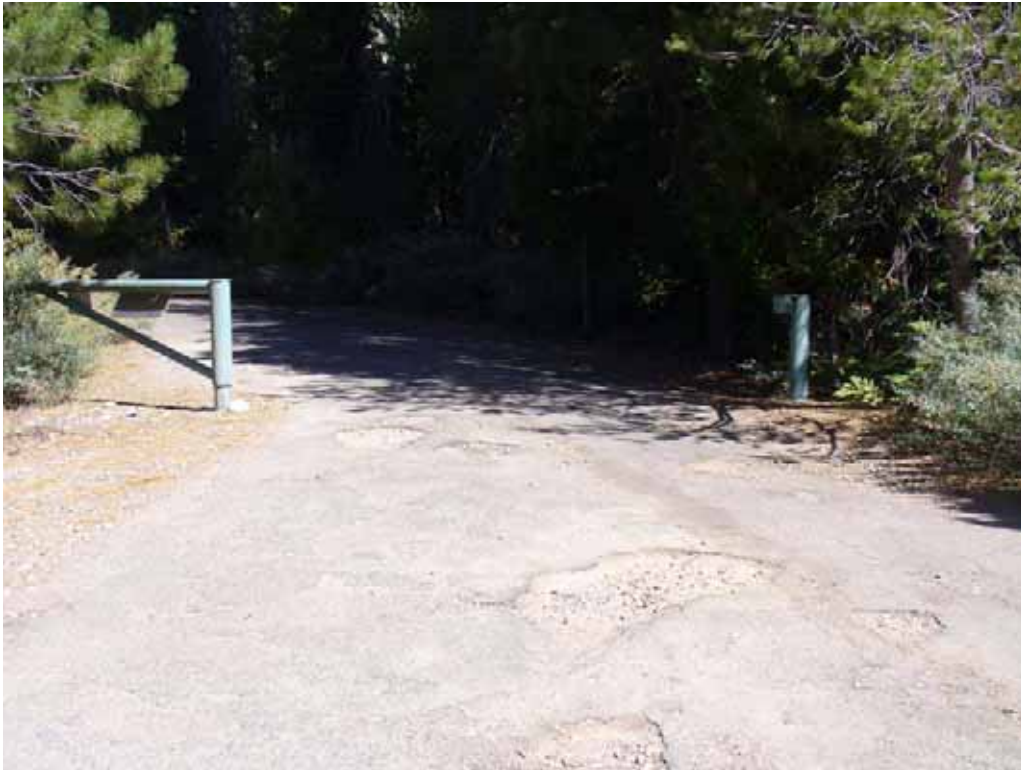
Photo D-2-3. Poor condition road surface at entrance to Big Meadows Campground. (8/21/08)

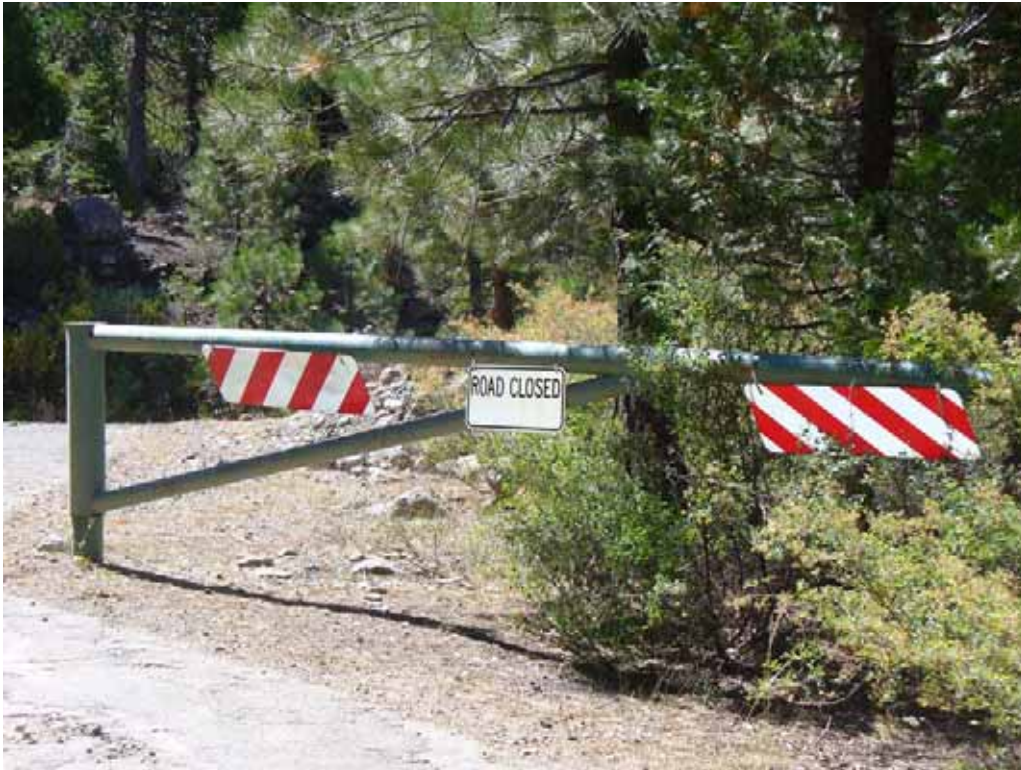
Photo D-2-5. Painted steel swing gate with reflective hazard signs at entrance to Big Meadows Campground. (8/21/09)

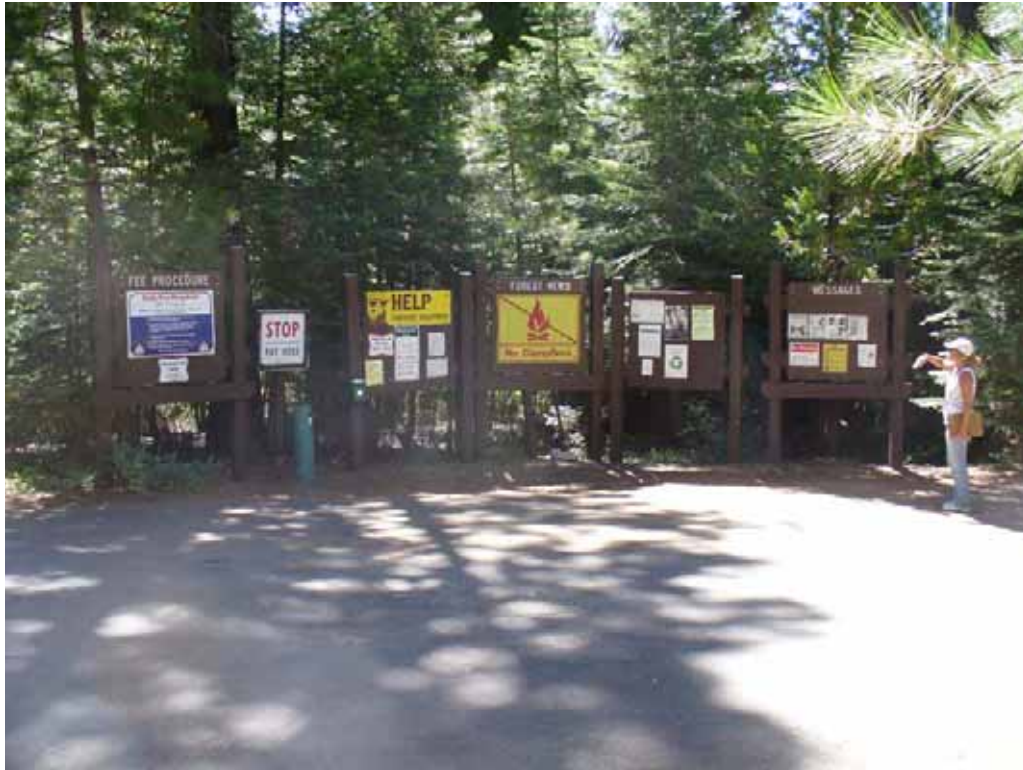
Photo D-2-7. Turn out and fee station at edge of Hell Hole Campground Parking Area. (8/21/08)

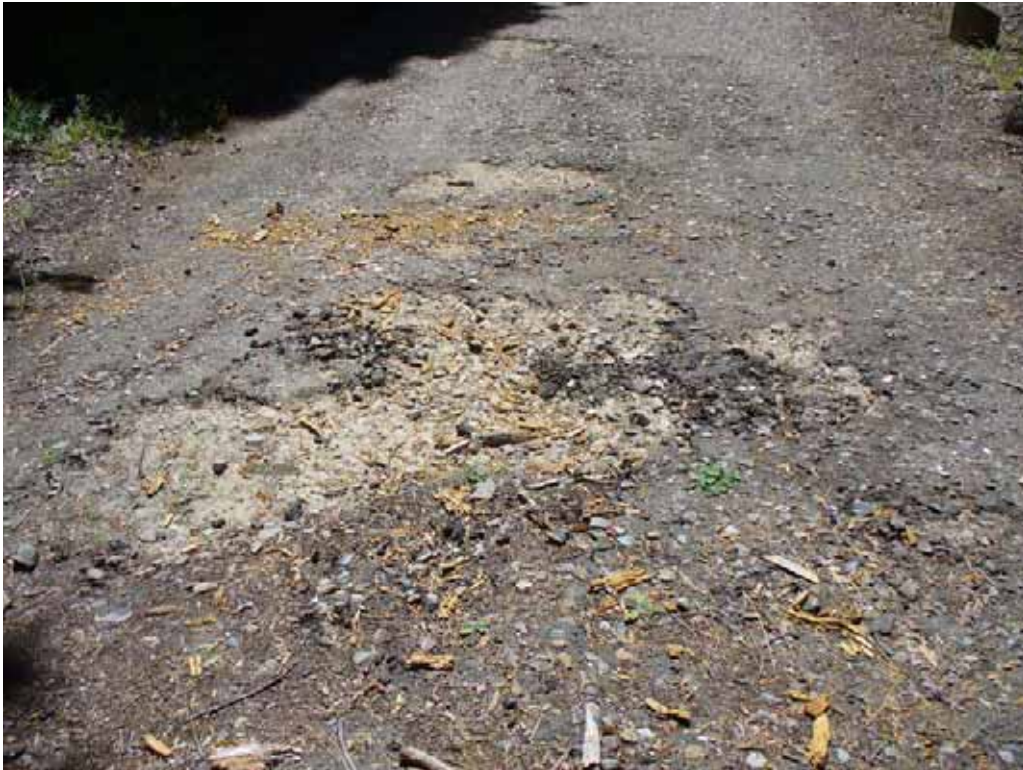
Photo D-2-9. Example of poor condition pavement in campsite spur. (8/21/08)

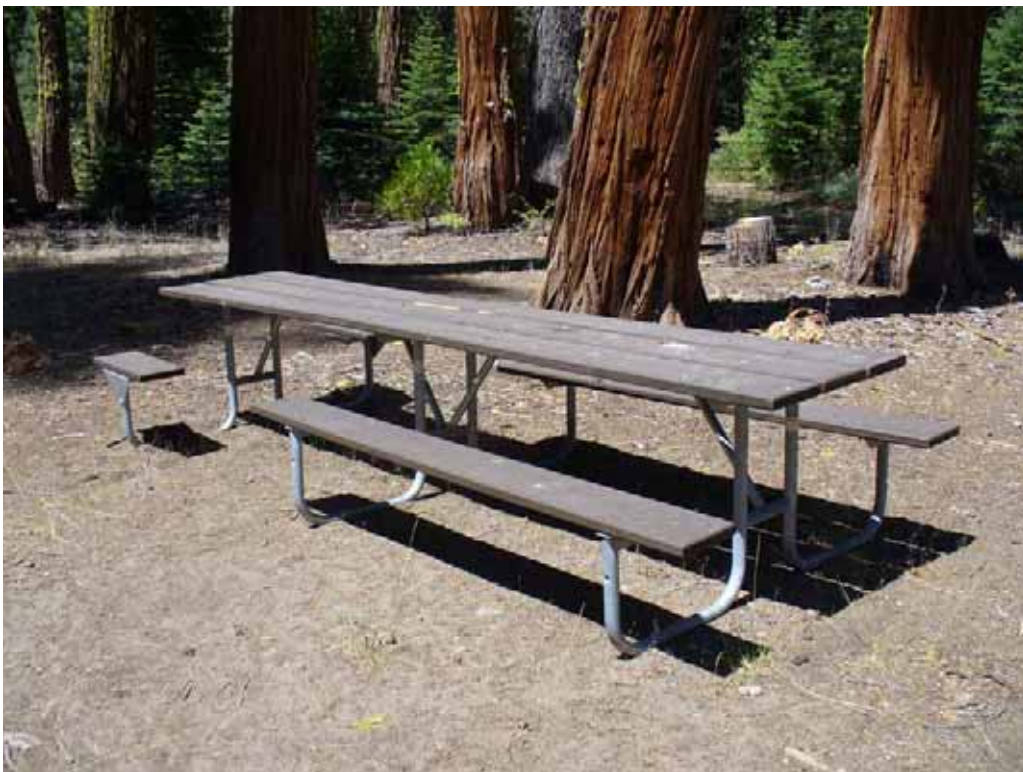
Photo D-2-14. Example of a double accessible table in good condition. (8/21/08)

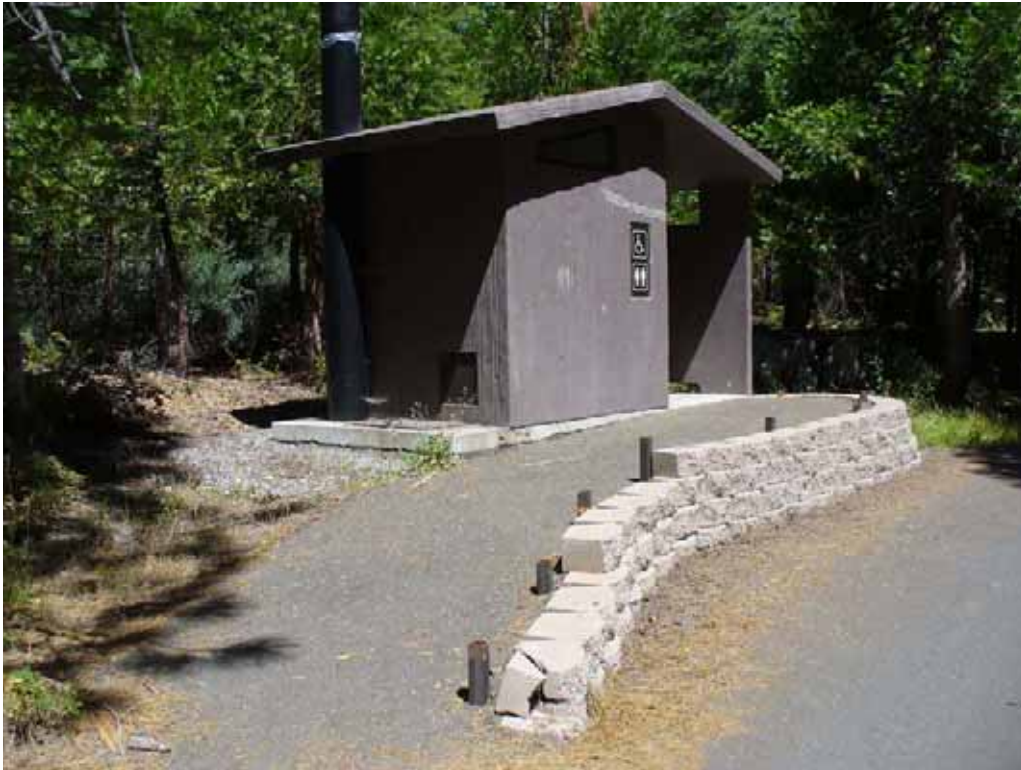
Photo D-2-15. New single-unit, pre-cast concrete toilet (CXT) – accessible. Note that ramp is missing handrail. The handrail was added later in 2008.

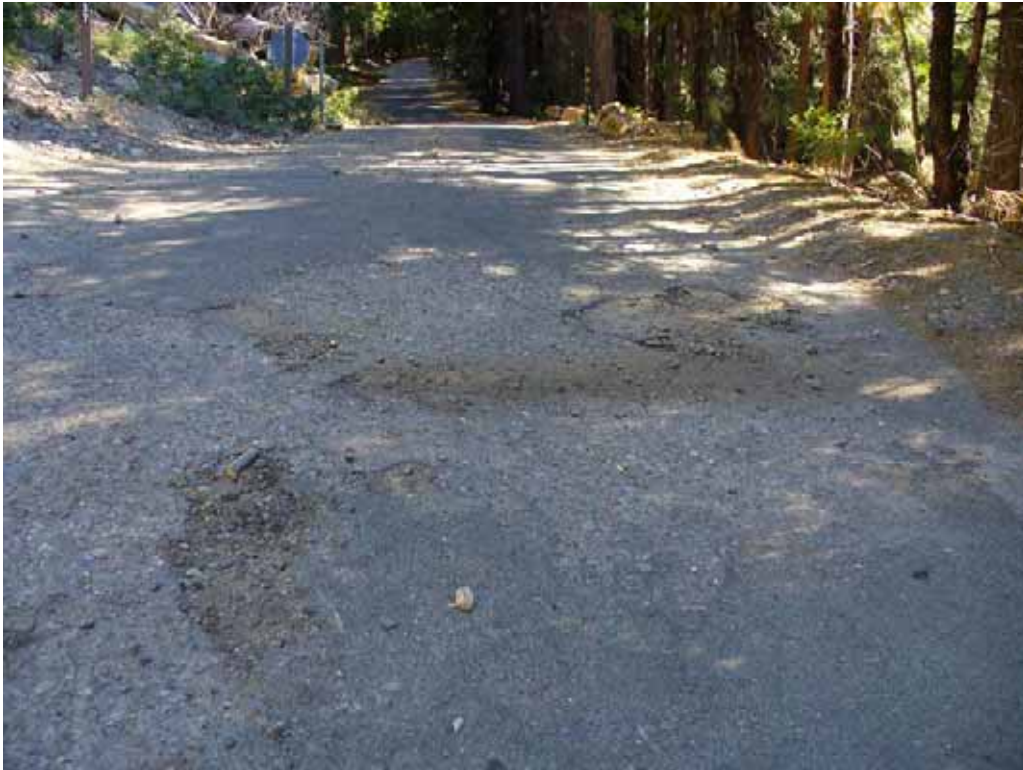
Photo E-2-3. Poor condition road surface at entrance to Hell Hole Campground. (8/21/08)

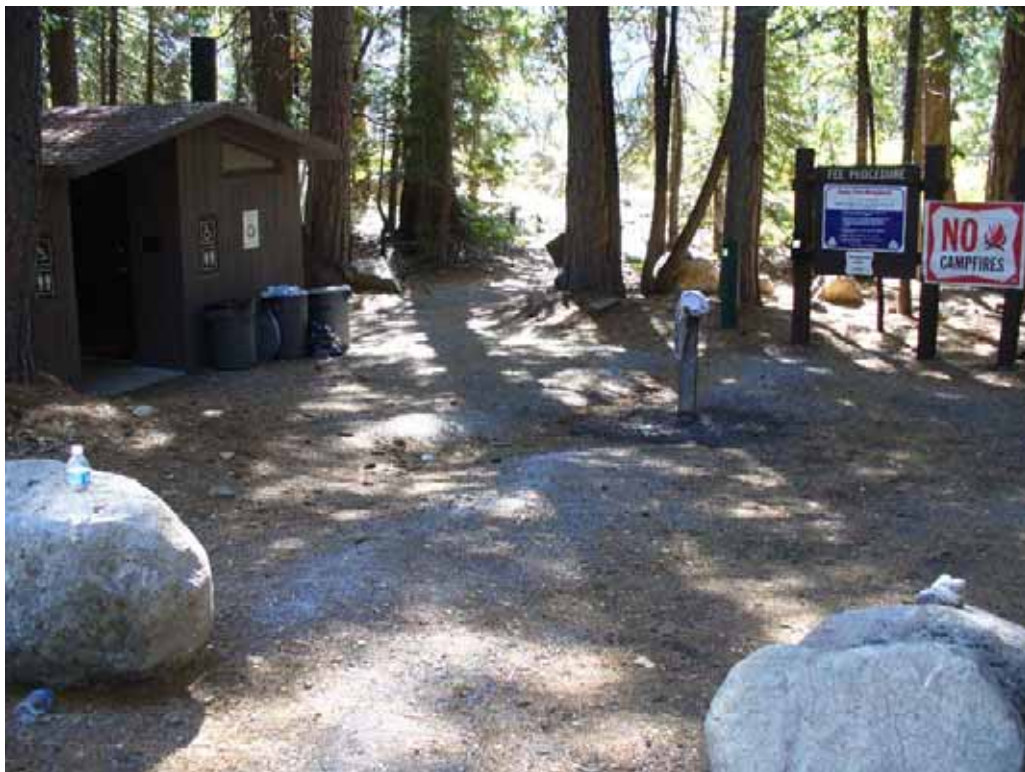
Photo E-2-14. Single unit, accessible, vault toilet adjacent to fee station. Note poor drainage conditions between water faucet and toilet. (8/21/08)

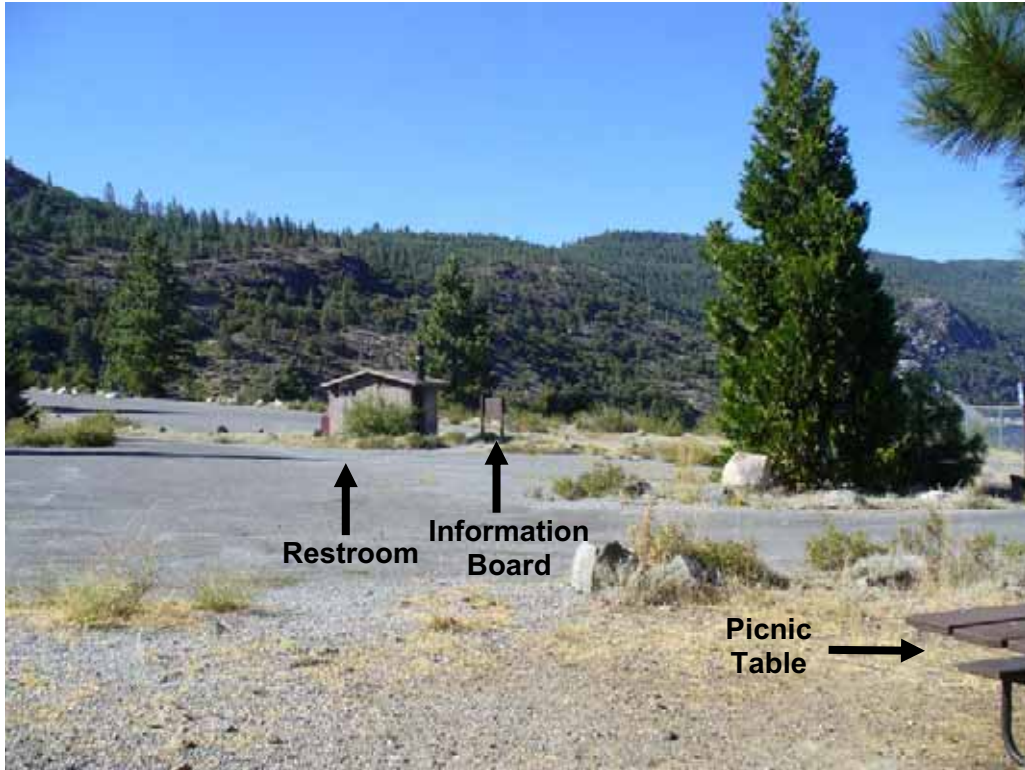
Photo H-2-21. Hell Hole Boat Ramp General Parking Area (southeastern portion). Surface is asphalt with chip seal in poor condition. Note restroom and information board in middleground and picnic table in foreground (right). (8/4/08)

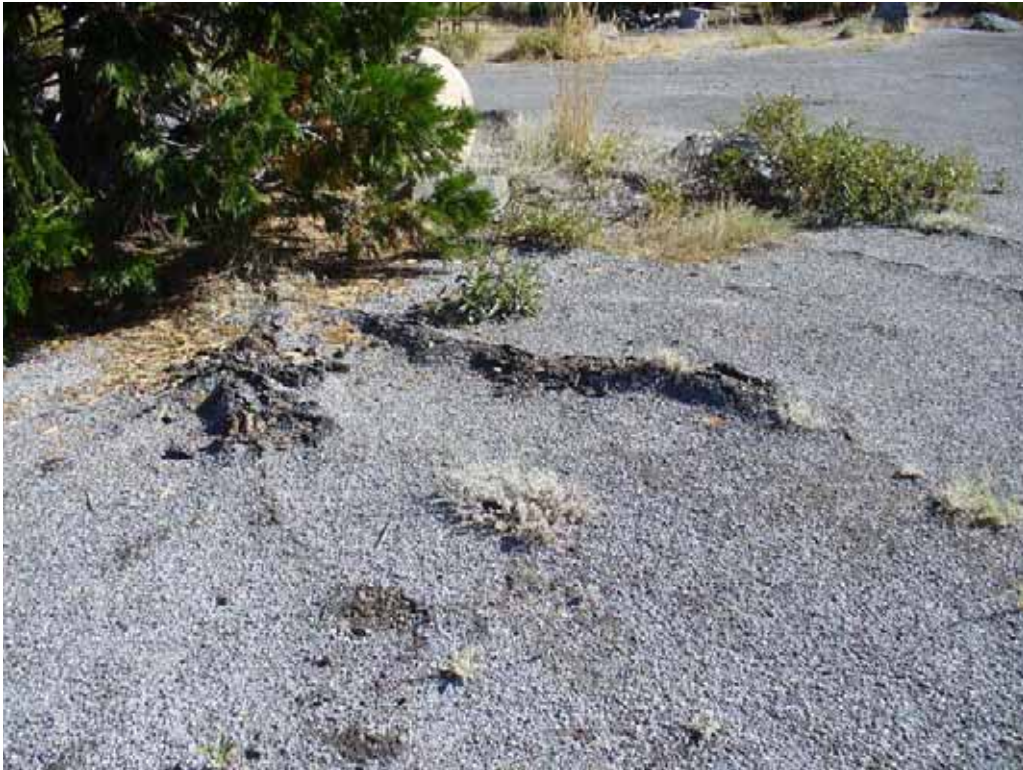
Photo H-2-27. Example of damaged surface in southeastern portion of parking area. (8/4/08)

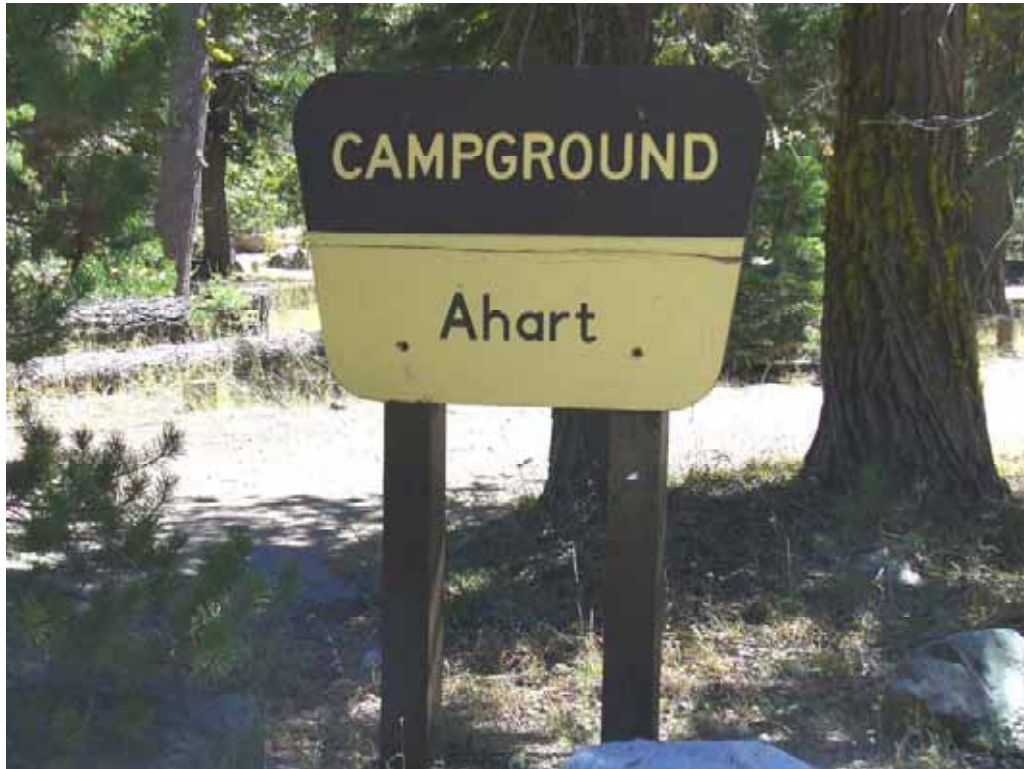
Photo I-2-2. Site identification sign at entrance to Ahart Campground. This site is in fair condition due to the large crack. (9/04/08)

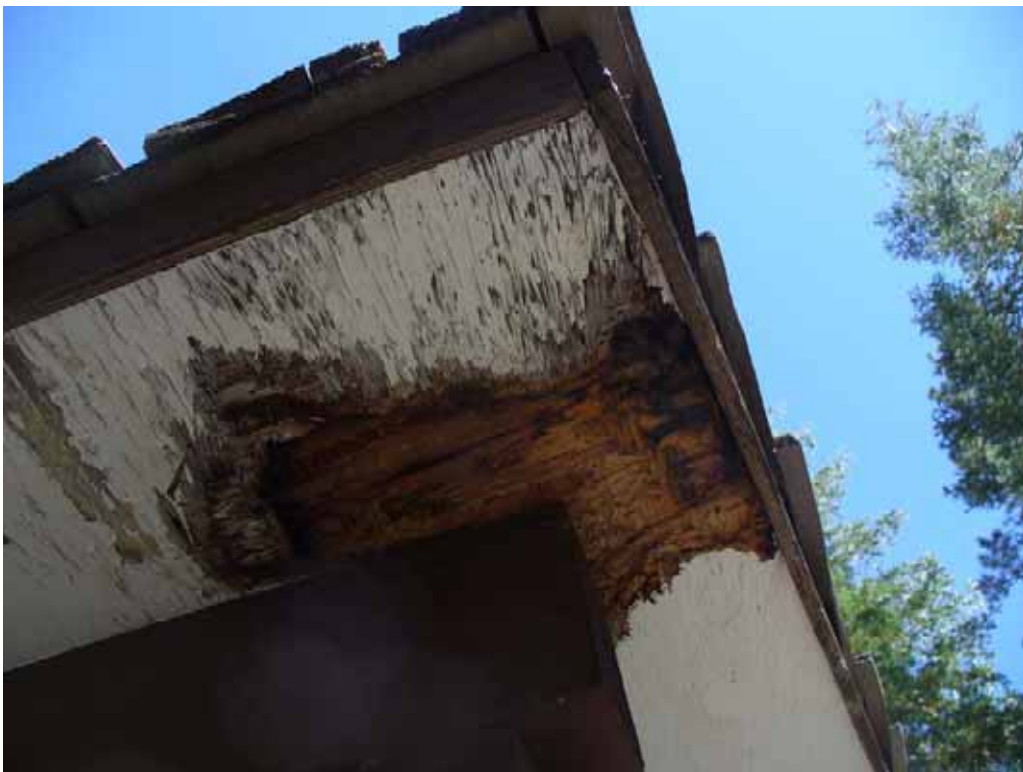
Photo I-2-14. Dry rot on roof and frame of toilet building No. 1. (9/04/08)

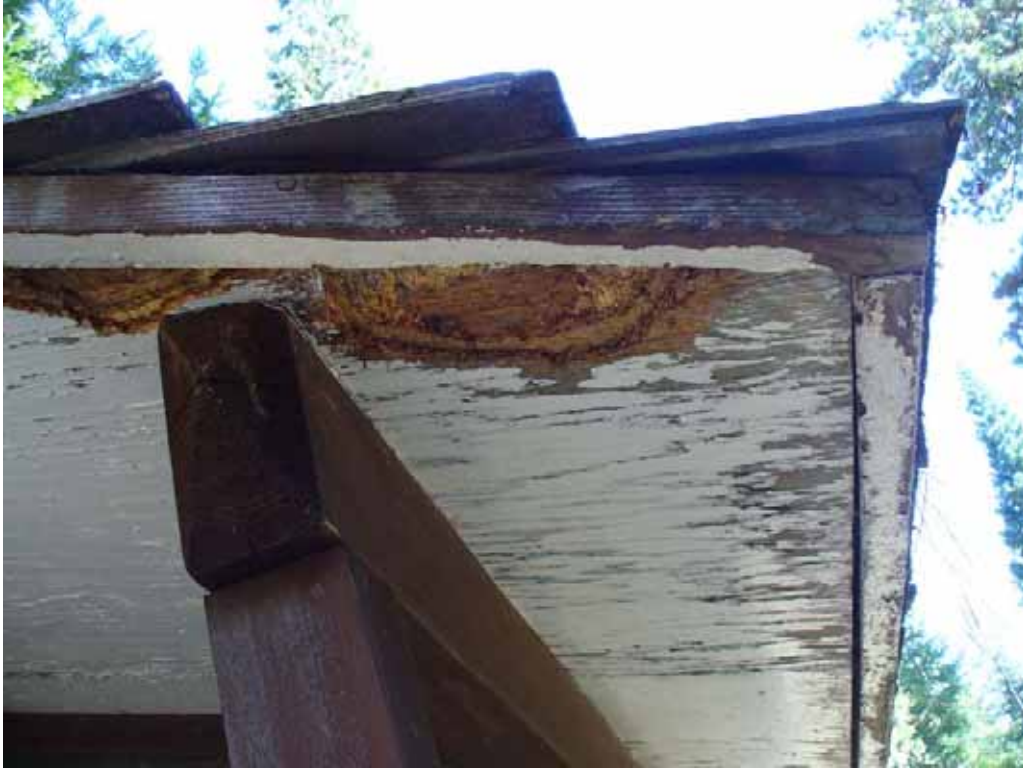
Photo K-2-11. Dry rot on bathroom structure No. 2. (9/04/08)

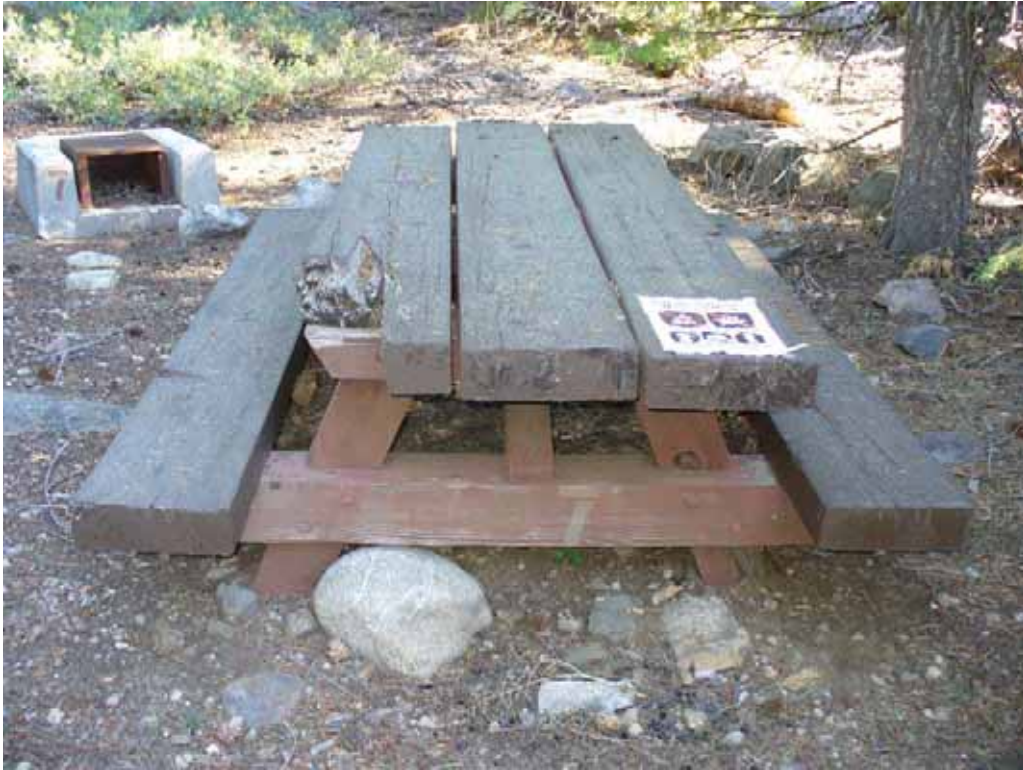
Photo L-2-21. Damaged table at Site 7. (7/24/08)

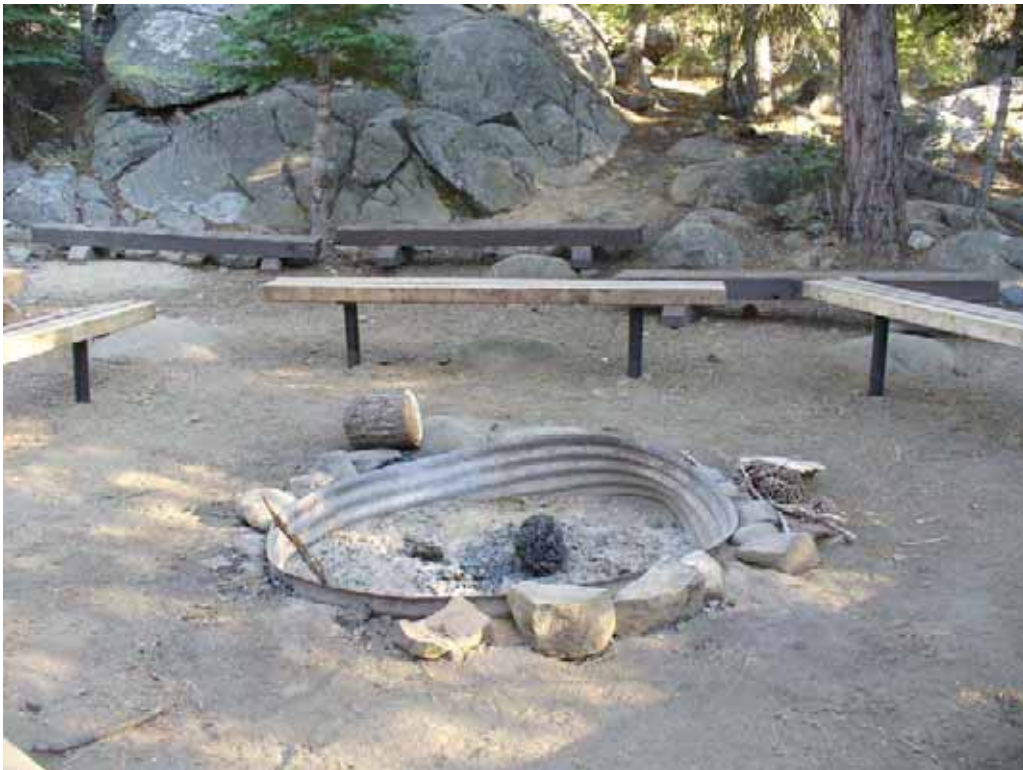
Photo N-2-14. Damaged group fire pit at Ponderosa. Note new benches in middle ground and old benches in background. (9/4/08)

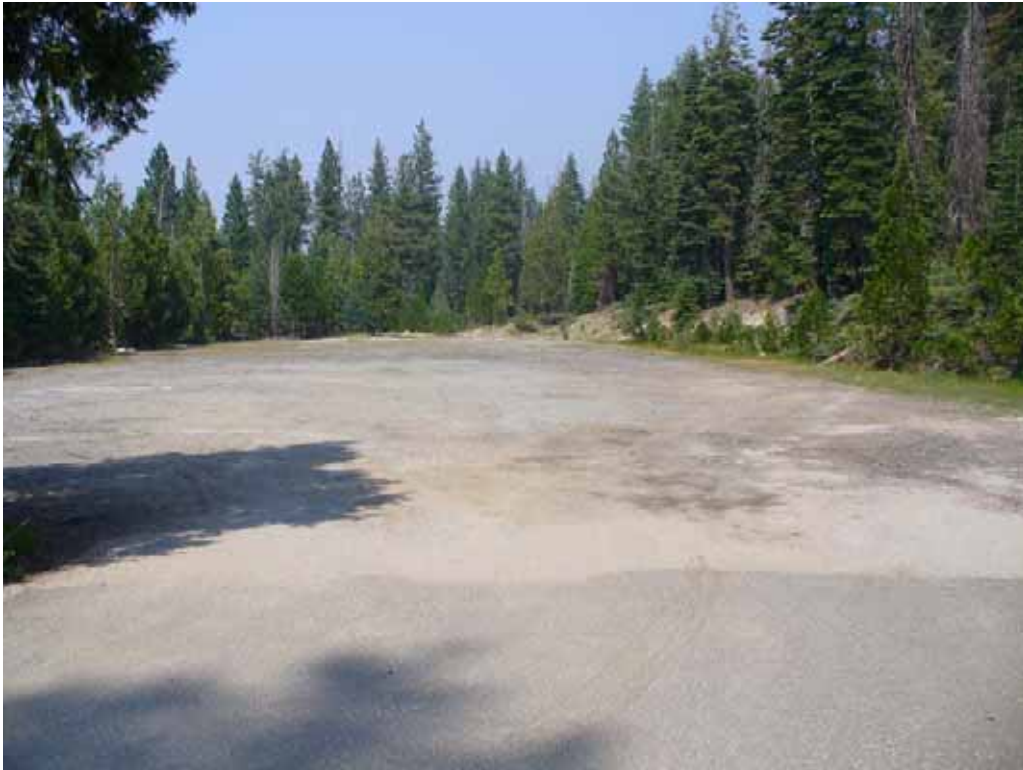
Photo O-2-5. French Meadows Boat Ramp Parking Area. Surface has deteriorated to aggregate base rock. (7/23/08)

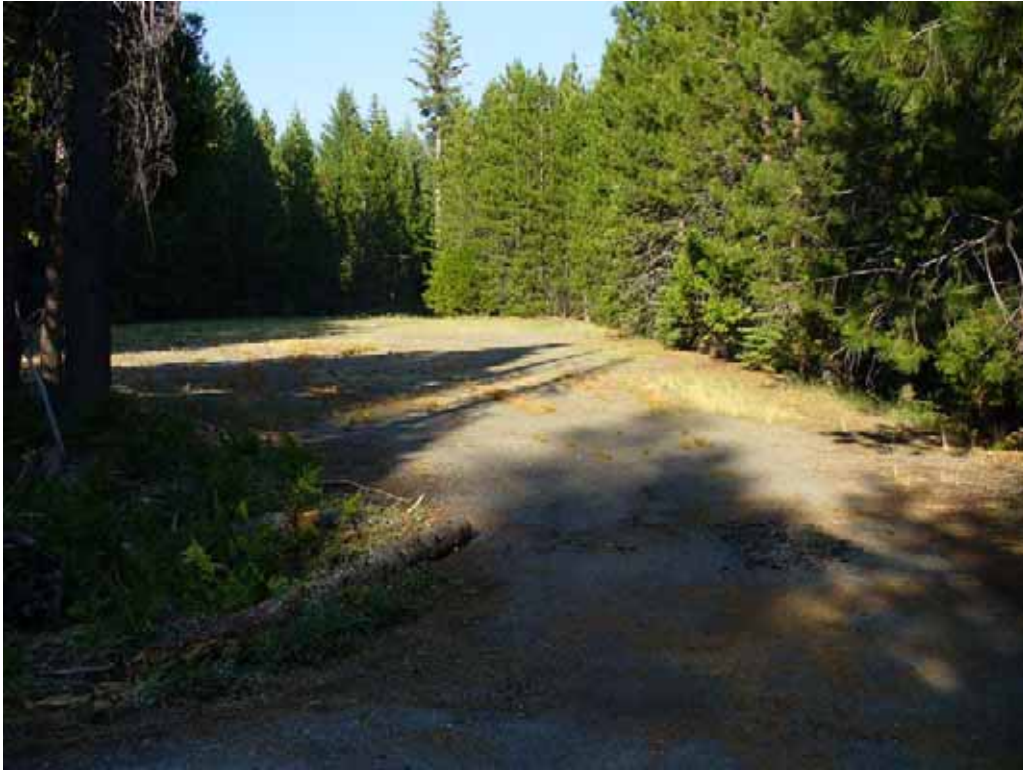
Photo P-2-9. South entrance to McGuire Boat Ramp Parking Area – northeast lot. Surface has deteriorated to base rock and is in poor condition. (7/23/08)

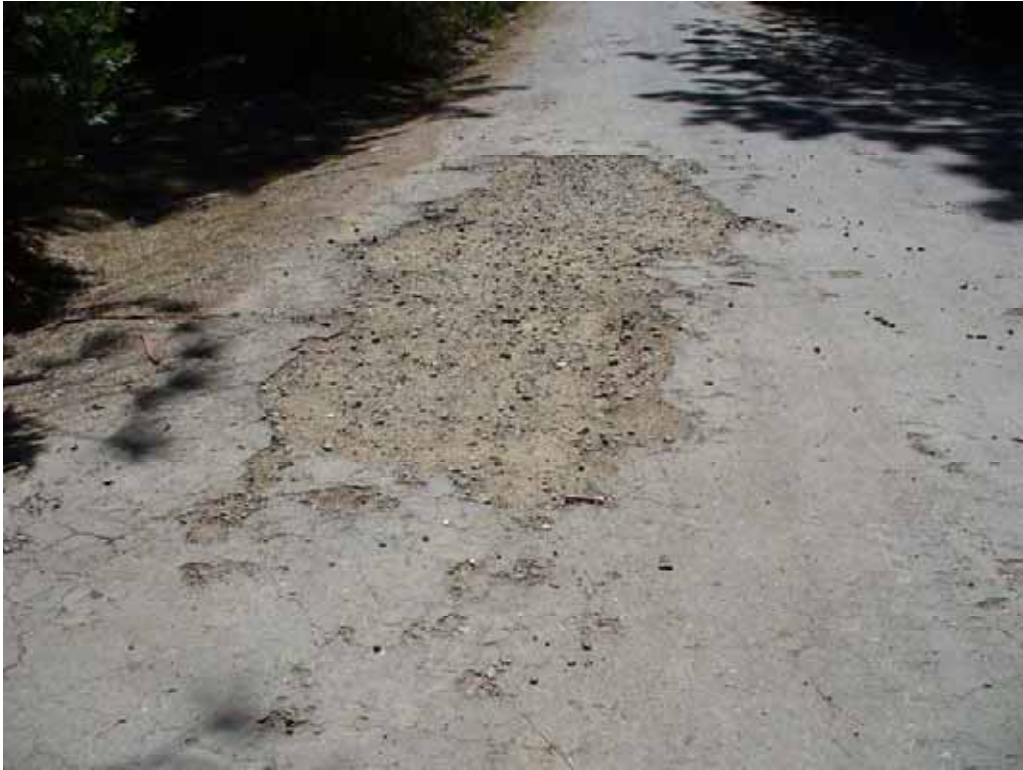
Photo R-2-3. Example of poor condition pavement along Middle Meadows Campground Access Road (14N28). (8/21/08)

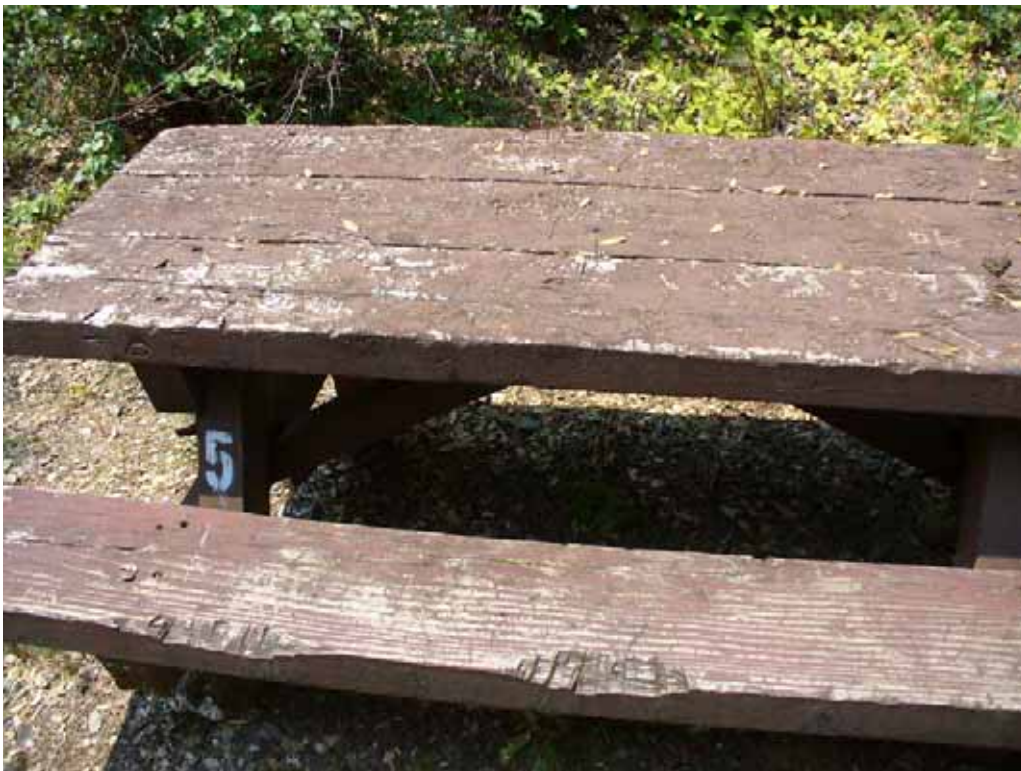
Photo S-2-6. Site 5 picnic table. Table is in poor condition and does not meet accessibility standards.

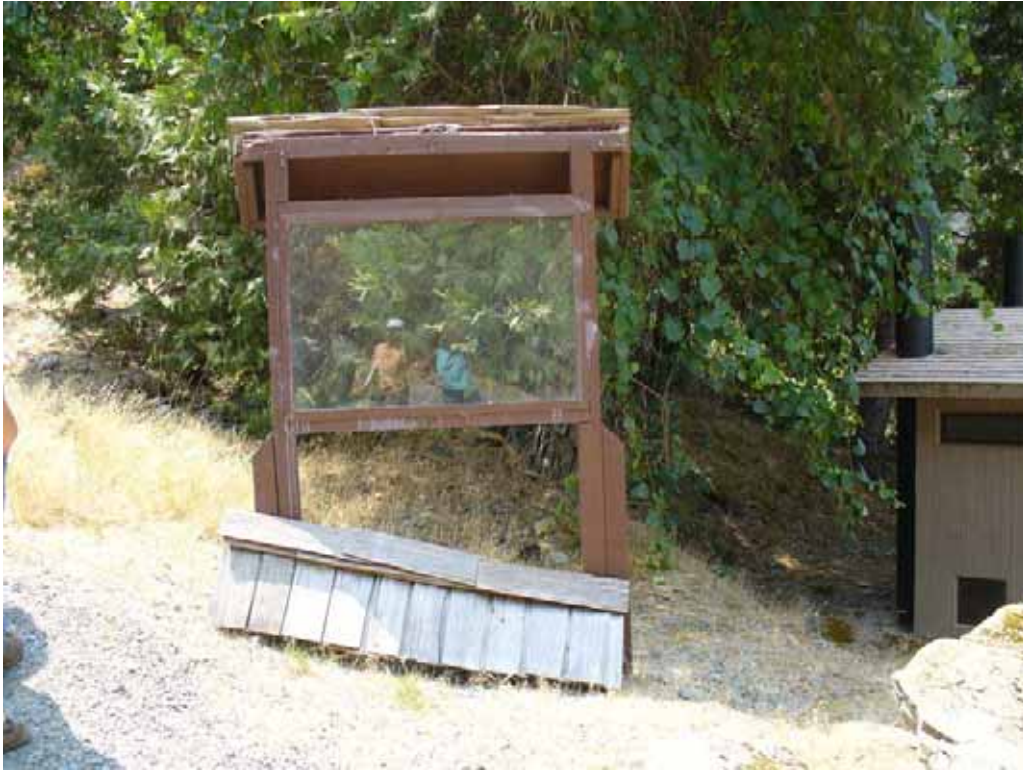
Photo T-2-9. Damaged information board adjacent to CXT upslope from parking area. (7/23/08)

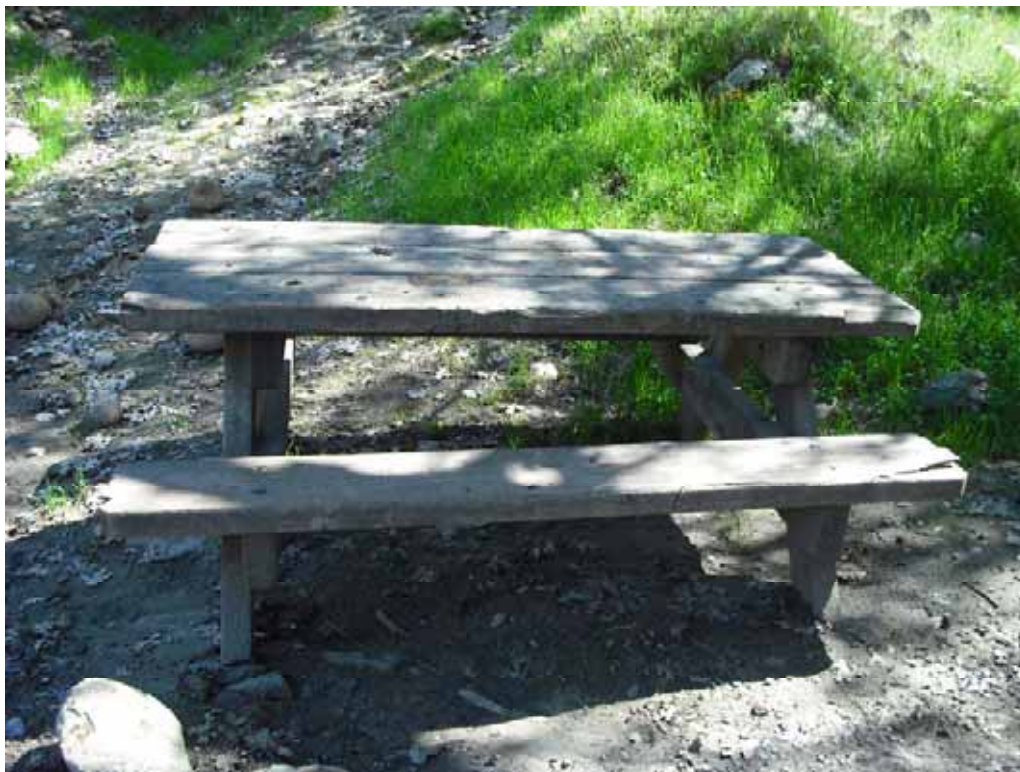
Photo V-2-24. Example of heavy wood picnic table in Campsite 4. Campsite 4 includes two tables. Both are damaged and are in poor condition. (3/12/09)

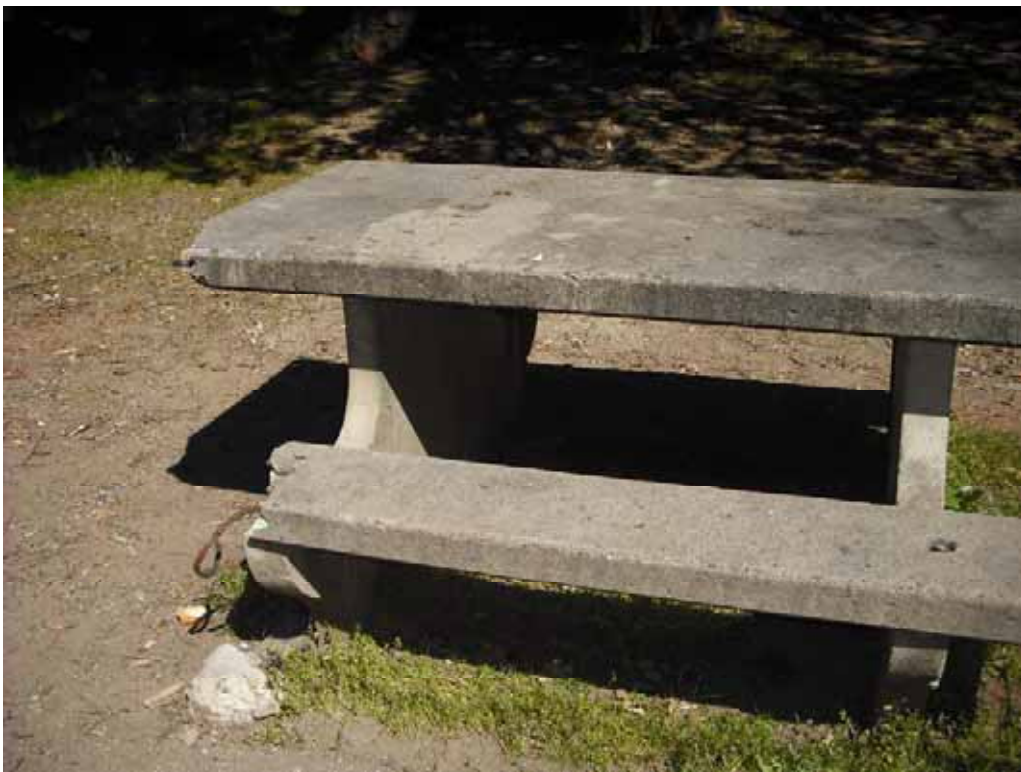
Photo V-2-26. Concrete table located in Campsite 5. Table is damaged and in poor condition. (3/12/09)
