Placer County Water Agency

Re: FERC Project No. 2079-CA; NATDAM No. CA00856
Ralston Afterbay Dam, State of California No. 1030-4, Placer County

September 20, 2004

Ralston Afterbay Spillgate Incident Investigation

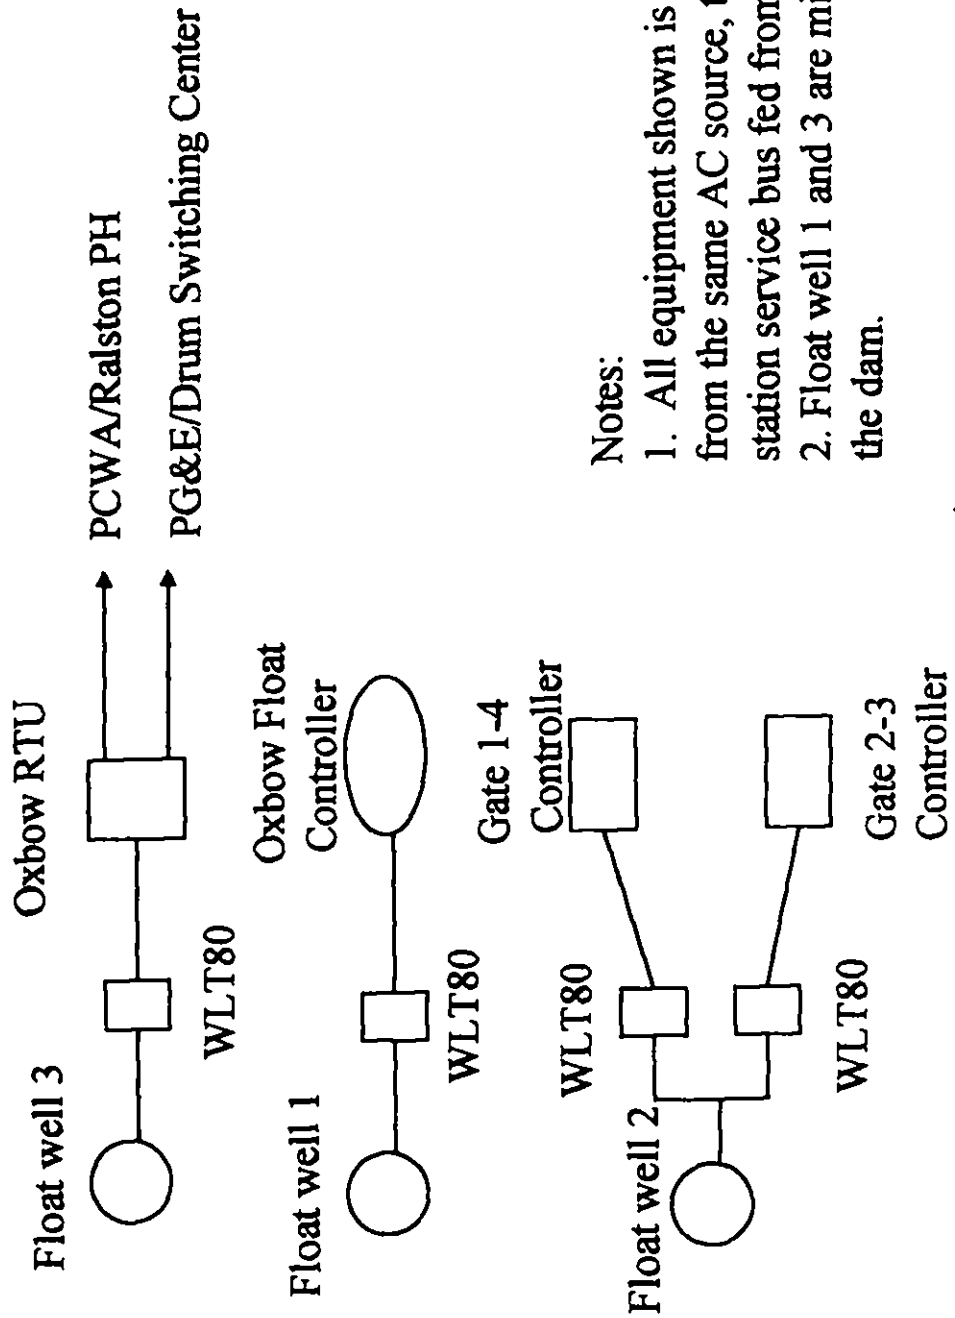
Placer County Water Agency Ralston Afterbay Spillgate/Float Controls

- Floatwell 1, which feeds the Oxbow Powerhouse float controller, has a 10' range. When water levels are below the 10' range, it does not provide an accurate indication on the powerhouse LED readout of the reservoir water level. Ralston Afterbay was below the operable range of floatwell 1 at the beginning of the black start testing.
- Floatwell 2, which feeds the spillgate controllers, has a single float, but drives two separate Sierra Control Systems WLT80s. One WLT80 sends water elevation information to gate 1 & 4 controller and the other WLT80 sends water elevation information to gate 2 & 3 controller. No data is

- Floatwell 3 which feeds water elevation information to SCADA at Ralston and Drum powerhouses was found to be hung up and sticking immediately after the gates were closed. Clearly erroneous Ralston Afterbay SCADA water level alarms were received at Drum beginning 26 minutes 54seconds after the first gate operation at 5:57 a.m. and persisted for approximately 1hr. 45 minutes into the incident. The float was freed and normal readings were resumed. PCWA's hydrographer speculates that it hung up during the rapid drawdown caused by the gate opening (personal communication-Steve Jones).

- **Conclusion – Malfunction of the WLT80s has not been ruled out. The floats themselves are not likely to be factors in the incident. While the float in floatwell 1 was found hung up, it is likely that the float hung up as a result of the gate opening and closing. We do not believe the float was a likely contributor to the incident.**
- **Recommendation 4 – Test all WLT80s to ensure that they are sending accurate signals. Check for carbon tracking which is known to be a maintenance problem with WLT80s.**
- **Recommendation 5 – Extend the range of floatwell 1 (Oxbow float controller) to full range. This would be desirable, but not absolutely necessary if a SCADA monitor is installed in Oxbow Powerhouse control room.**
- **Recommendation 6 – Consider changing floatwell equipment to DC power supply.**
