Appendix D-2
Big Meadows Campground
Photographs

Photo D-2-1. Site identification sign at entrance to Big Meadows Campground. (8/21/08)

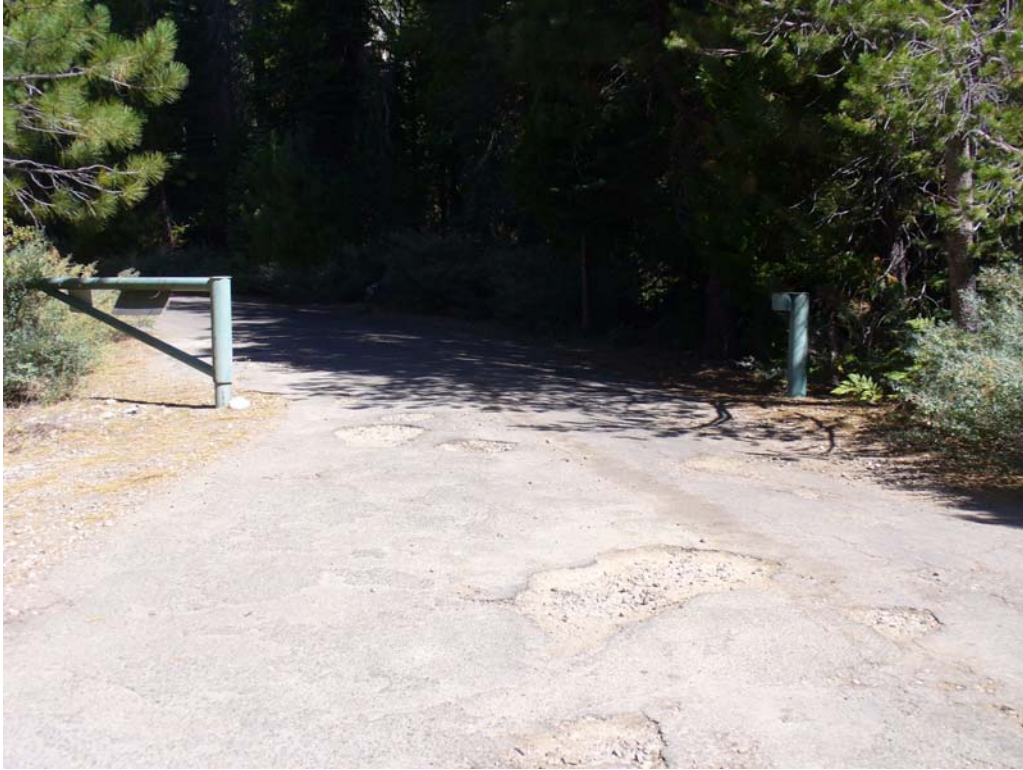
Photo D-2-3. Poor condition road surface at entrance to Big Meadows Campground. (8/21/08)

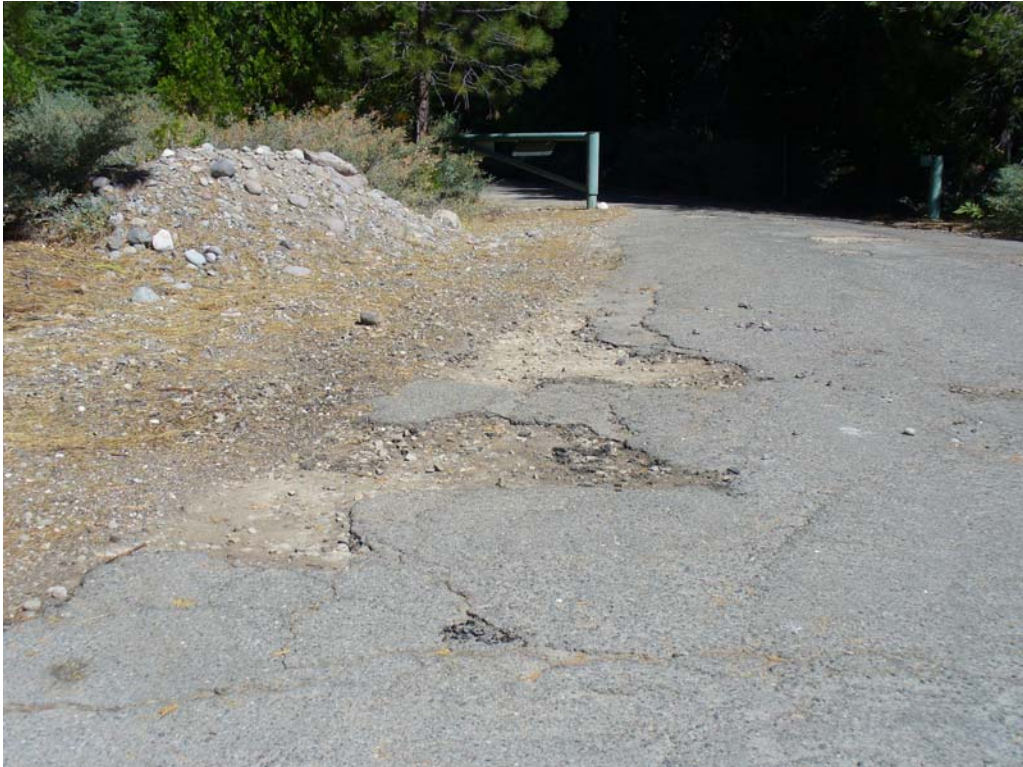
Photo D-2-4. Poor condition road surface at entrance to Big Meadows Campground. (8/21/08)

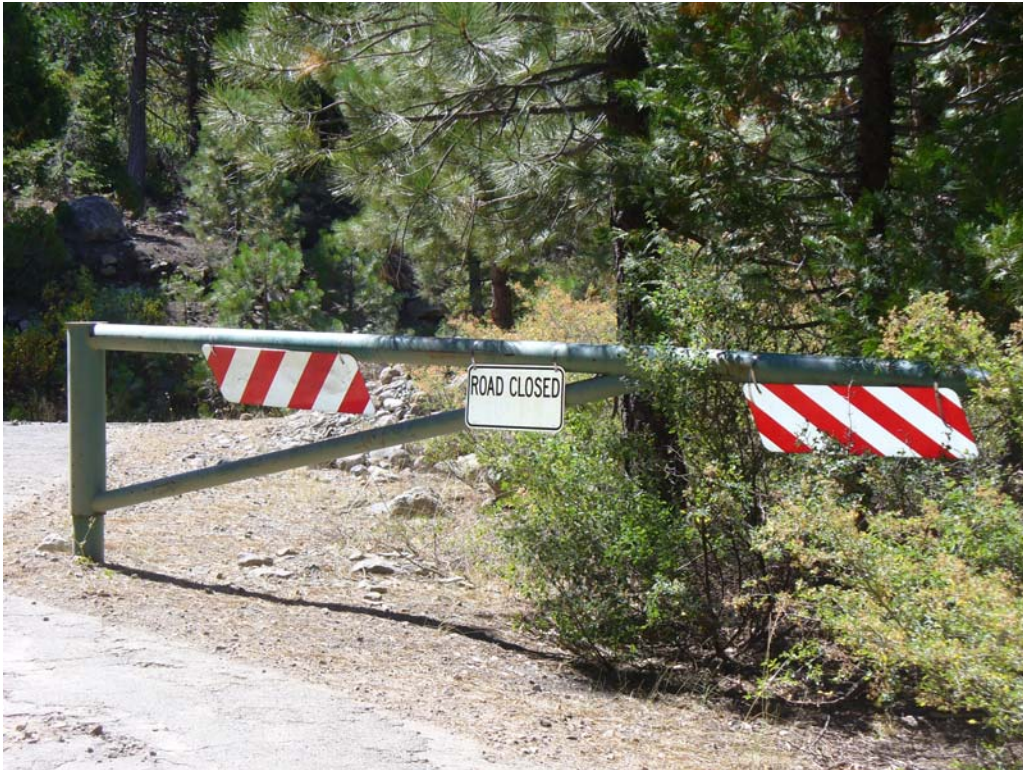
Photo D-2-5. Painted steel swing gate with reflective hazard signs at entrance to Big Meadows Campground. (8/21/09)

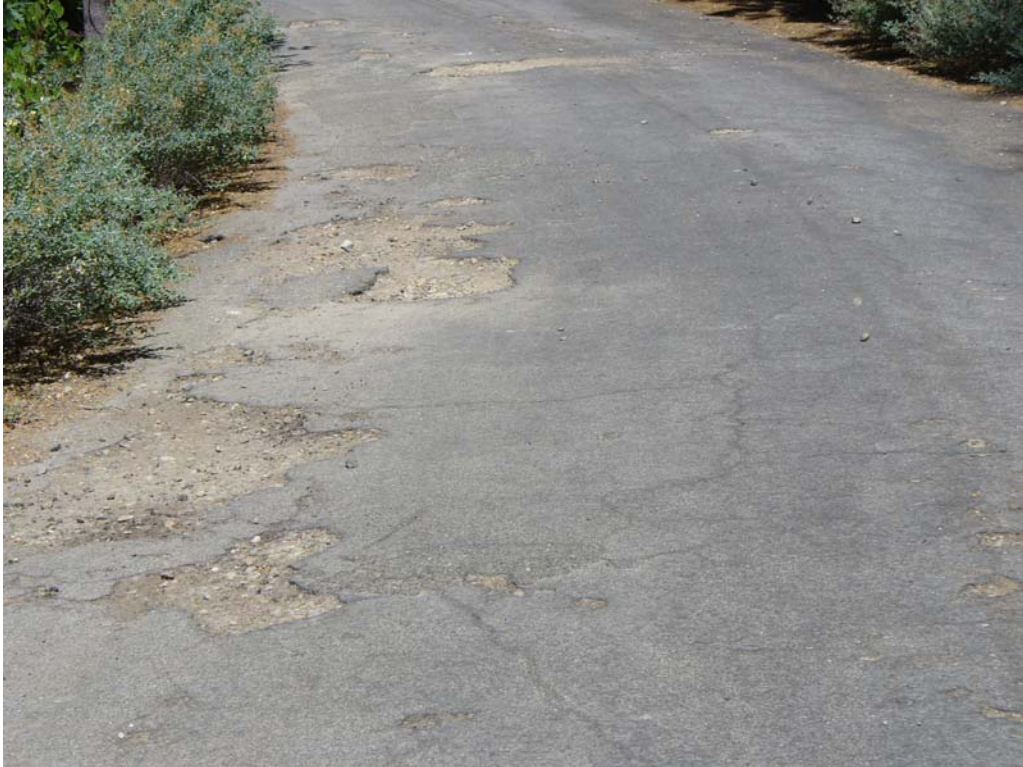
Photo D-2-6. Poor condition pavement along 14N43, the access road to Big Meadows Campground (8/21/08).

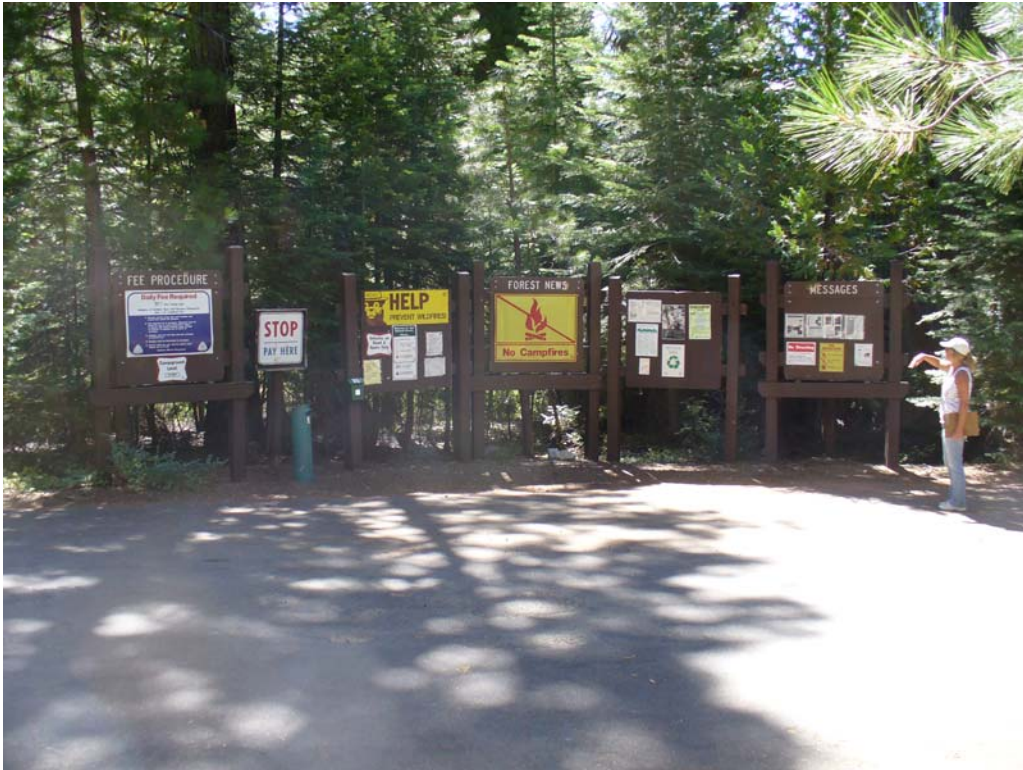
Photo D-2-7. Turn out and fee station at edge of Hell Hole Campground Parking Area. (8/21/08)

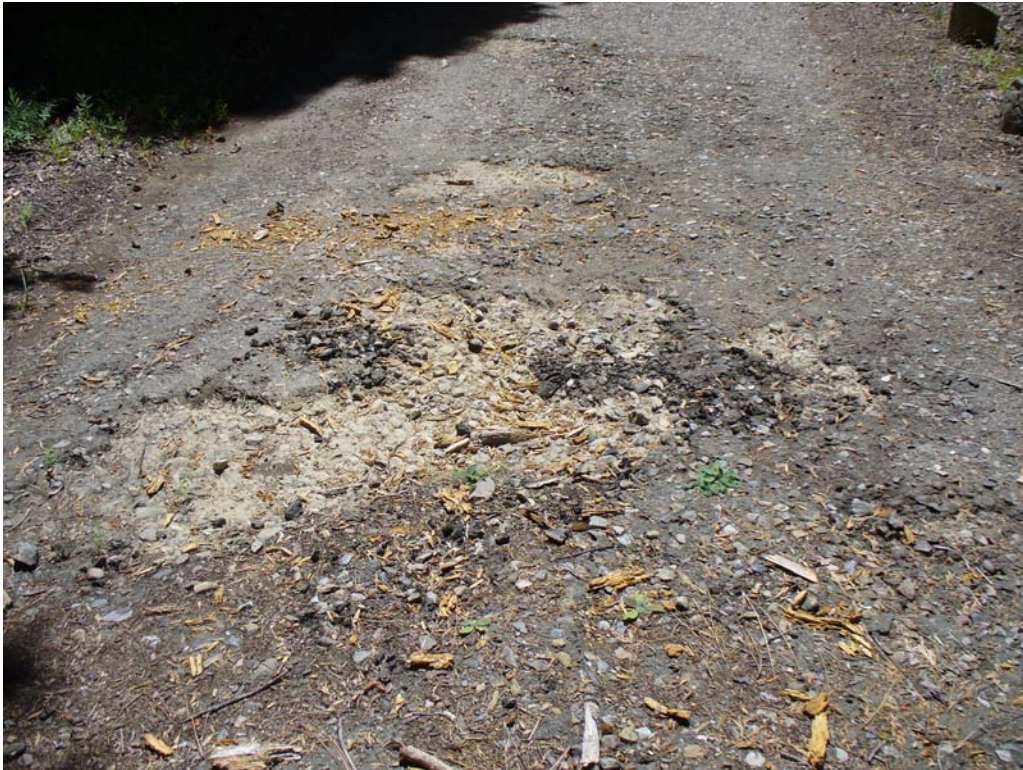
Photo D-2-9. Example of poor condition pavement in campsite spur. (8/21/08)

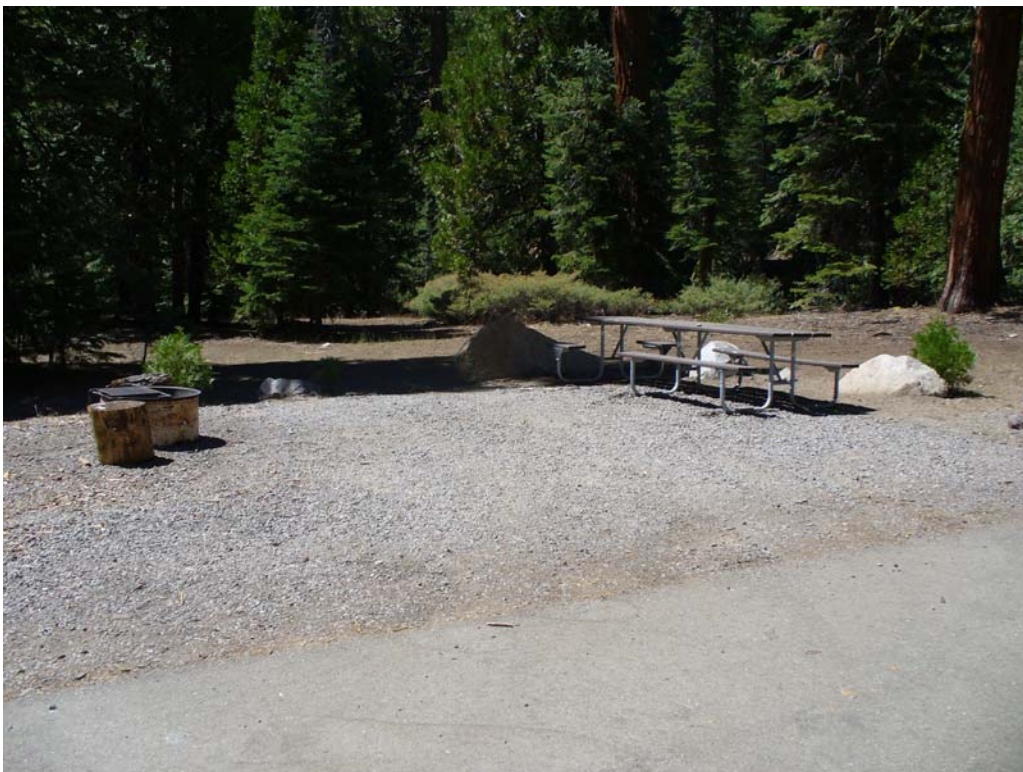
Photo D-2-10. Fully accessible site – Site 52. (8/21/08)

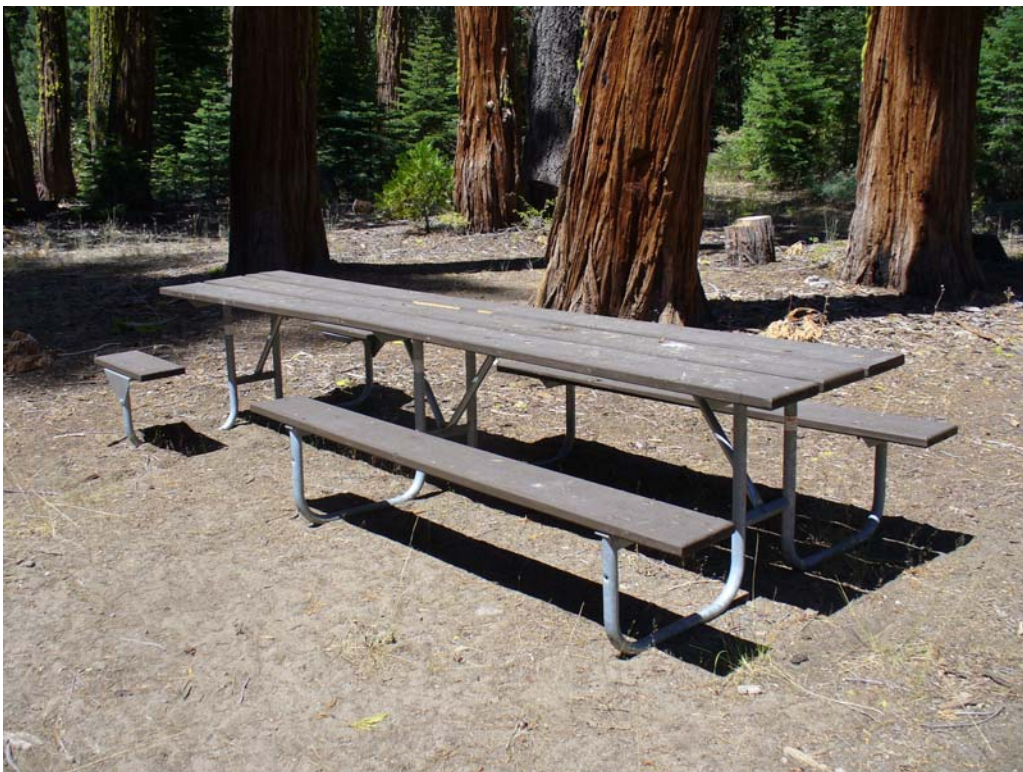
Photo D-2-14. Example of a double accessible table in good condition. (8/21/08)

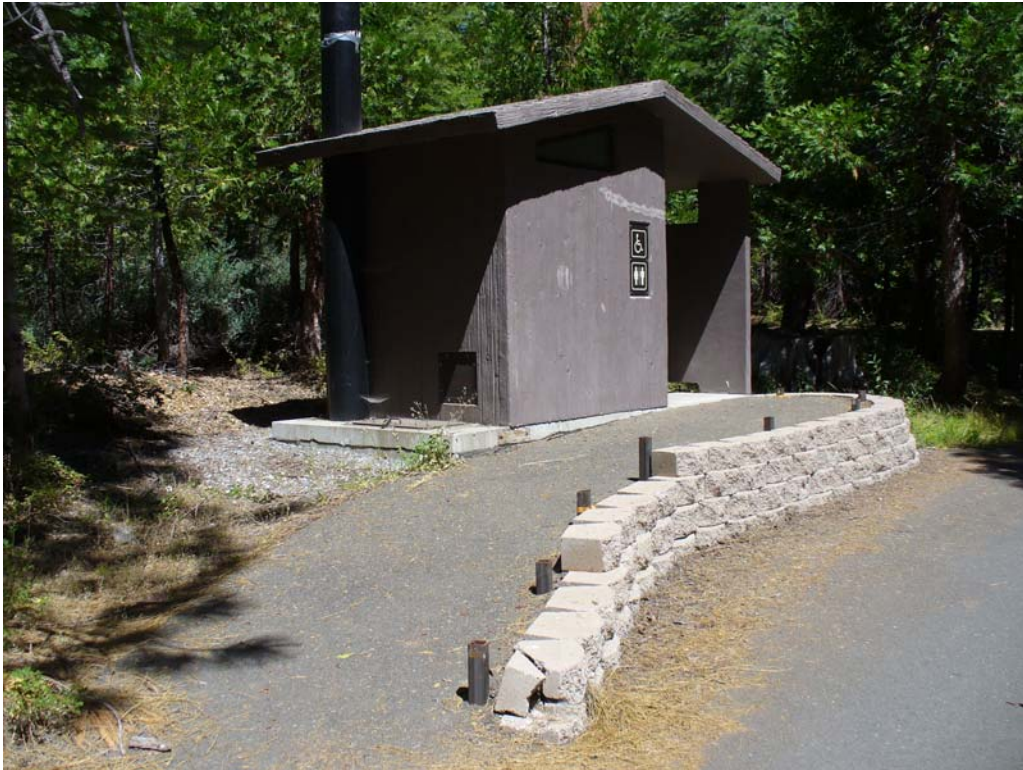
Photo D-2-15. New single-unit, pre-cast concrete toilet (CXT) – accessible. Note that ramp is missing handrail. The handrail was added later in 2008.

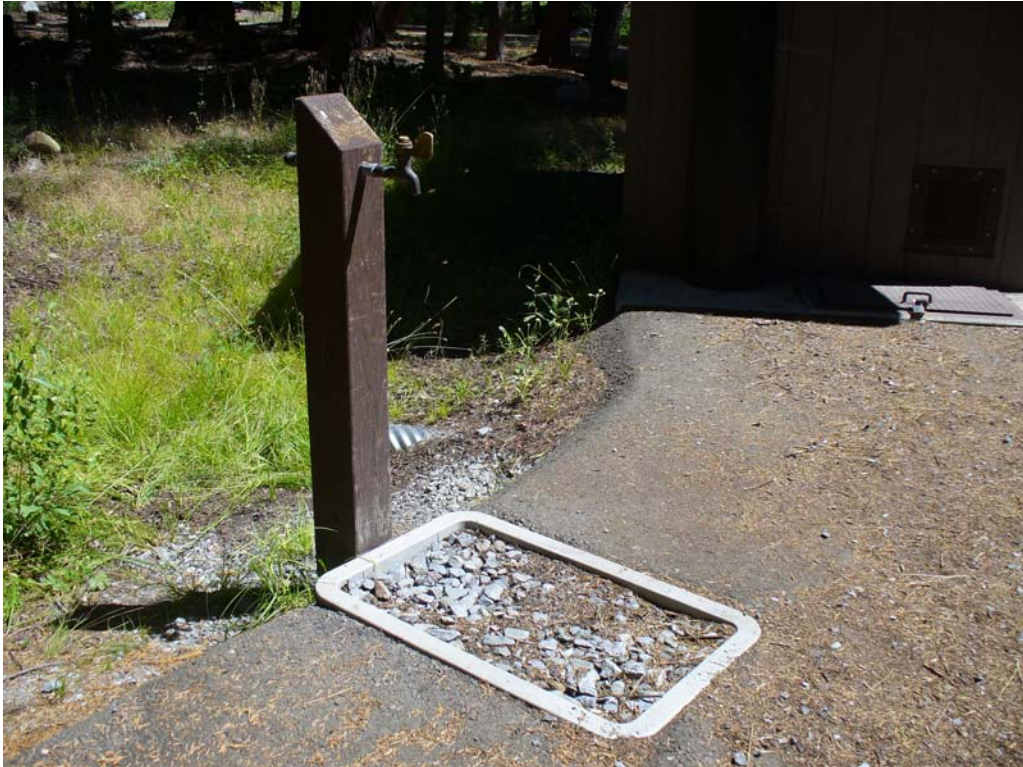
Photo D-2-16. Example water faucet - accessible (8/21/08)
