Appendix P-2
McGuire Boat Ramp
Photographs

McGuire Boat Ramp Parking Areas

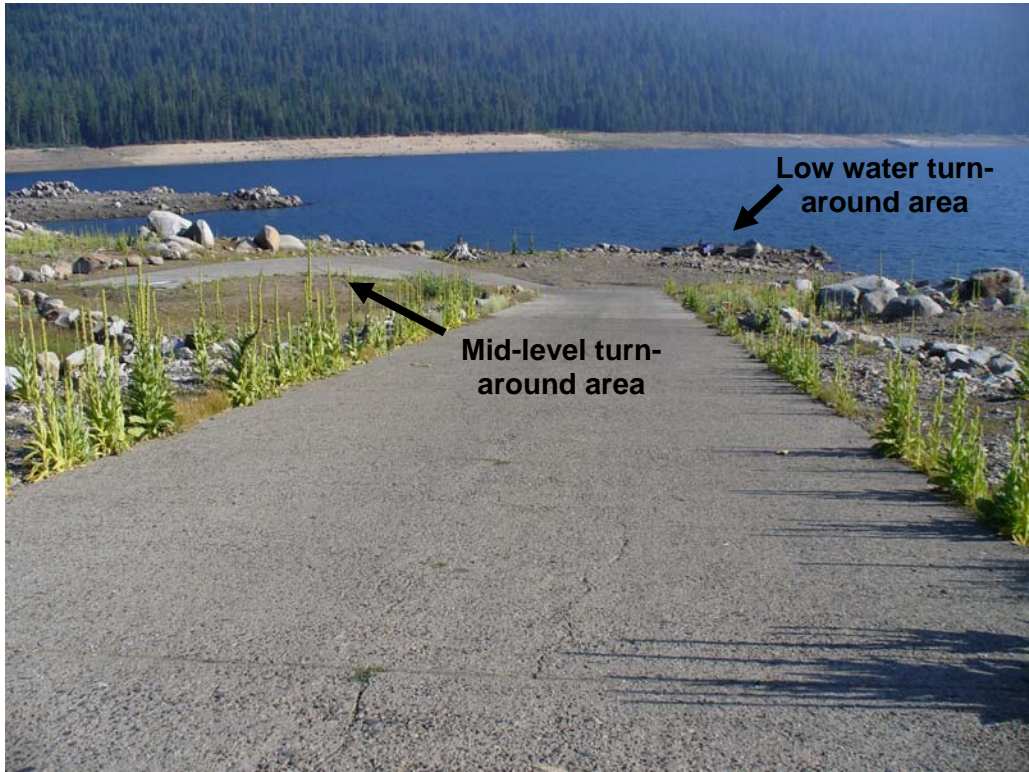
Photo P-2-1. McGuire Boat Ramp on July 23, 2008 (WSE = 5,220 ft).

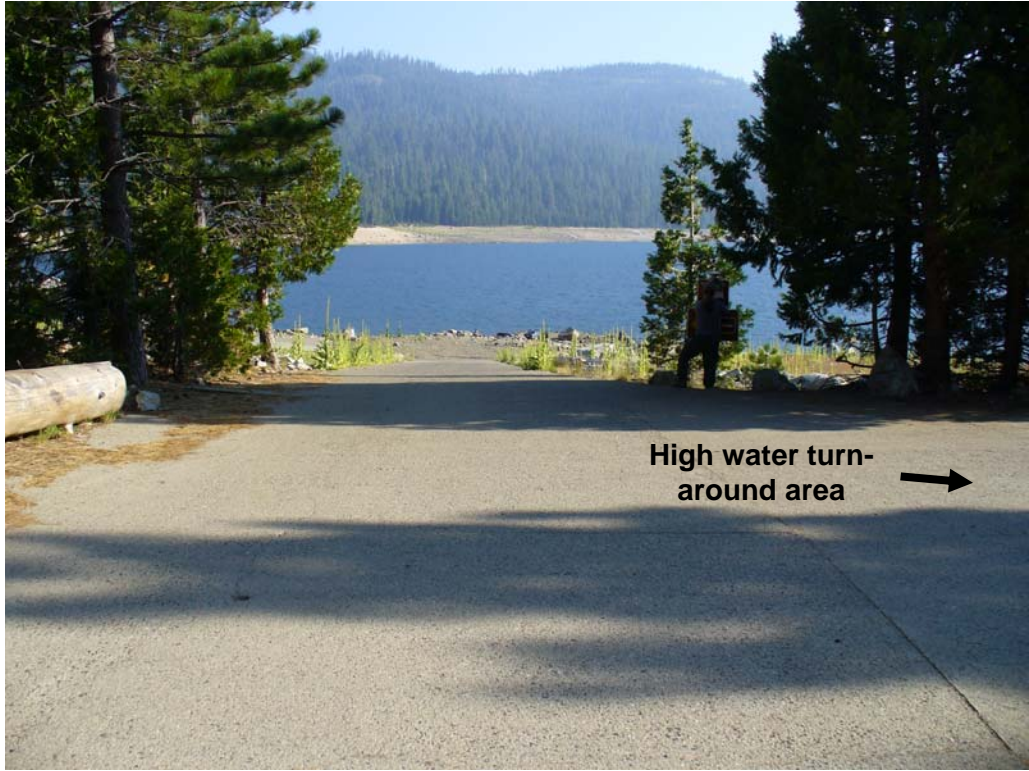
Photo P-2-2. View of McGuire Boat Ramp from top of ramp. (7/23/08)

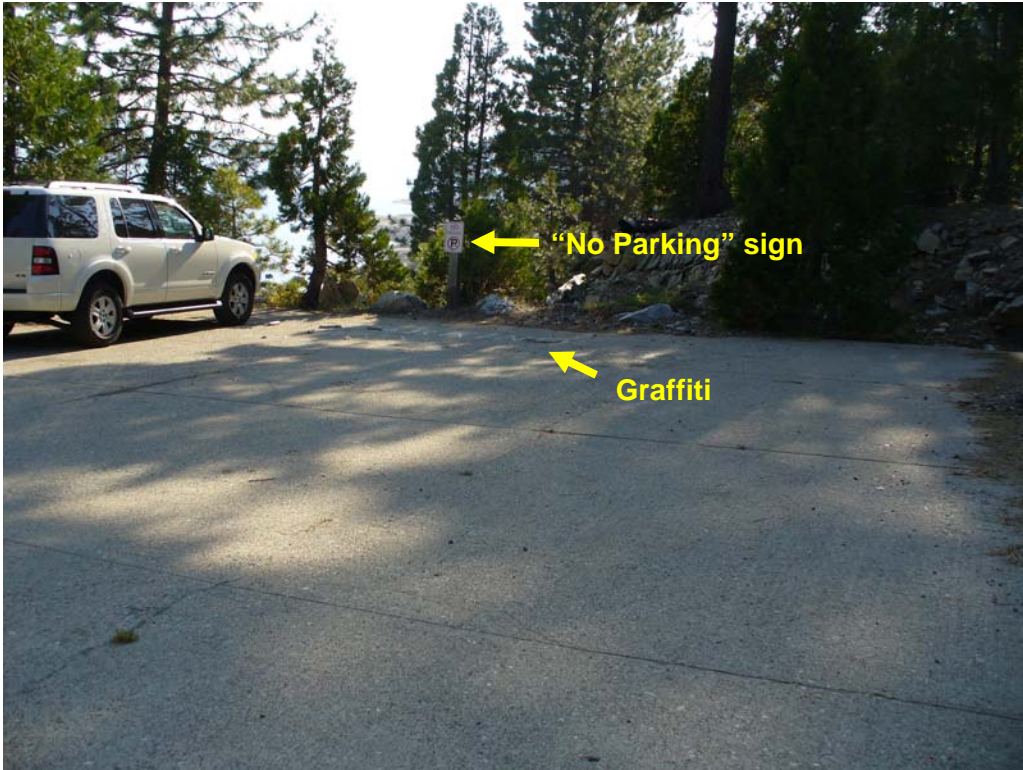
Photo P-2-3. High water turn-around and loading/unloading area. Note “no parking” sign and graffiti on surface. (7/23/08)

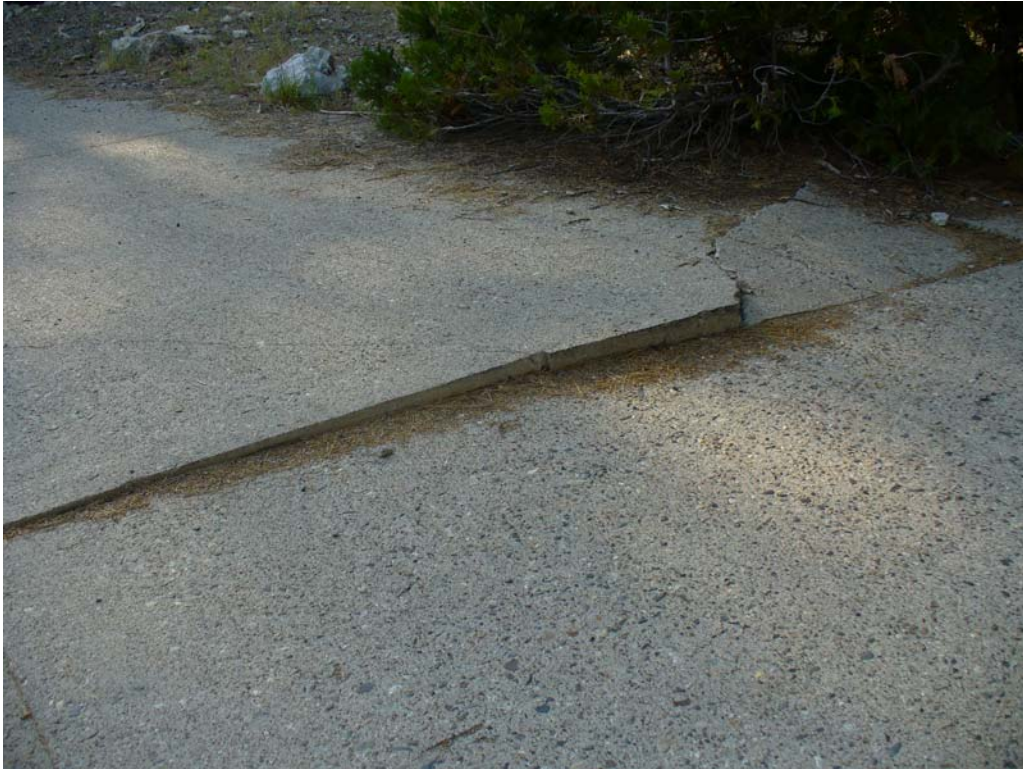
Photo P-2-4. Uplifted concrete at edge of high water turn-around area. (7/23/08)

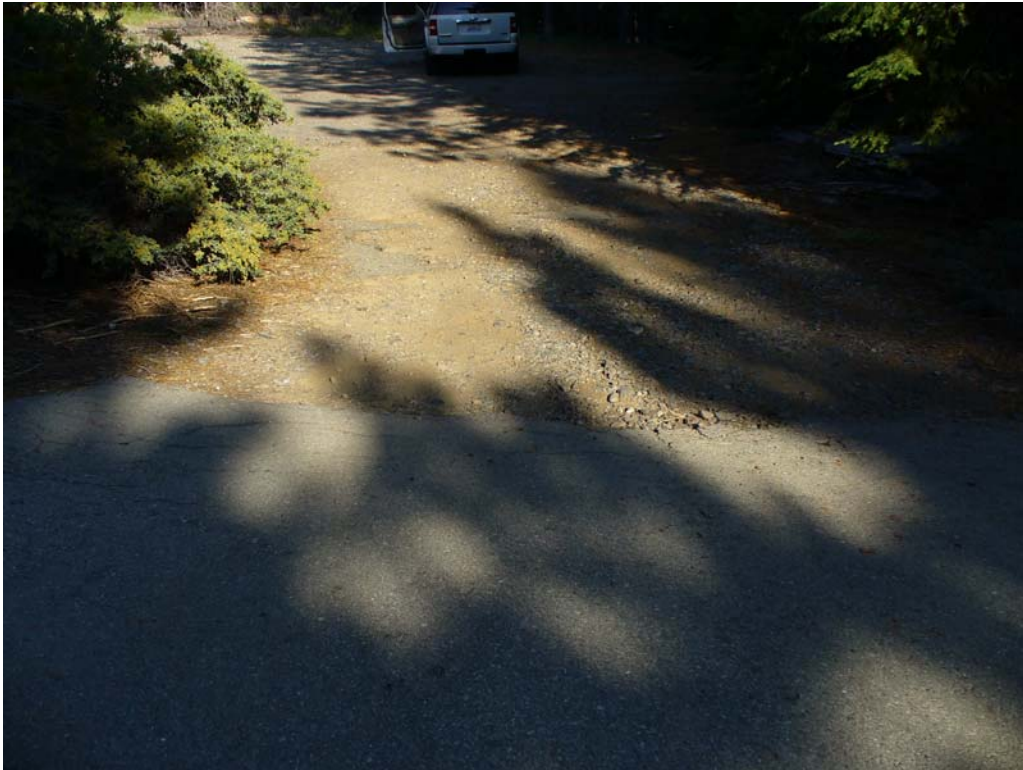
Photo P-2-5. Entrance to McGuire Boat Ramp Parking Area – southeast lot. Note transition from asphalt pavement access road to base rock in parking area. (7/23/08)

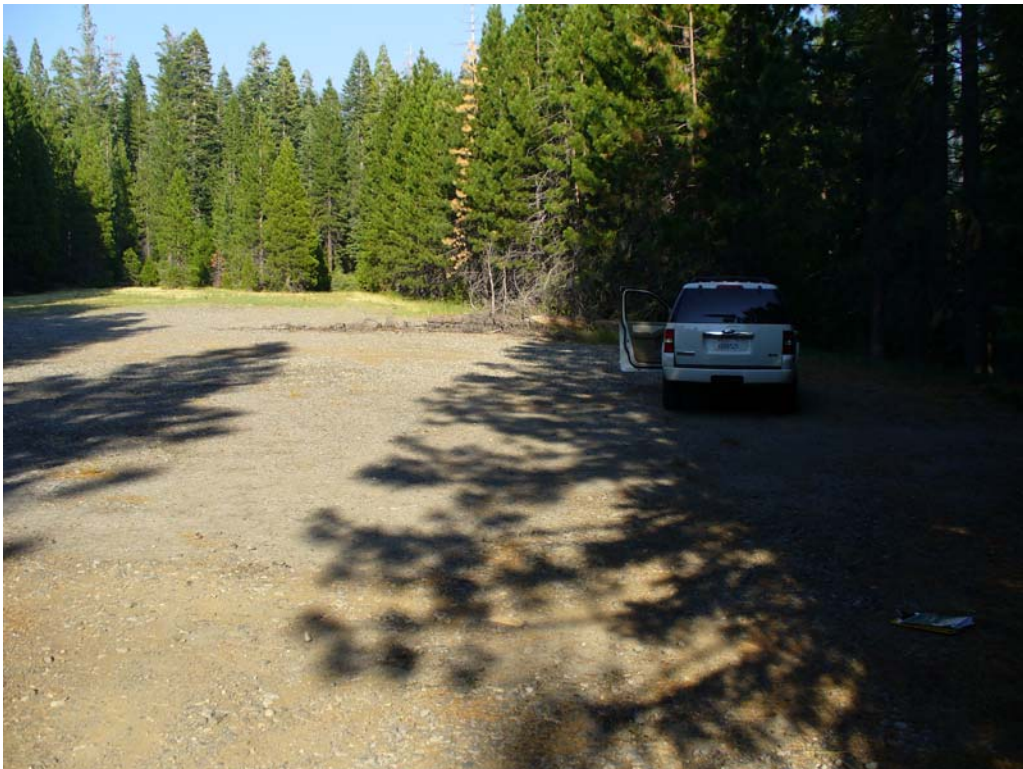
Photo P-2-6. McGuire Boat Ramp Parking Area – southeast lot. Surface has deteriorated to base rock and is in poor condition. (7/23/08)

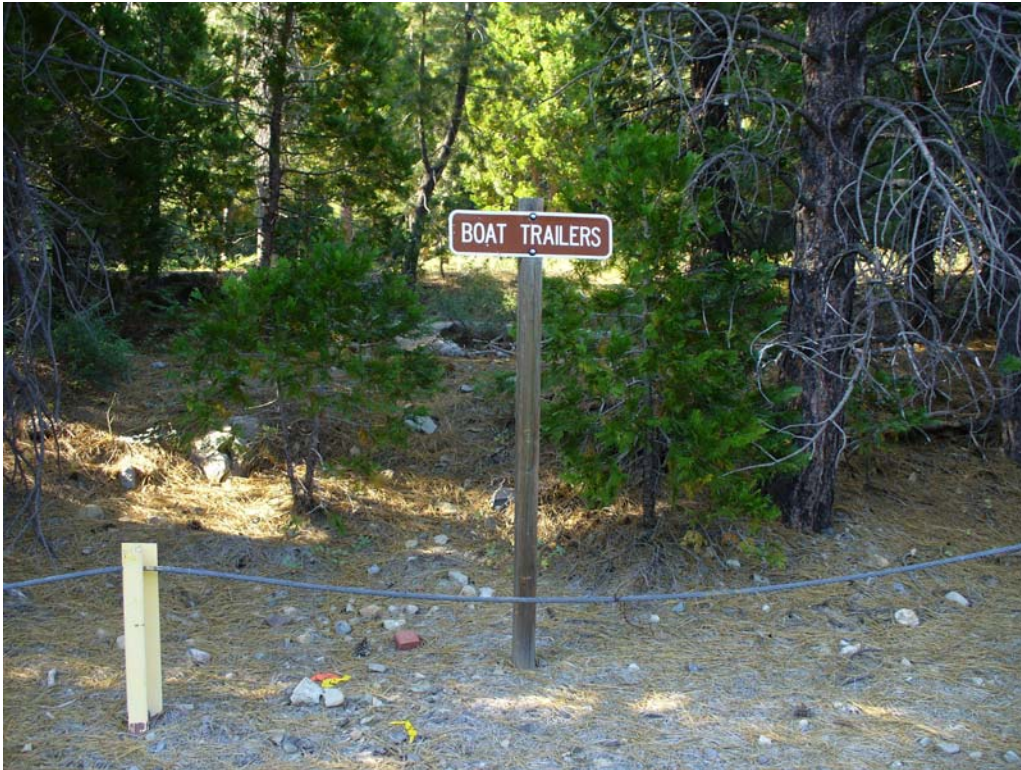
Photo P-2-7. Sign and post and cable barrier fence along north side of McGuire Boat Ramp Parking Area southeast lot. (7/23/08)

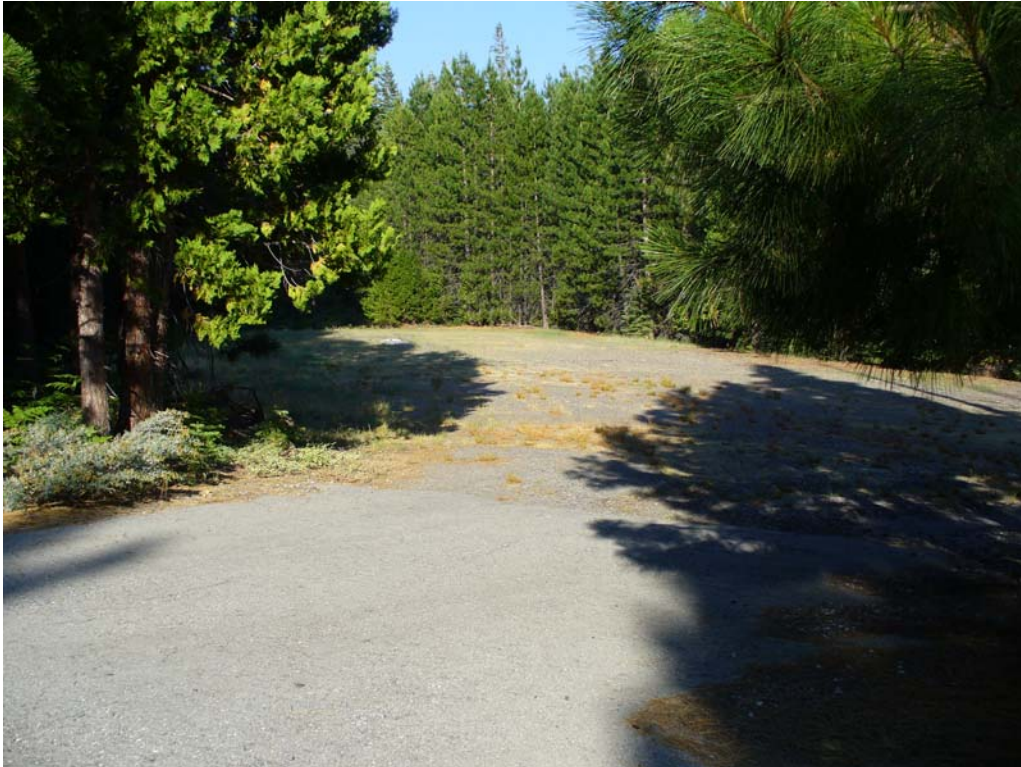
Photo P-2-8. North entrance to McGuire Boat Ramp Parking Area – northeast lot. Note transition from asphalt pavement access road to base rock in parking area. (7/23/08)

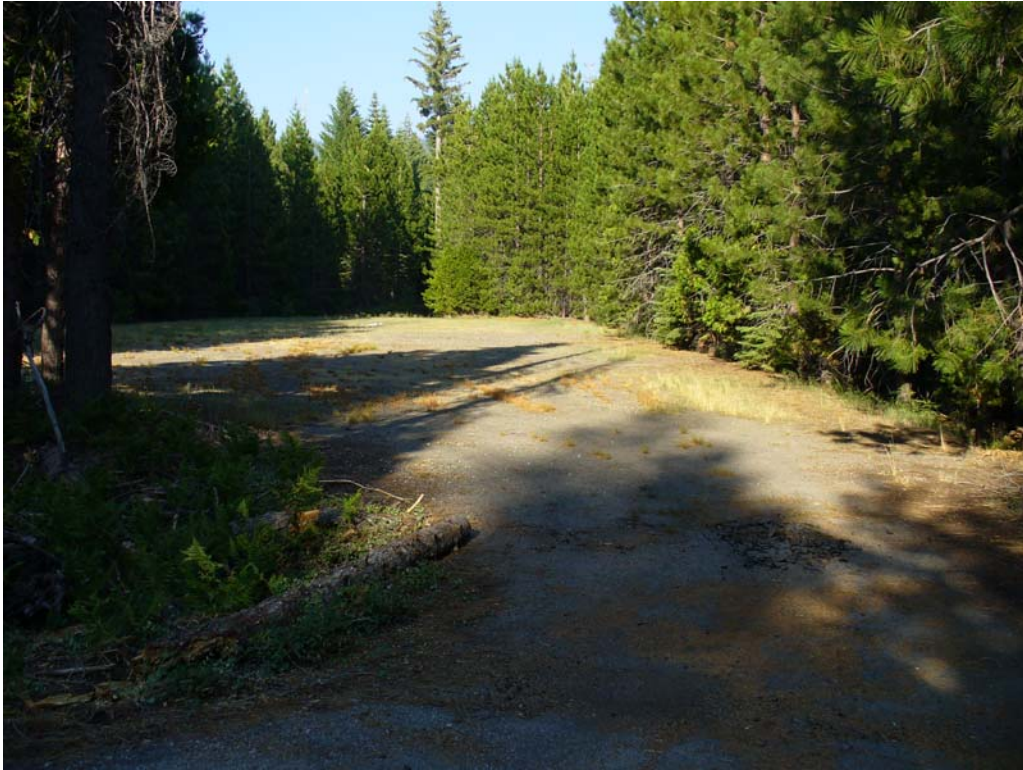
Photo P-2-9. South entrance to McGuire Boat Ramp Parking Area – northeast lot. Surface has deteriorated to base rock and is in poor condition. (7/23/08)

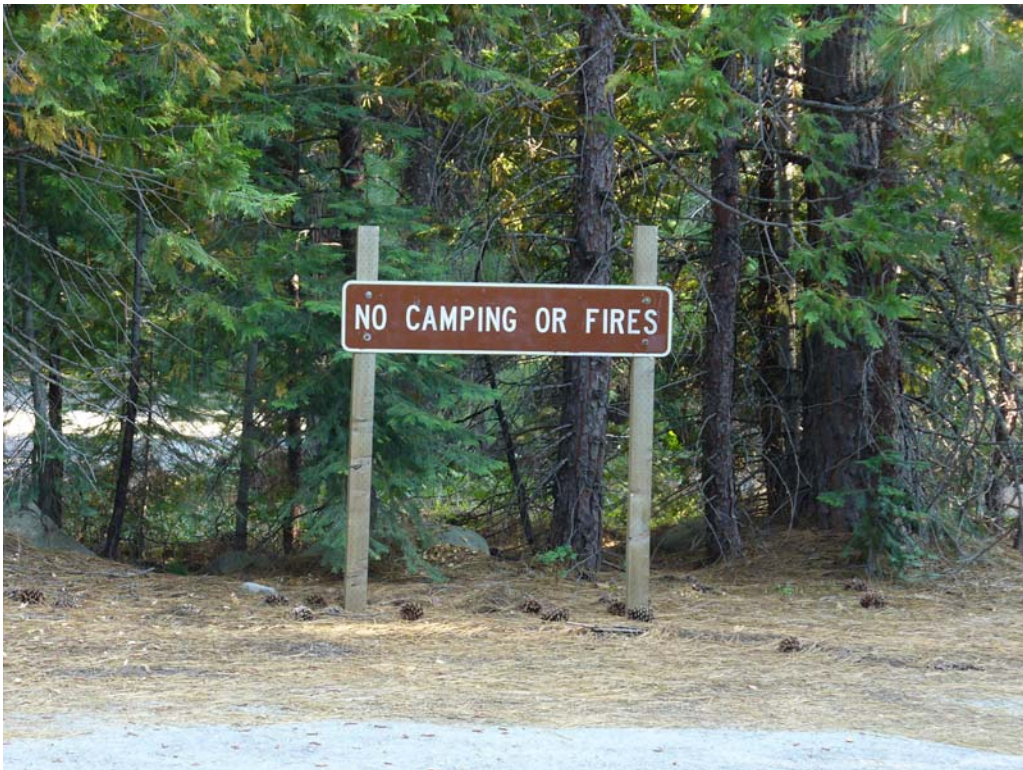
Photo P-2-10. Sign along access road near McGuire Boat Ramp Parking Area – between northeast and southeast lots. (7/23/08)
