**Placer County Water Agency
Middle Fork American River Project
(FERC No. 2079)**

**REC 1 – RECREATION USE AND FACILITIES
TECHNICAL STUDY REPORT**

Placer County Water Agency
P.O. Box 6570
Auburn, CA 95604

May 2010

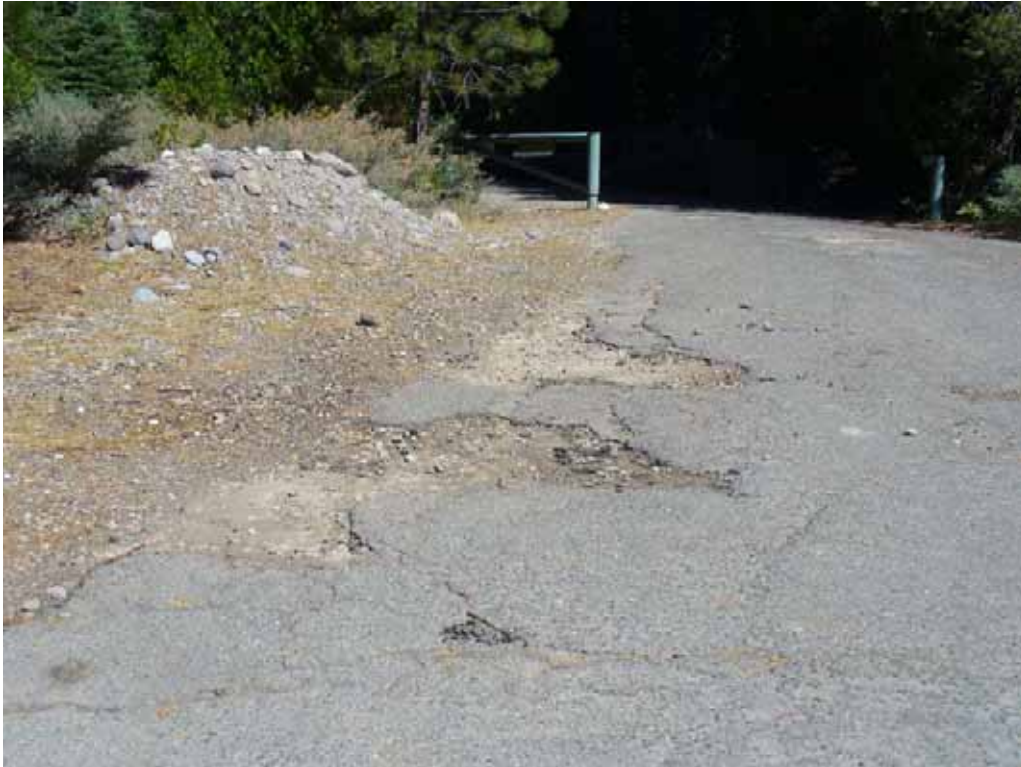
Photo D-2-4. Poor condition road surface at entrance to Big Meadows Campground. (8/21/08)

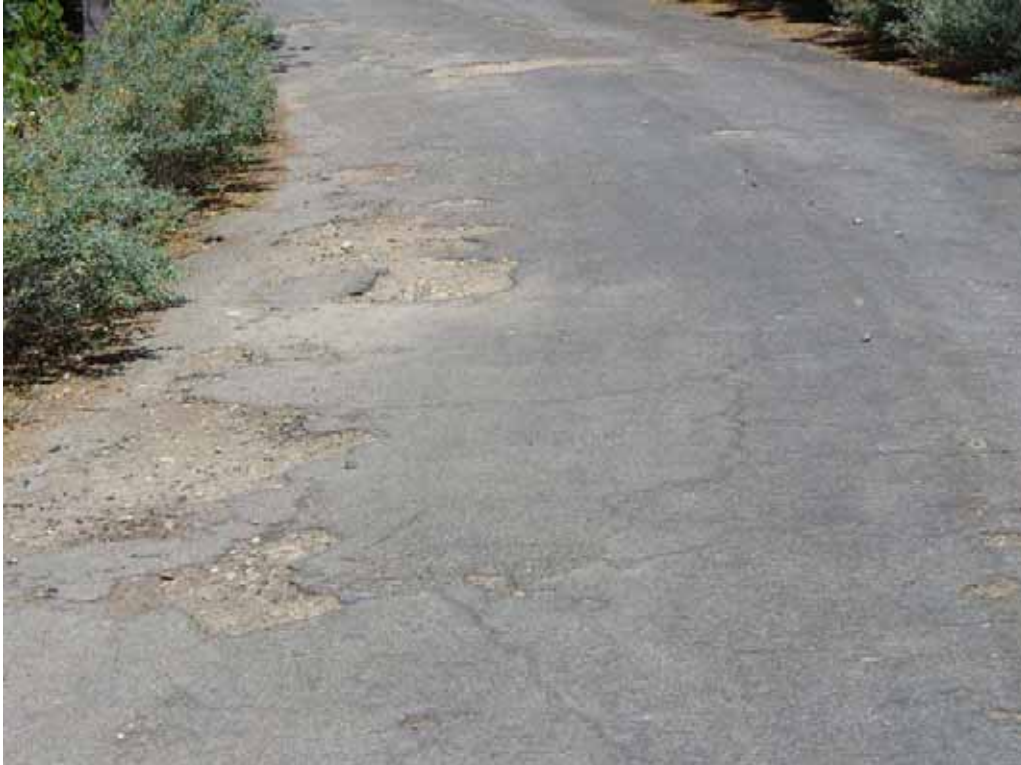
Photo D-2-6. Poor condition pavement along 14N43, the access road to Big Meadows Campground (8/21/08).

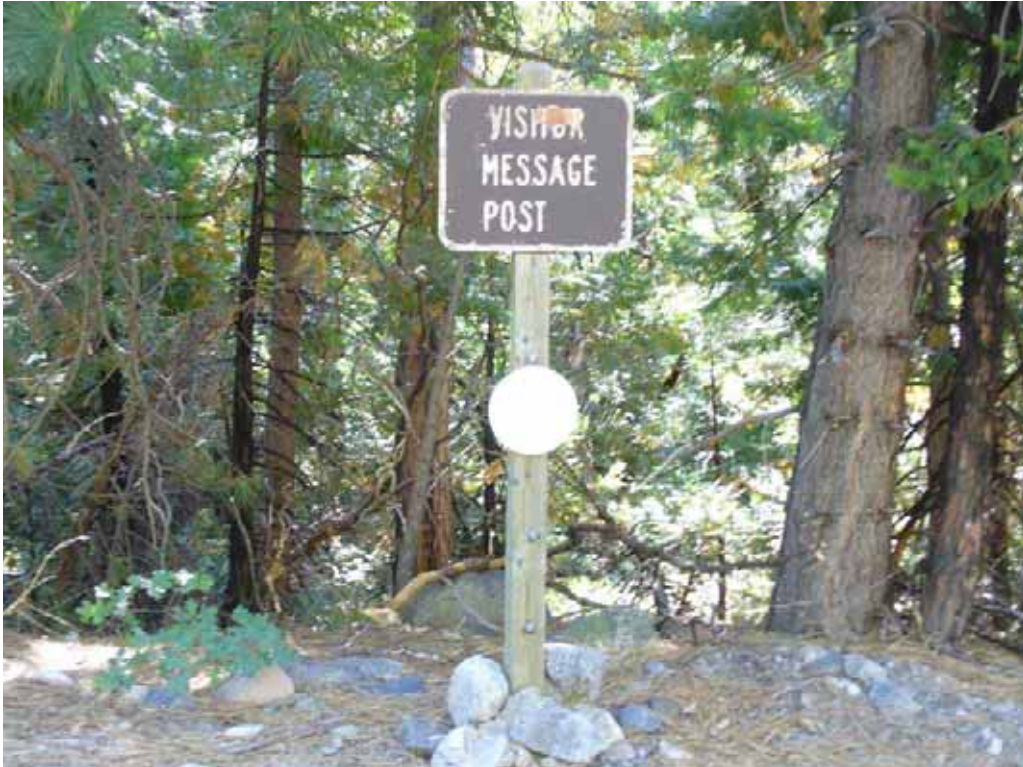
Photo E-2-4. Photo E-14. Visitor message post, poor condition. (8/21/09)

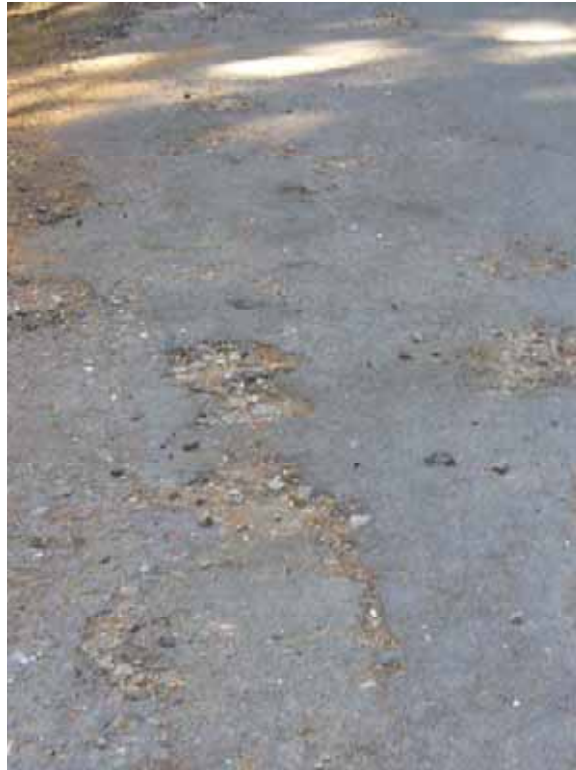
Photo E-2-7. Poor condition pavement at edge of Hell Hole Campground Parking Area. (8/21/08)

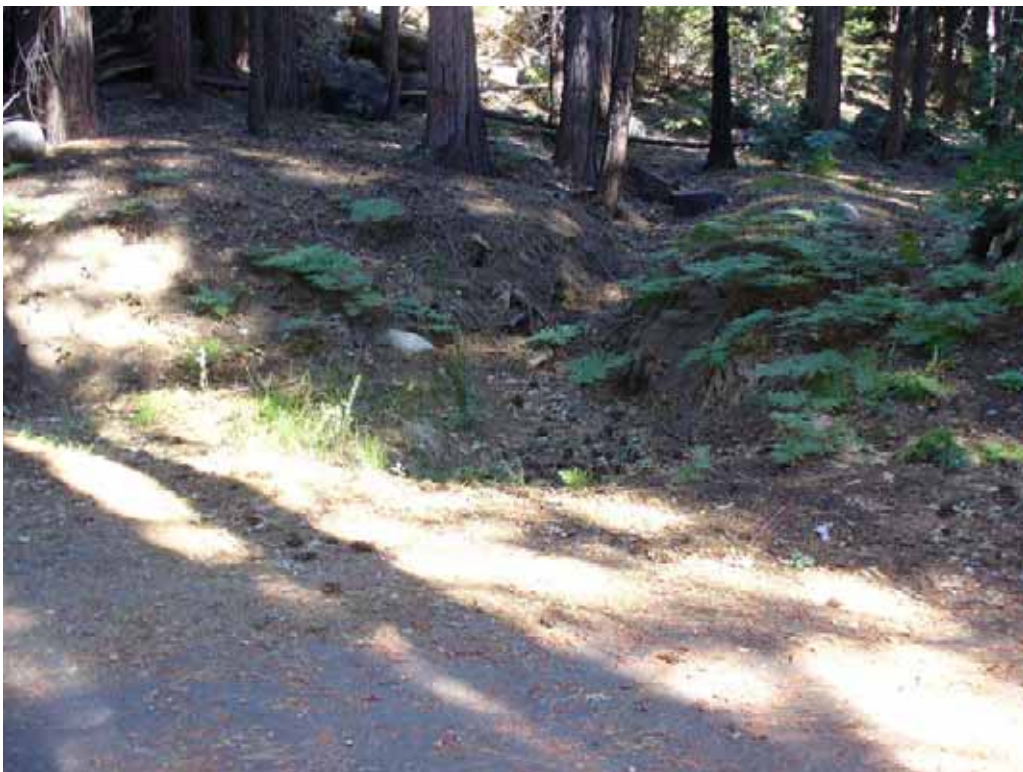
Photo E-2-10. Drainage into parking area. (8/21/08)

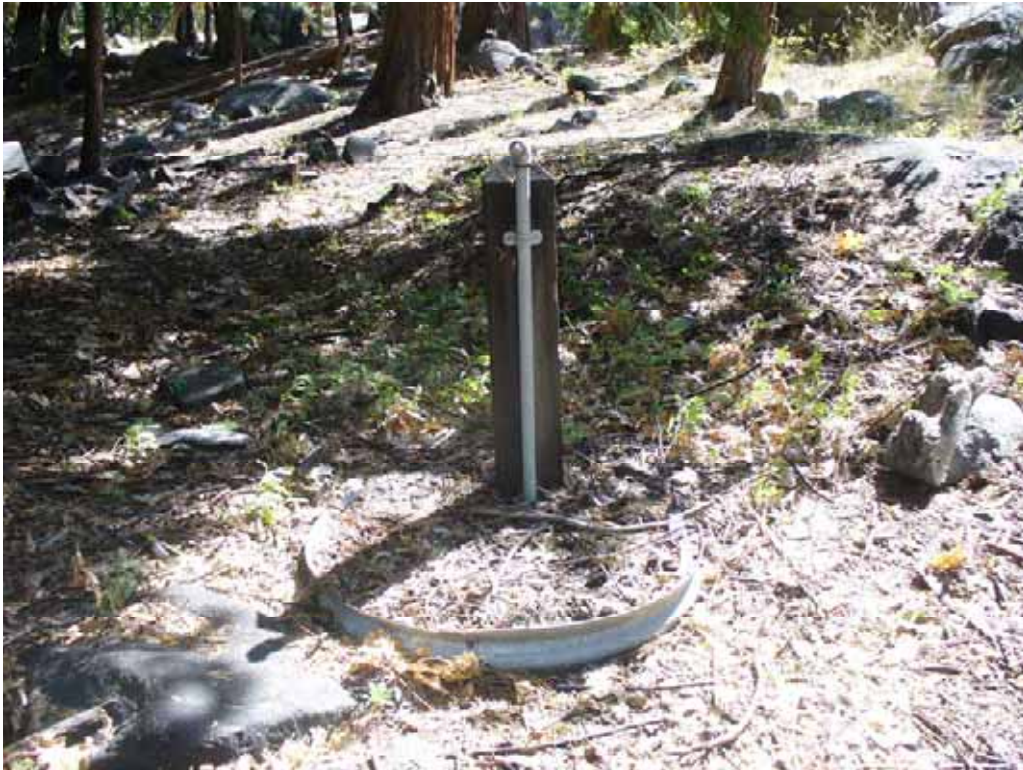
Photo E-2-17. Out of service water faucet. (8/21/09)

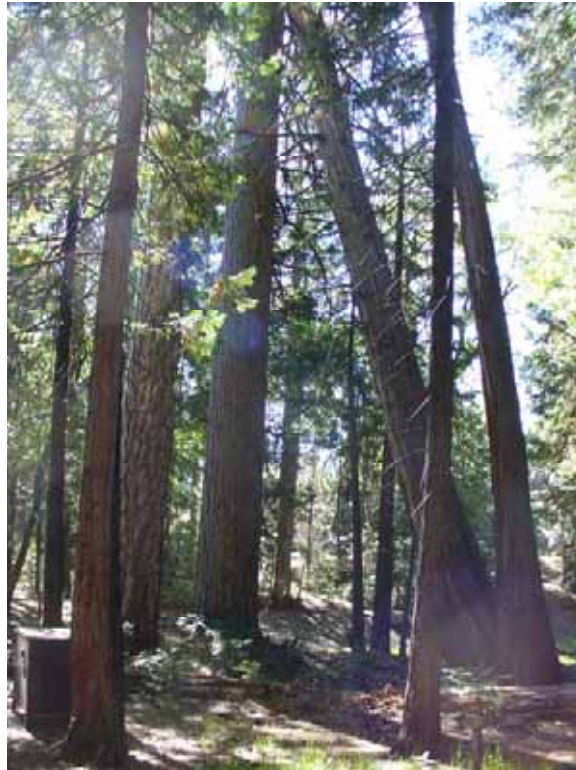
Photo E-2-21. Hazard tree near Site 2. (8/21/08)

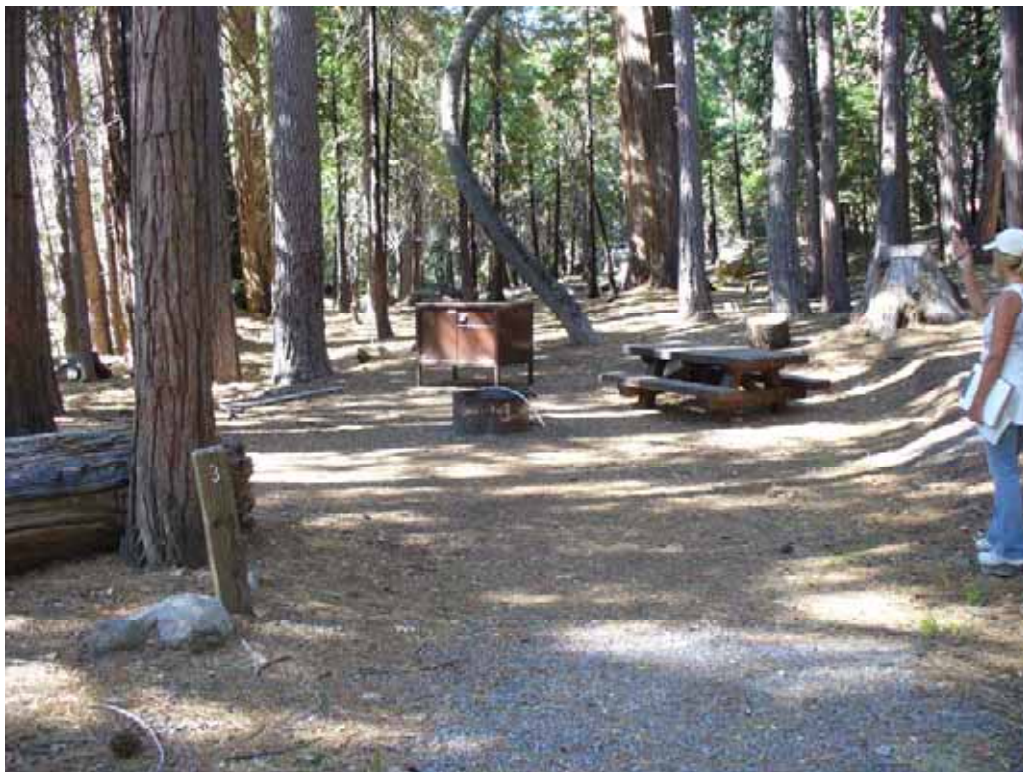
Photo E-2-22. Example site – Site 3. Site is accessible but table is not. (8/21/09)

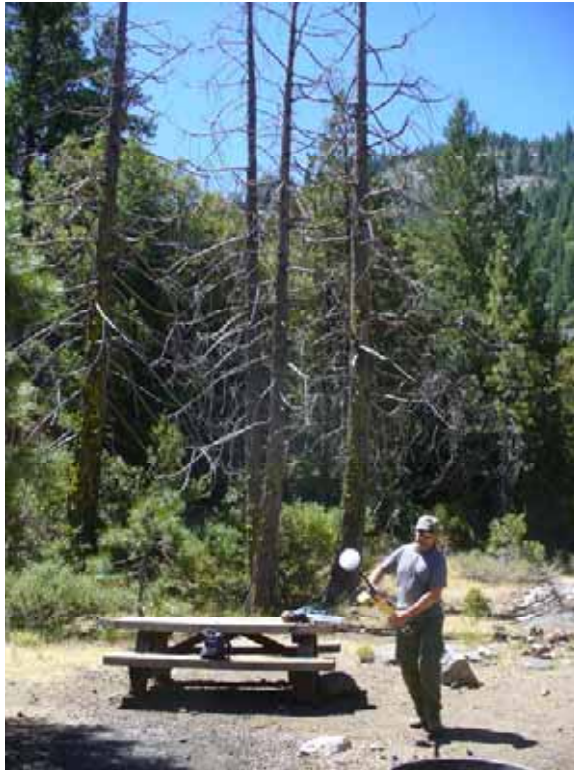
Photo F-2-9. Picnic table at Site 6. Note hazard trees in middle ground. (8/4/08)

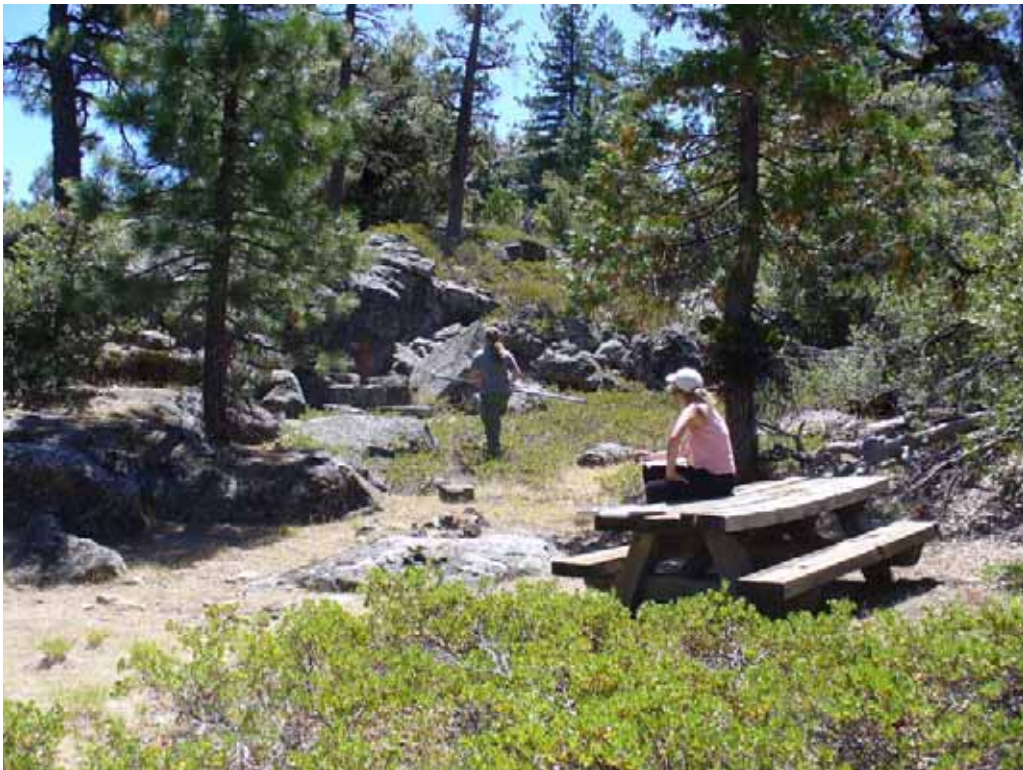
Photo F-2-12. Site 8. Note encroaching brush. (8/4/08)

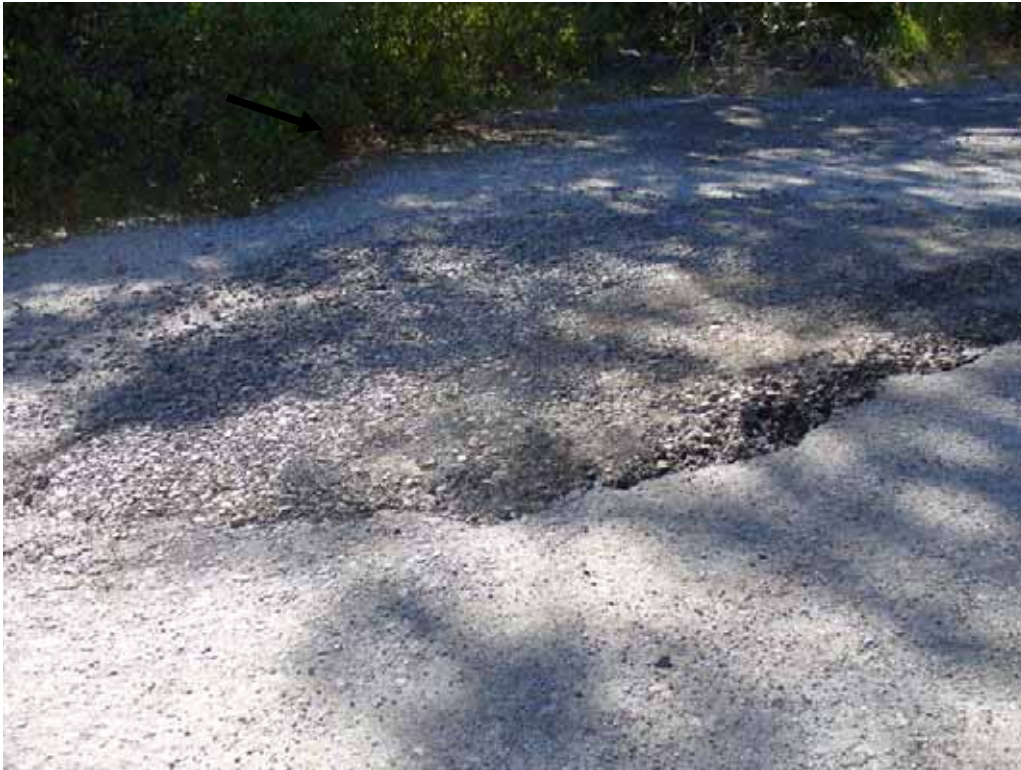
<p>Condition of Facility. The parking area is in poor condition. The parking area is paved but the pavement has deteriorated to base rock in parts and several potholes are present. The CXT is relatively new and in good condition. The trail includes paved pathways and landings, masonry stairs, and steel handrails. All of these components were recently upgraded and therefore are in good condition. One picnic table located along the trail is in poor condition. The vista is surrounded by a masonry wall, which is in good condition. The surface of the vista appears to have been paved or chip sealed but grasses are protruding through the pavement and overall the surface is in poor condition.</p>
<p>Accessibility Conditions: The parking area does not include any designated handicap parking areas. The surface does not meet accessibility standards in some areas due to potholes, level changes, and poor surface conditions. The CXT in the parking area is accessible. However, the surface area surrounding the CXT is not well consolidated. The picnic table does not have sufficient clear space. The trail traverses relatively steep terrain and is not accessible due to level changes, obstacles (e.g. stairs), and excessive running and cross slopes. The vista is not accessible due to level changes and obstacles.</p>

Photo G-2-3. Example of damaged pavement surface in Hell Hole Vista Parking area. (8/20/08)

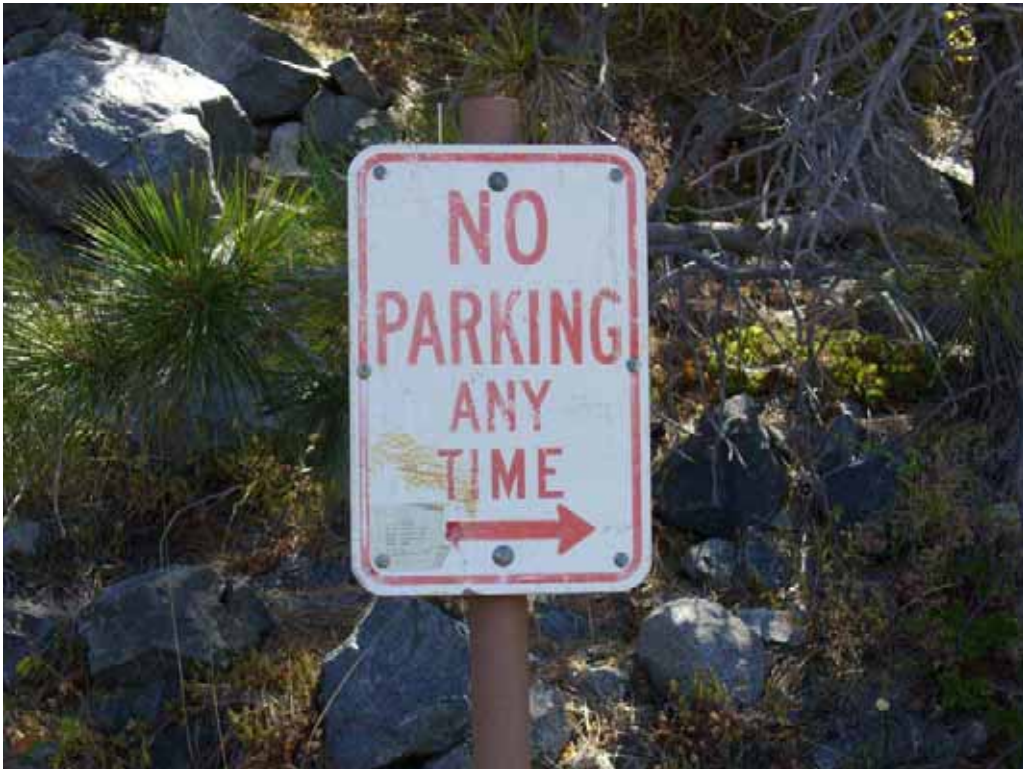
Photo H-2-2. Example of “no parking” sign located along Hell Hole Boat Ramp. Condition is “fair” due to faded lettering. (8/4/08)

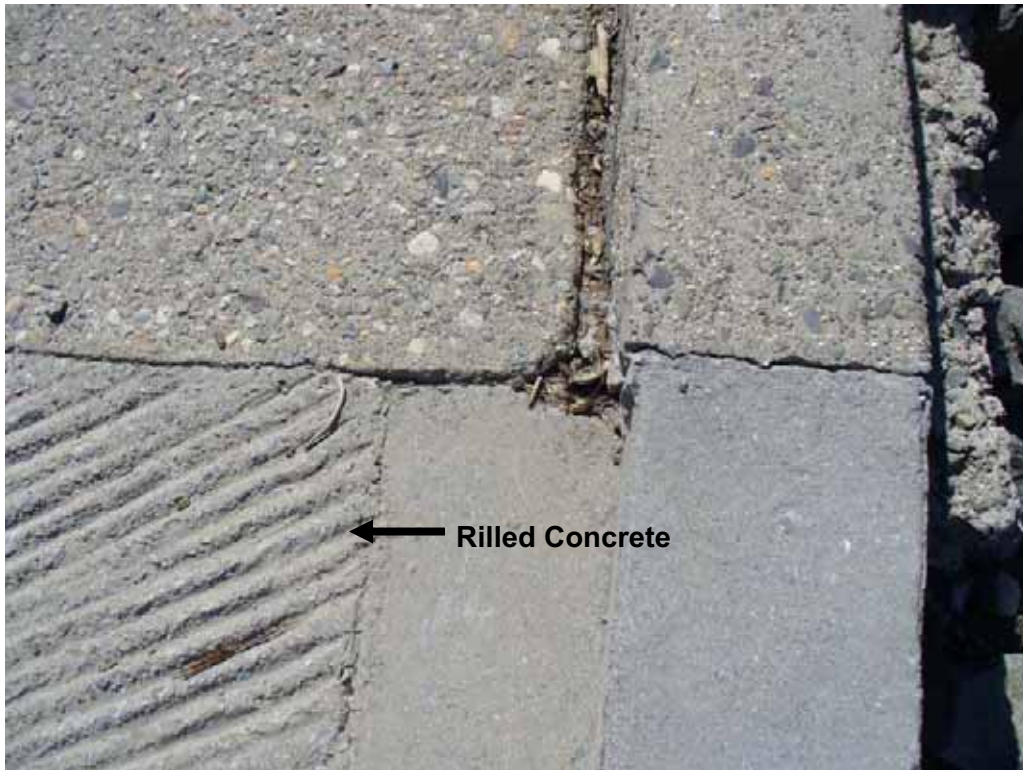
Photo H-2-5. Example of rilled concrete at lower end of ramp. (8/4/08)

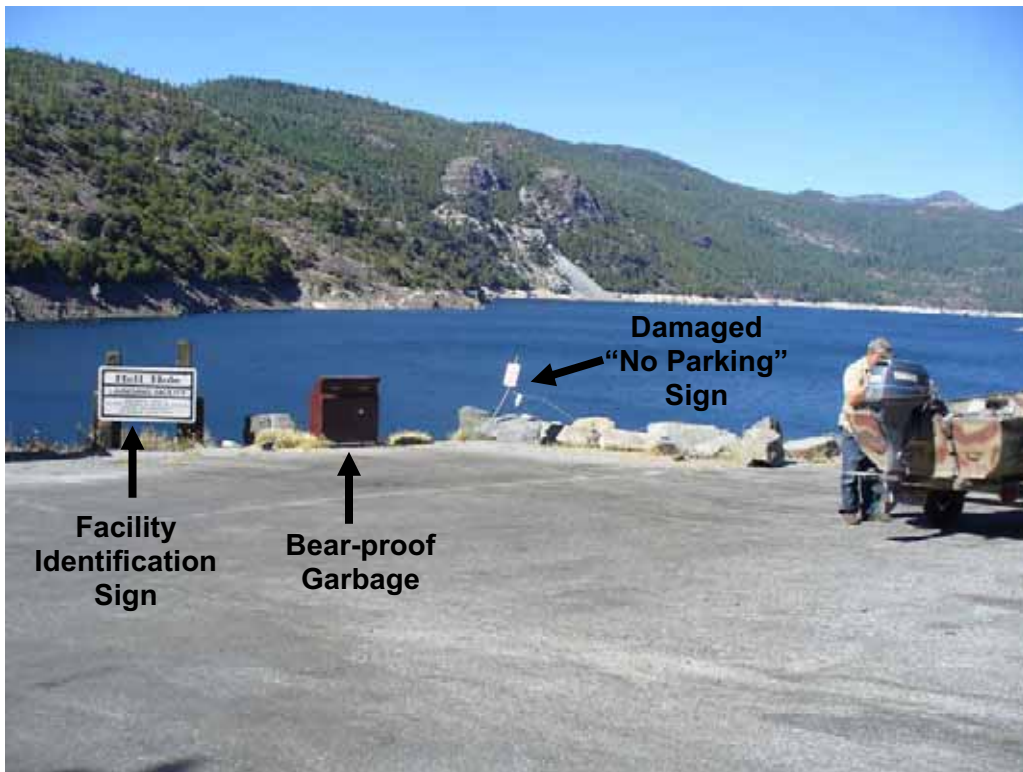
Condition of Facility: Overall facility condition is good. However, the parking stalls need to be re-striped and some of the signage is in fair to poor condition due to faded paint and bullet holes. The bathroom, a single-unit CXT, was installed in 2000 and is in good condition. Two bear-proof garbage containers are available adjacent to the toilets and are in good condition. One picnic table and pedestal grill are available. The table is in good condition, but the table boards are warped.
Accessibility Conditions: The bathroom is accessible. Neither of the parking lots have designated handicap parking stalls. The picnic table is not accessible due to its design. The bear-proof garbage containers are not considered accessible due to the handle design.
Health and Safety Concerns: Steep slopes between parking areas and reservoir.
Environmental and Cultural Concerns: None
Comments: Potable water is not available.

Photo H-2-8. Hell Hole Boat Ramp Parking Area, lower lot. Surface is in good condition but striping has faded. Note facility identification sign, bear-proof garbage container, and damaged "no parking" sign. (8/4/08)

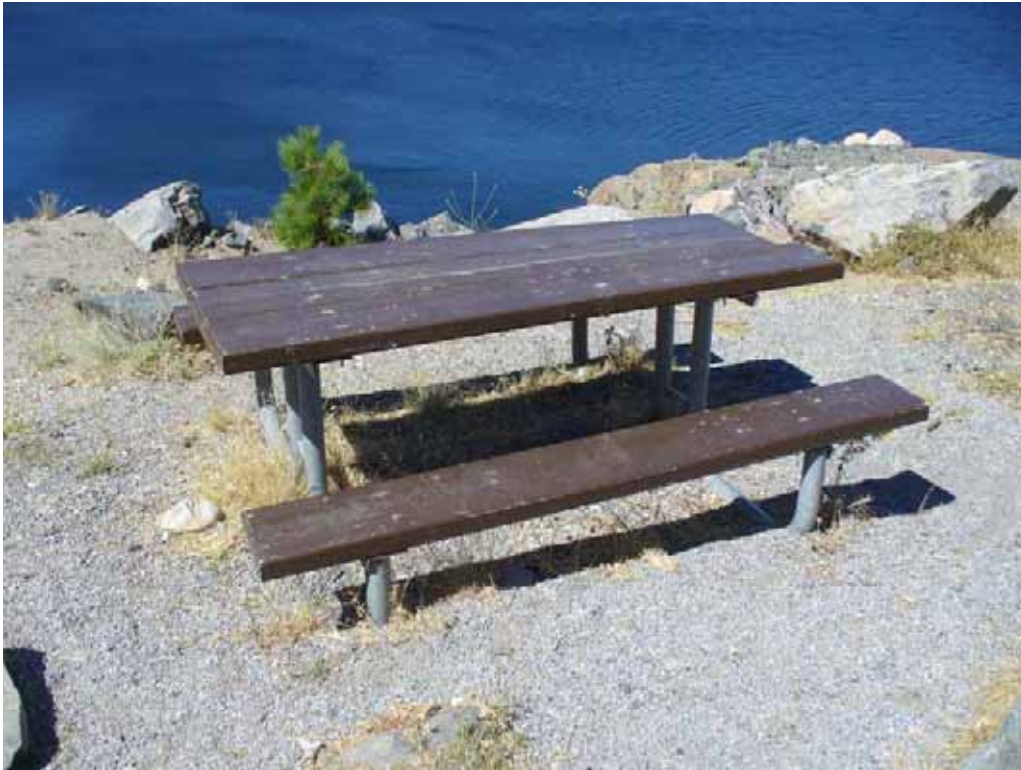
Photo H-2-13. Picnic table located in lower parking lot. Note warped table boards and flaking paint. Not disabled accessible due to design and small obstacles. (8/4/08)

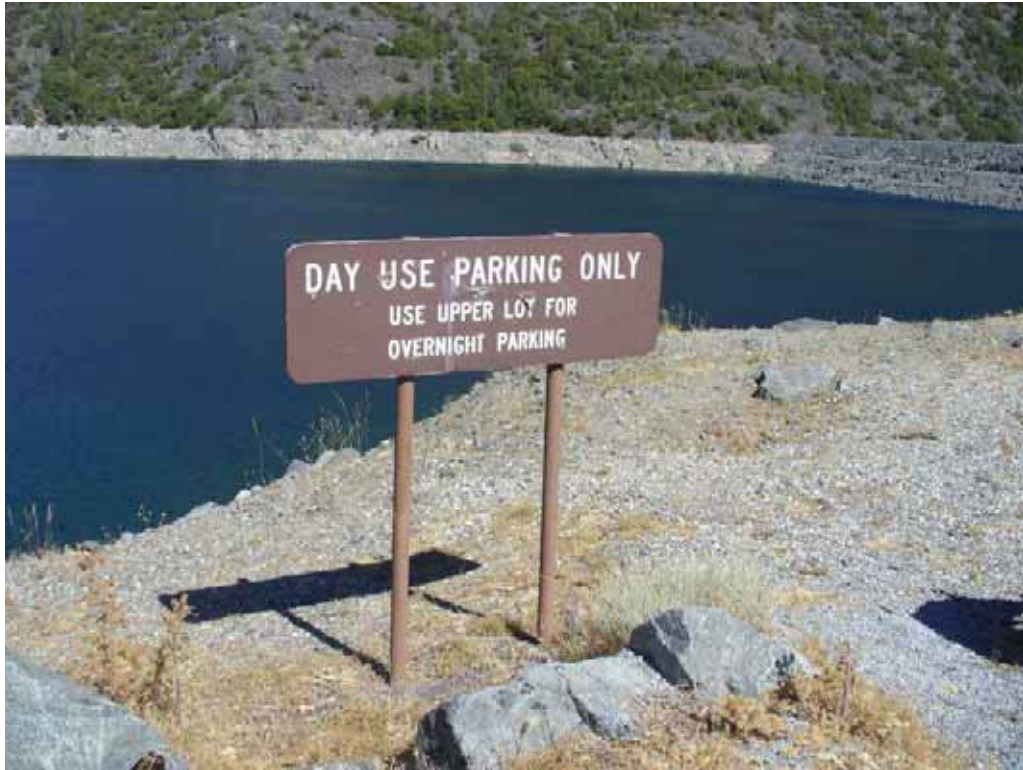
Photo H-2-15. Regulatory sign in lower parking lot. Constructed of painted MDO on steel posts. Good condition. (8/4/08)

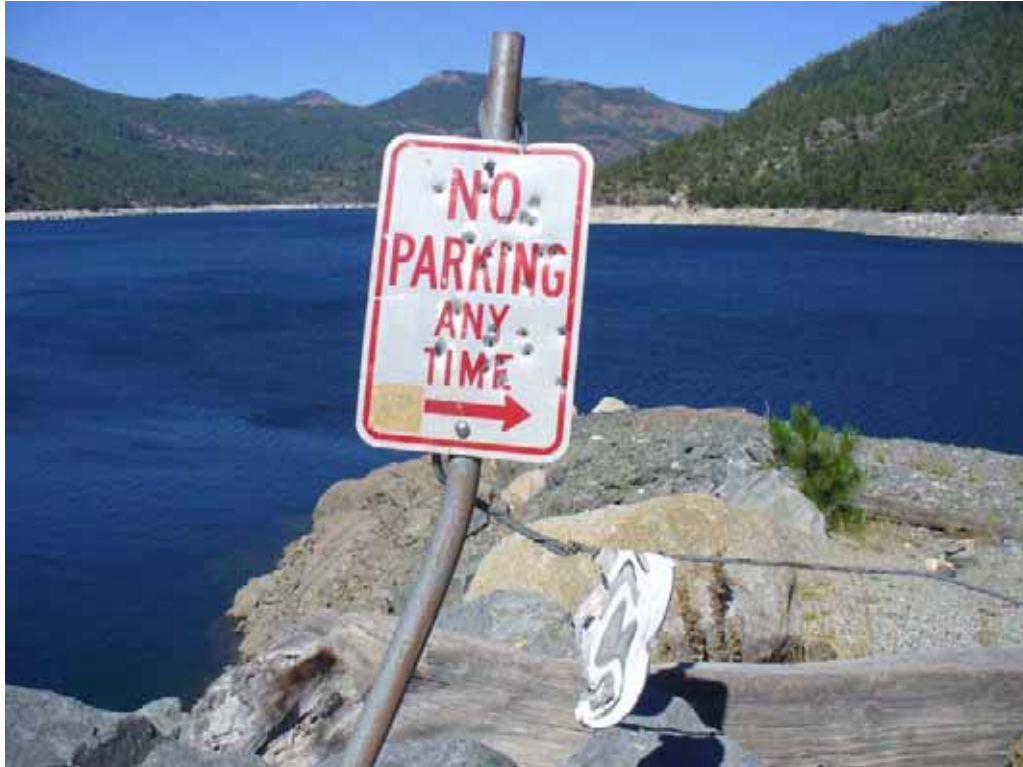
Photo H-2-16. Damaged "no parking" sign in lower lot. In poor condition due to bullet holes and bent steel post. (8/04/08)

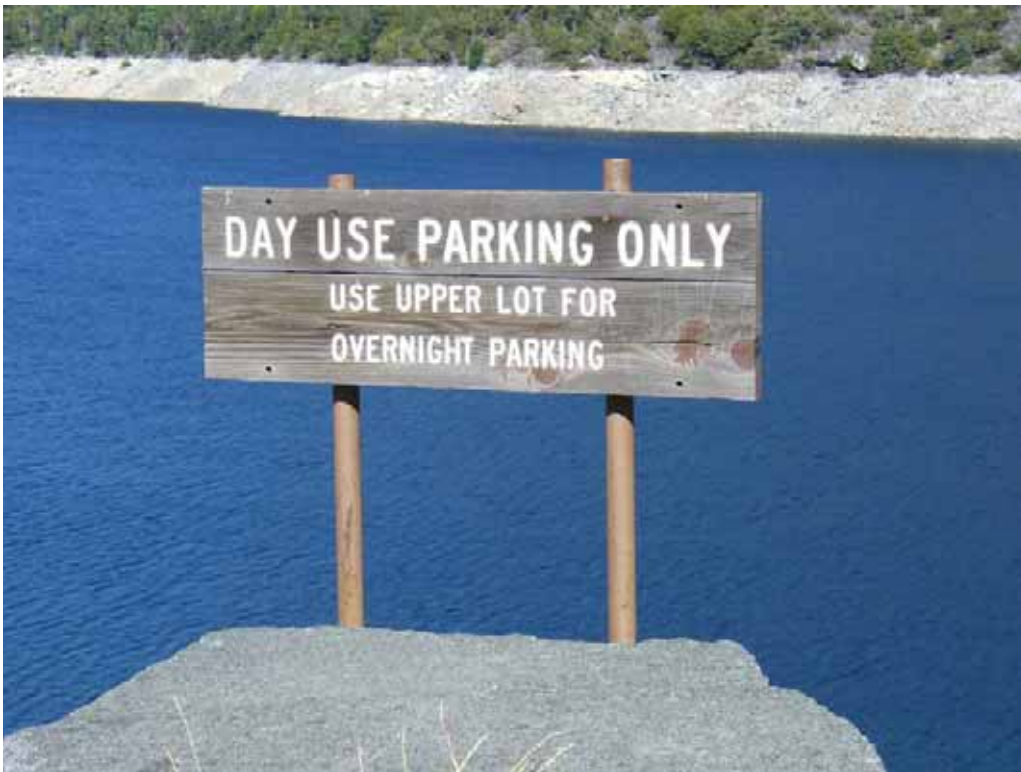
Photo H-2-18. Regulatory sign adjacent to upper parking lot. Constructed of wood on steel posts. Good condition. (8/4/08)

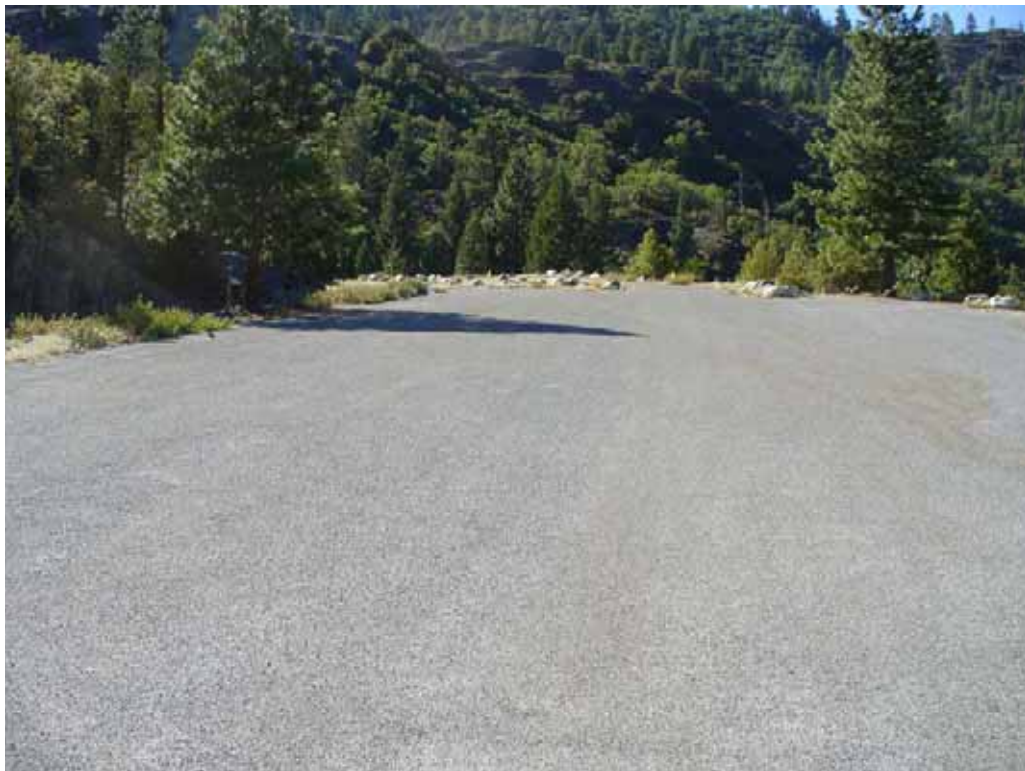
Photo H-2-22. Hell Hole Boat Ramp General Parking Area (northern portion). Surface is asphalt with chip seal in good condition. (8/4/08)

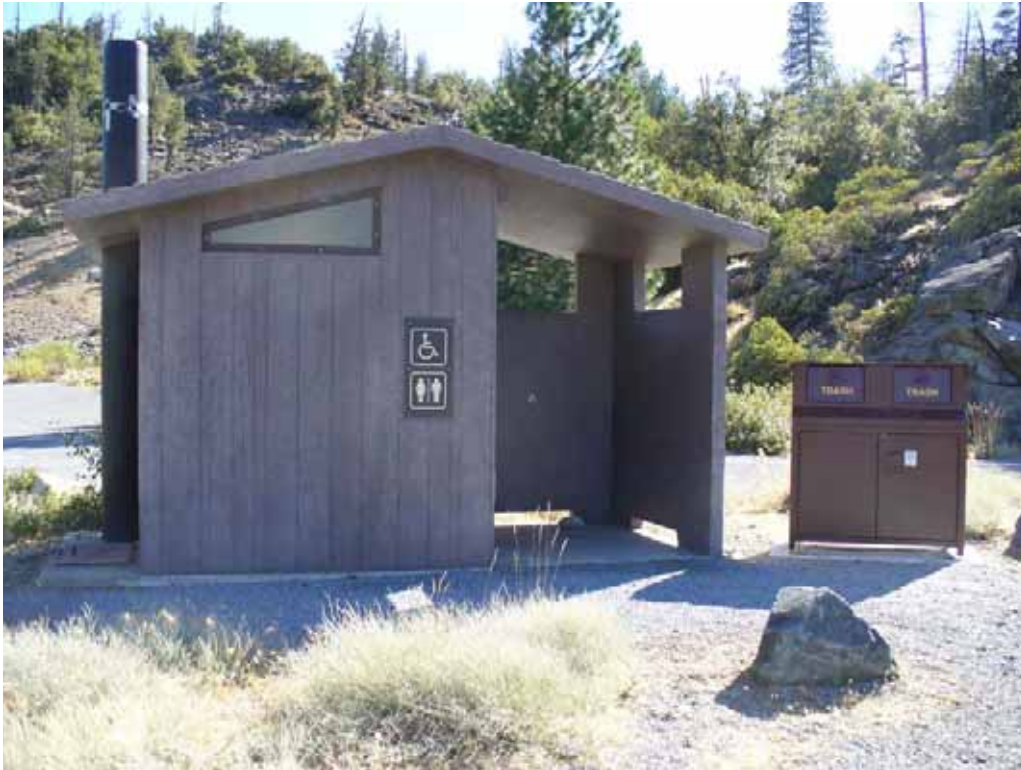
Photo H-2-23. Single unit pre-cast concrete toilet (CXT) located in Hell Hole Boat Ramp General Parking Area. Restroom is disabled accessible and in good condition. Note bear-proof garbage container adjacent to restroom. (8/4/08)

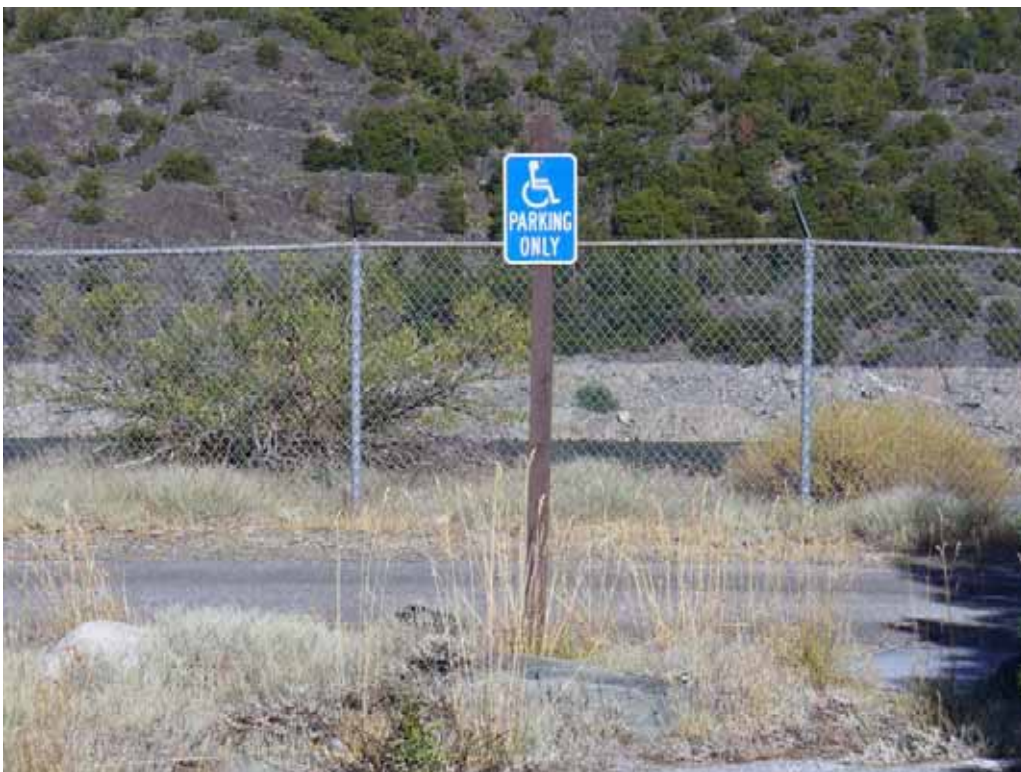
Photo H-2-24. Example of handicap parking sign in parking area. Painted aluminum mounted on wood post. Good condition. (8/4/08)

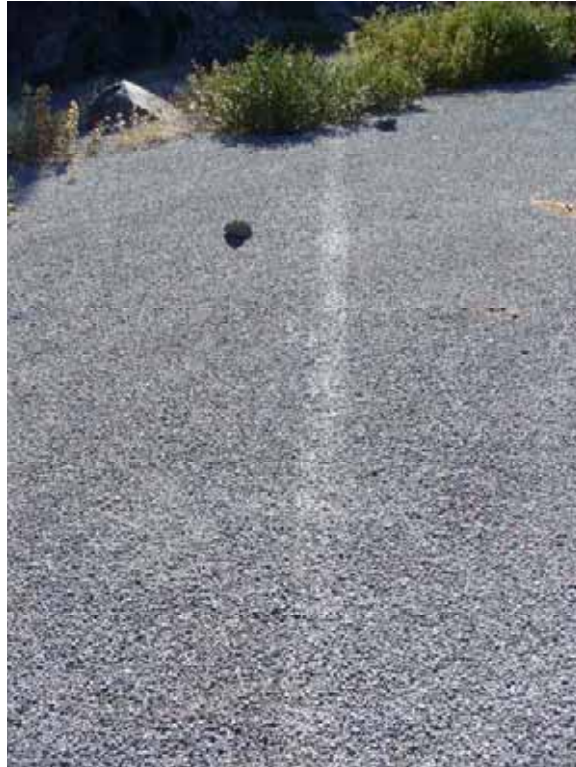
Photo H-2-26. Example of faded parking stall striping on asphalt with chip seal. (8/4/08)

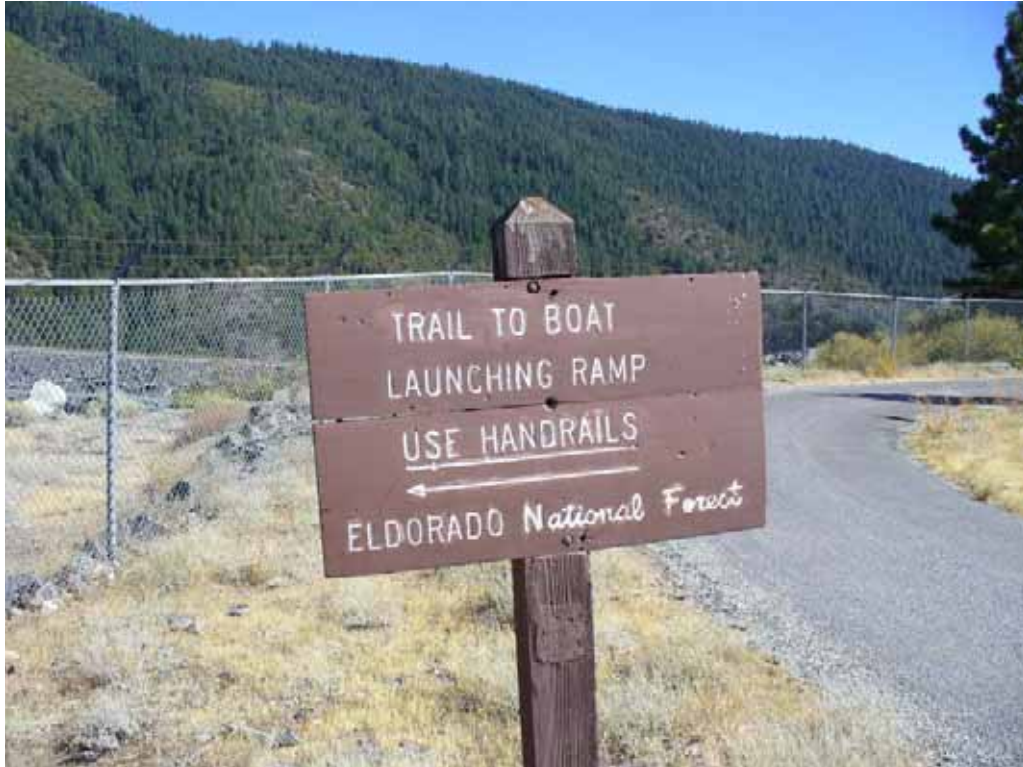
Photo H-2-30. Directional sign at entrance to trail/stairway to Hell Hole Boat Ramp. Sign is constructed of painted wood on wood post. Sign is in fair condition due to split boards and faded lettering. (8/4/08)

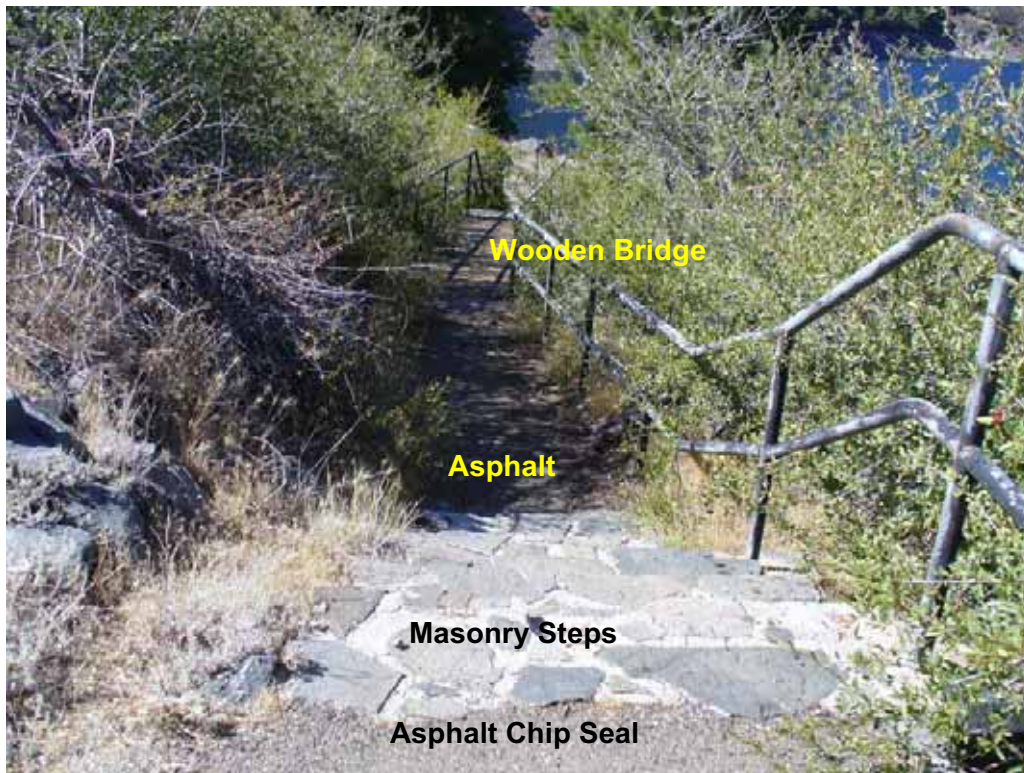
Photo H-2-31. Top portion of trail/stairway to Hell Hole Boat Ramp. Note various surface types: asphalt chip seal landing/masonry steps/asphalt/wooden bridge/asphalt. Also note steel handrails. Not disabled accessible. (8/4/08)

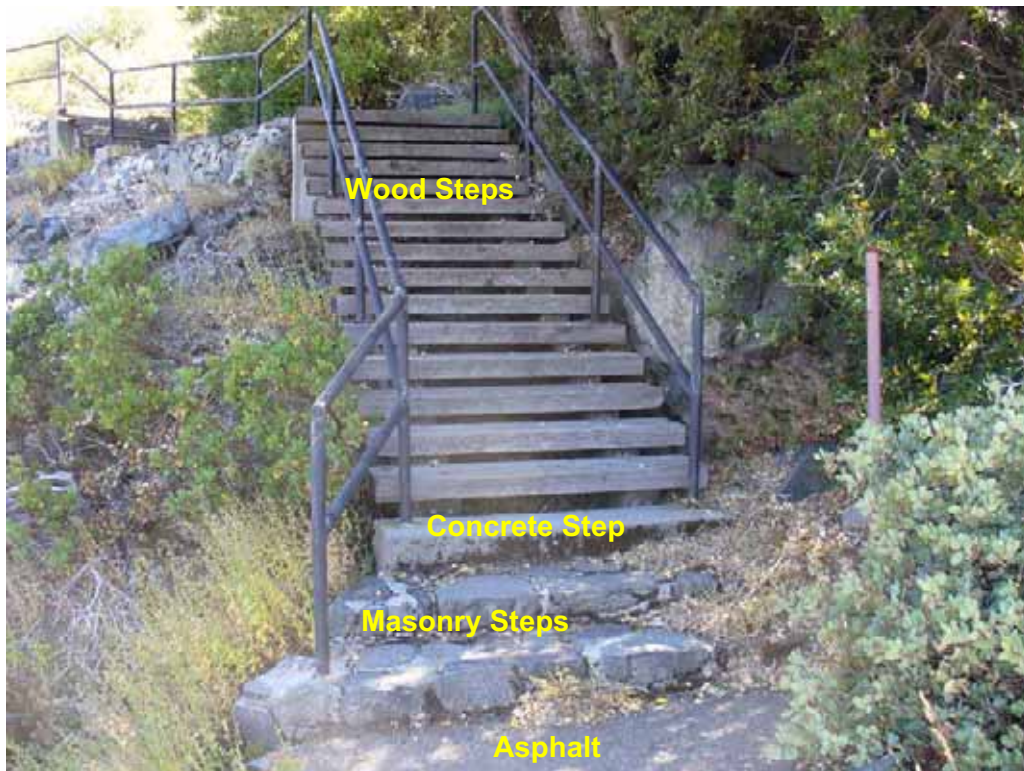
Photo H-2-32. Lower portion of trail/stairway looking up towards General Parking Area. Note various surface types: asphalt landing masonry steps/concrete step/wood steps. Also note steel handrails. Not disabled accessible. (8/4/08)

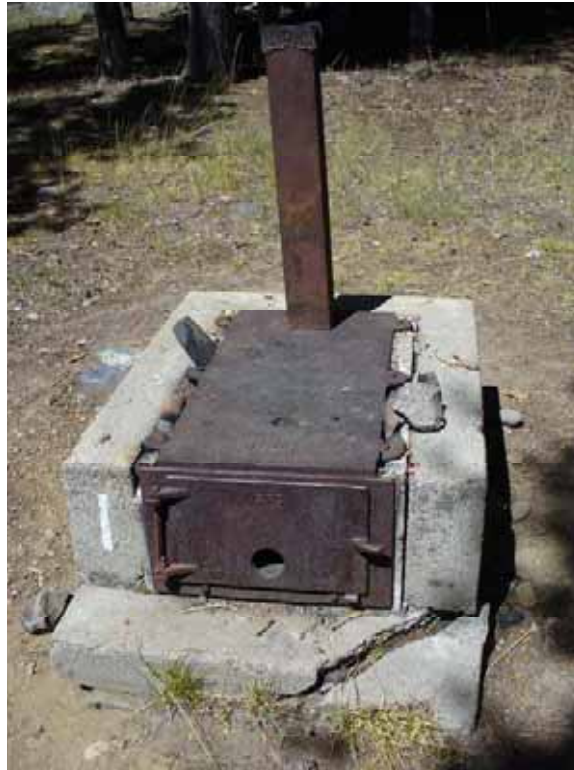
Photo I-2-7. Concrete and steel stove at site 1, poor condition. (9/04/08)

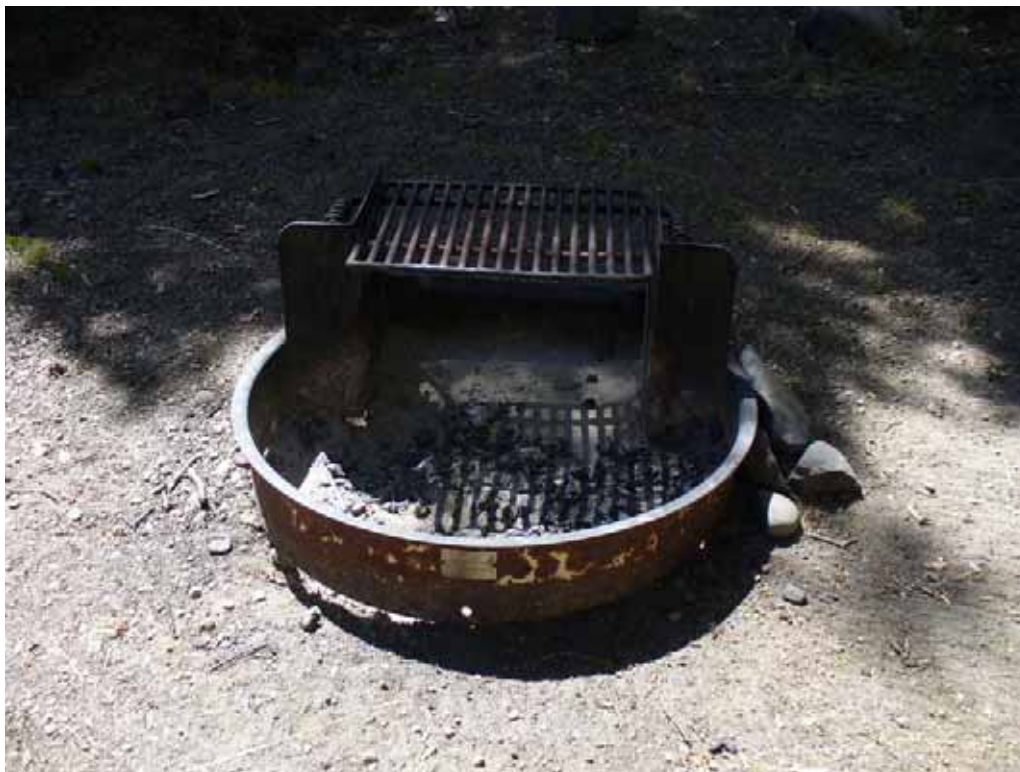
Photo I-2-8. Typical steel fire ring with grill, not accessible. (9/04/08)

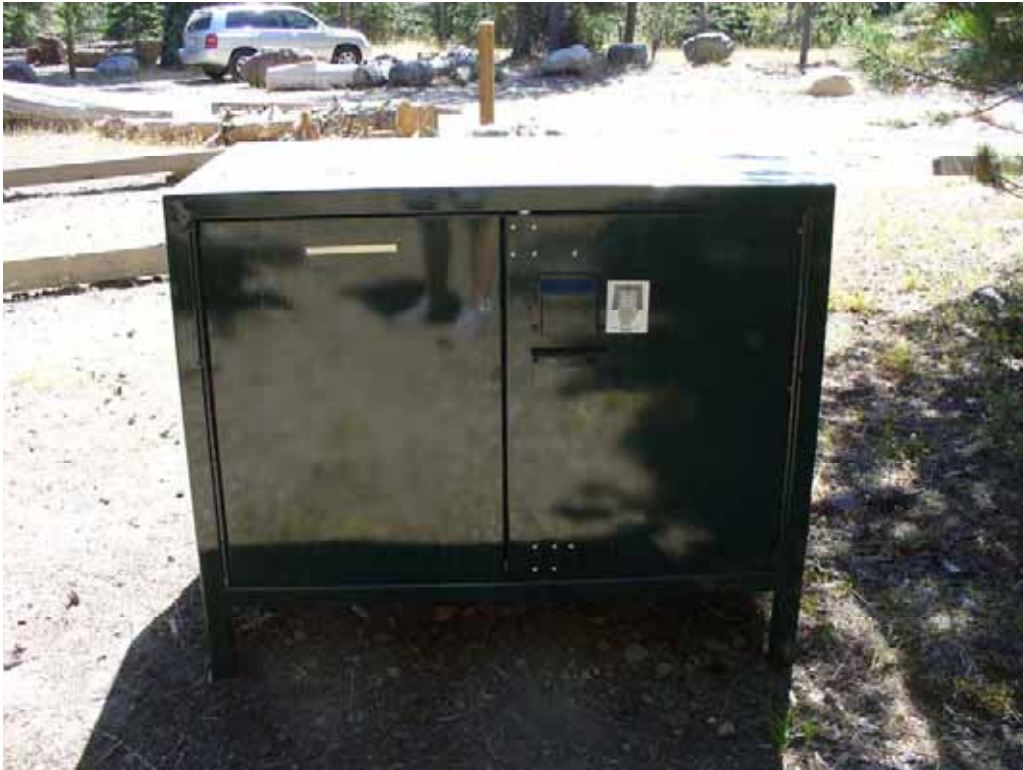
Photo I-2-9. Typical bear-proof food storage locker (bear box), new and in good condition. (9/04/08)

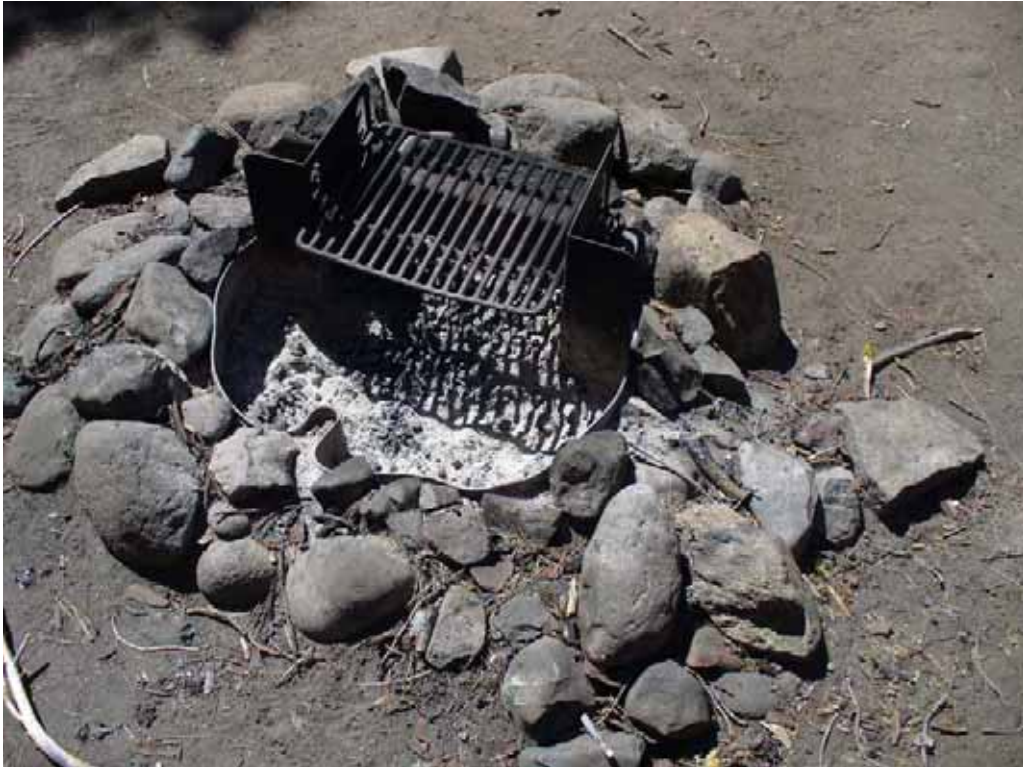
Photo I-2-10. Steel fire ring and grill, poor condition. (9/04/08)
