**Placer County Water Agency
Middle Fork American River Project
(FERC No. 2079)**

**REC 1 – RECREATION USE AND FACILITIES
TECHNICAL STUDY REPORT**

Placer County Water Agency
P.O. Box 6570
Auburn, CA 95604

May 2010

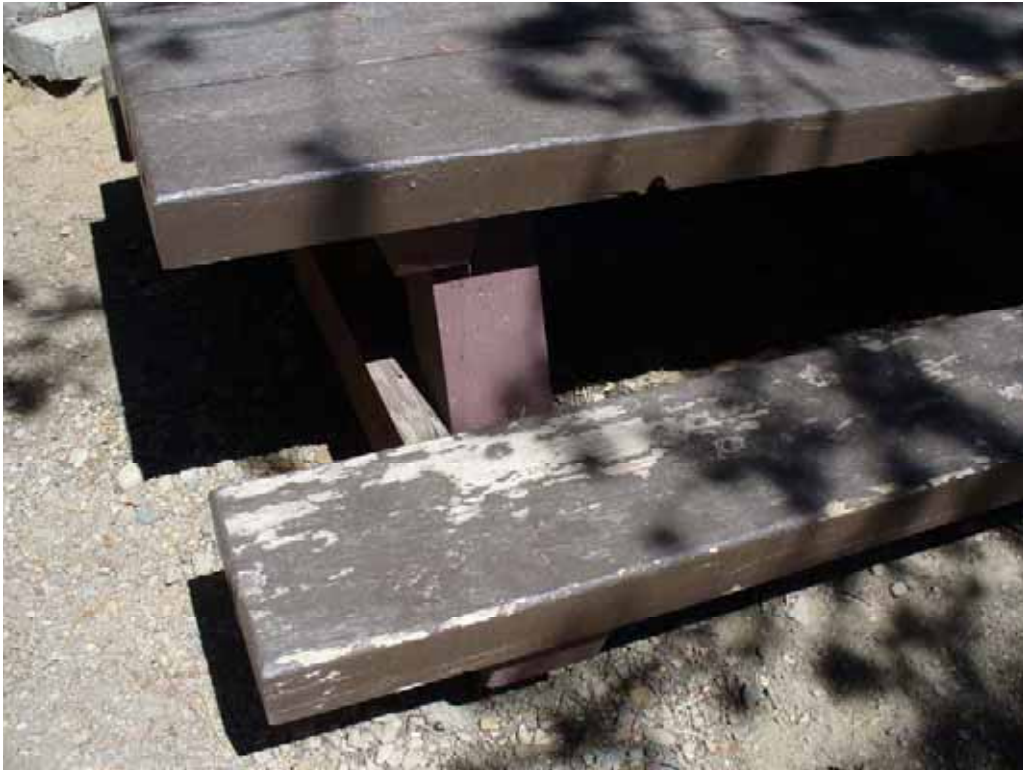
Photo I-2-11. Typical heavy wood table showing flaking paint. (9/04/08)

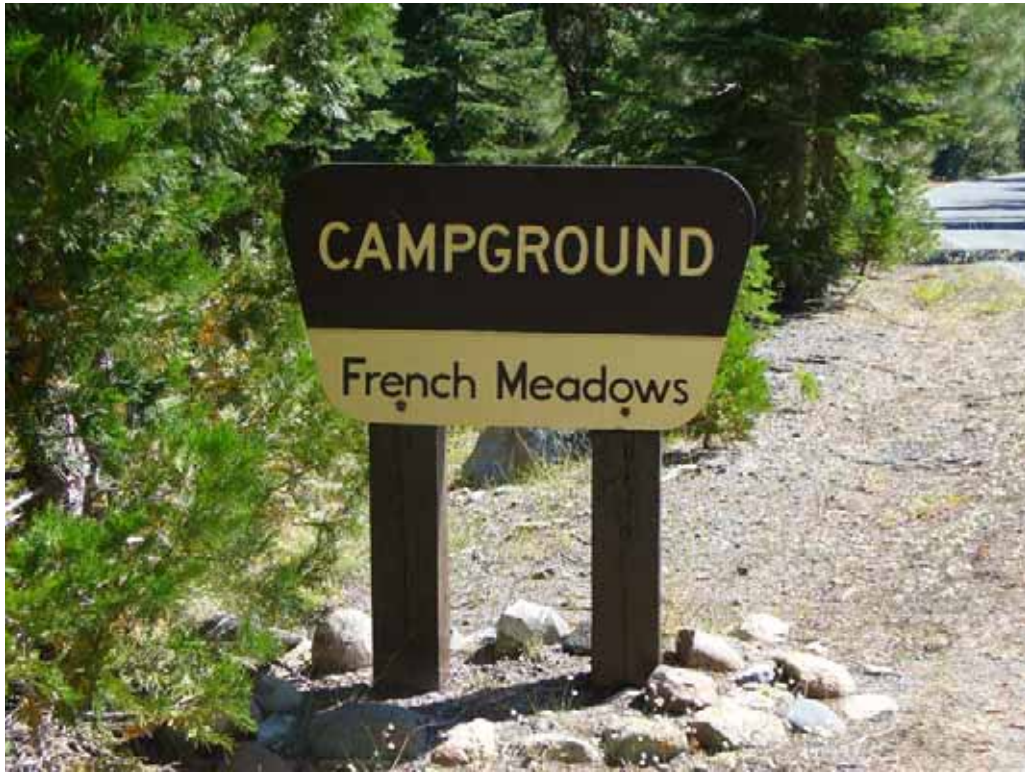
Photo J-2-1. Site Identification sign, good condition. (7/24/08)

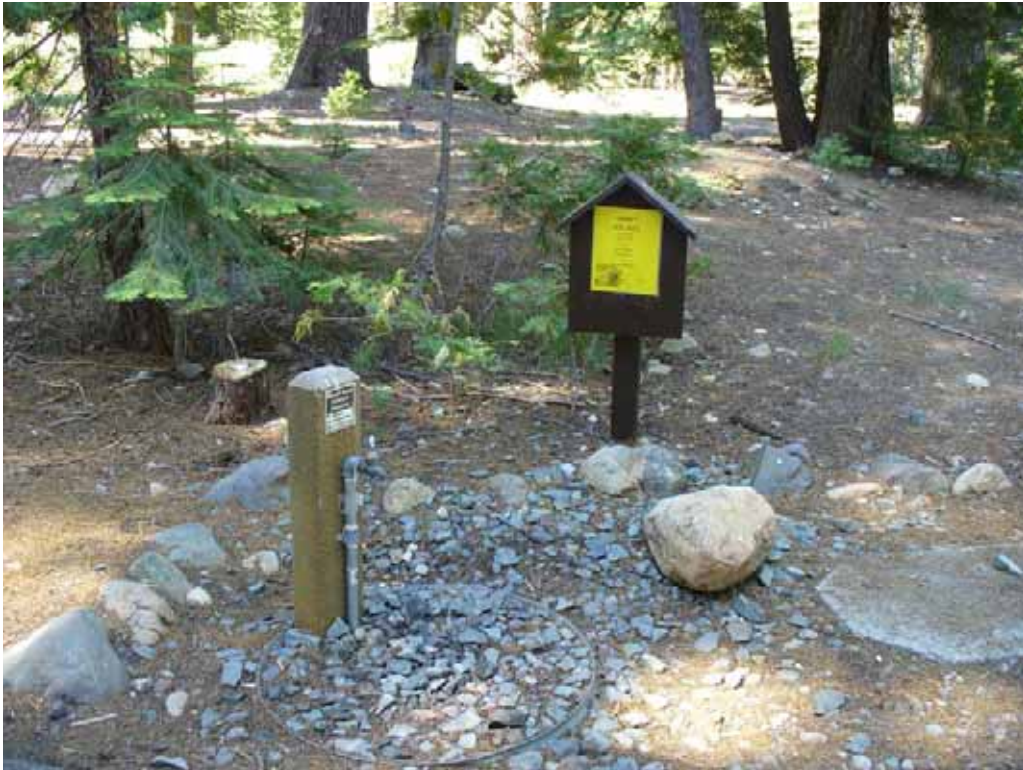
Photo J-2-9. Typical water faucet and information board. Faucet is not accessible. (7/24/08)

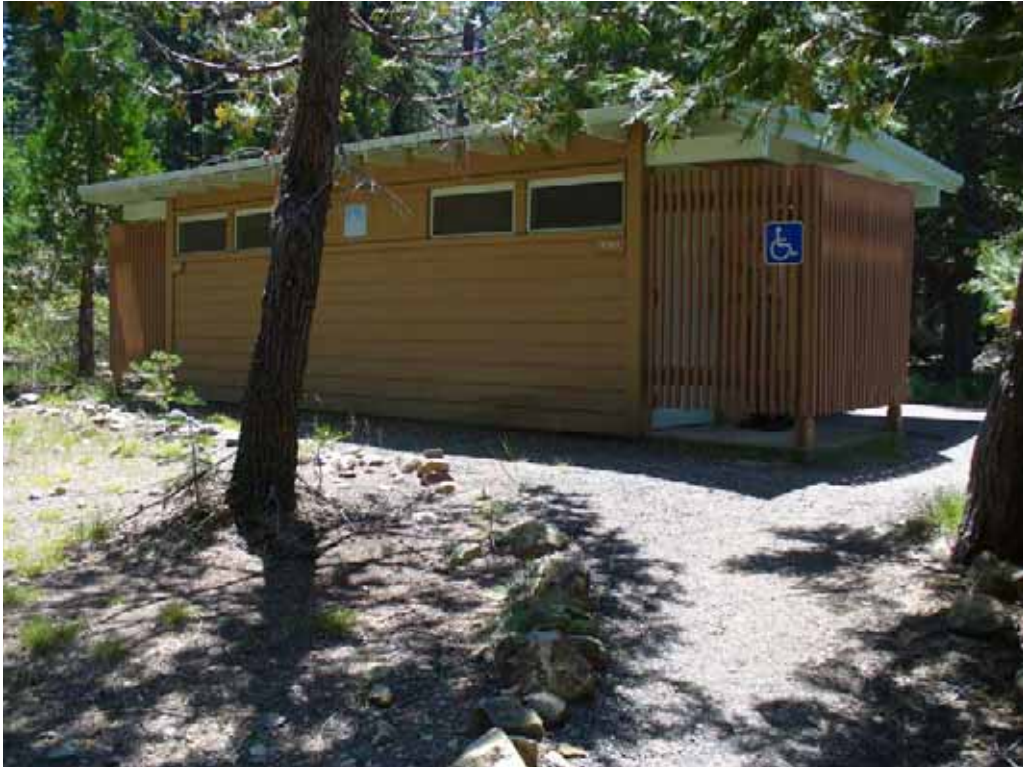
Photo J-2-10. Wood bathrooms with have flush toilets and sinks, converted to be accessible. Note accessible pathway. (7/24/08)

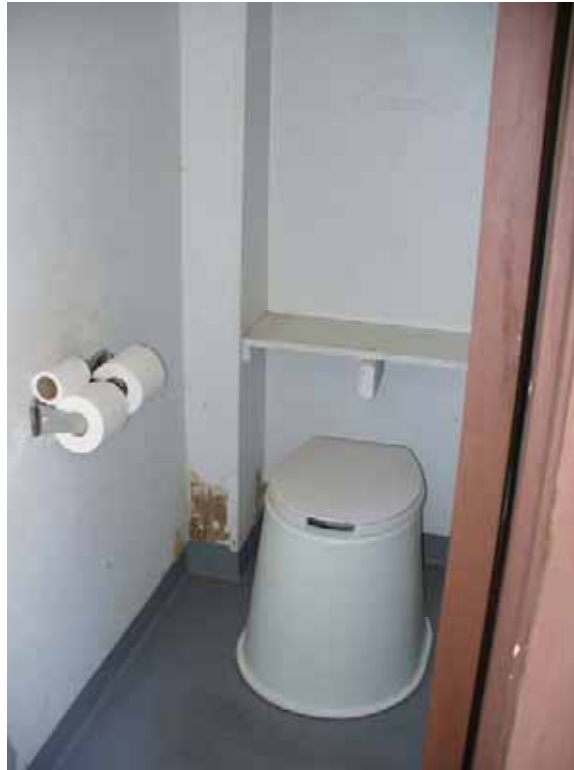
Photo J-2-15. Inside of bathroom #3. (7/24/08)

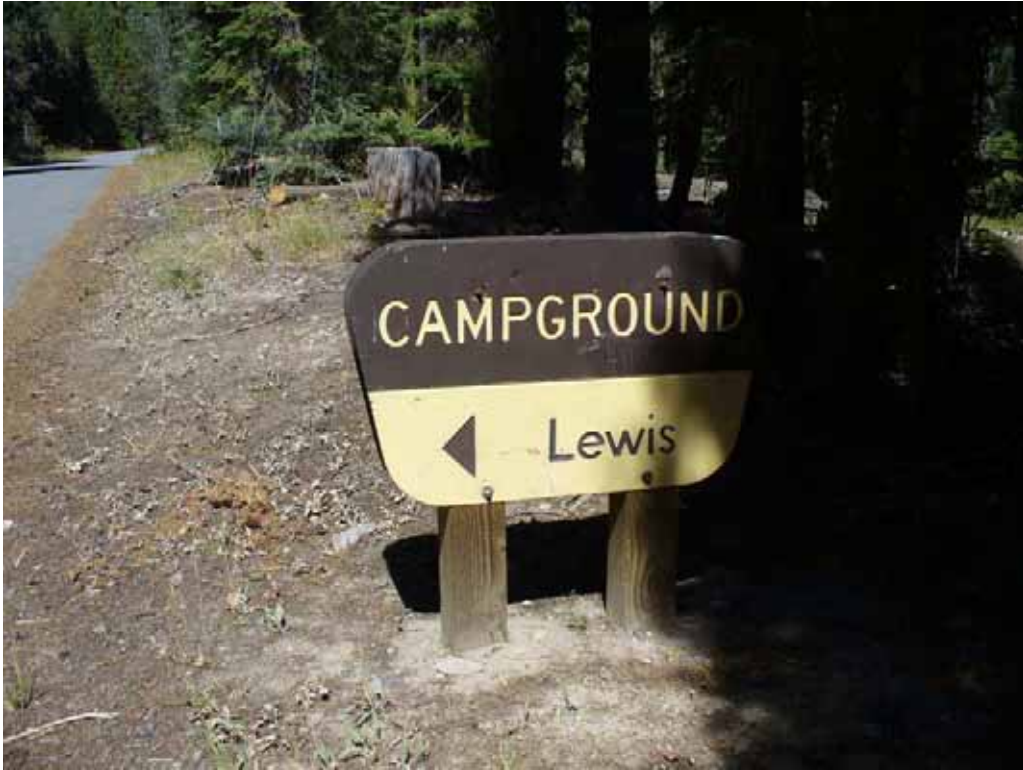
Photo K-2-1. Site Identification sign, good condition. (9/04/08)

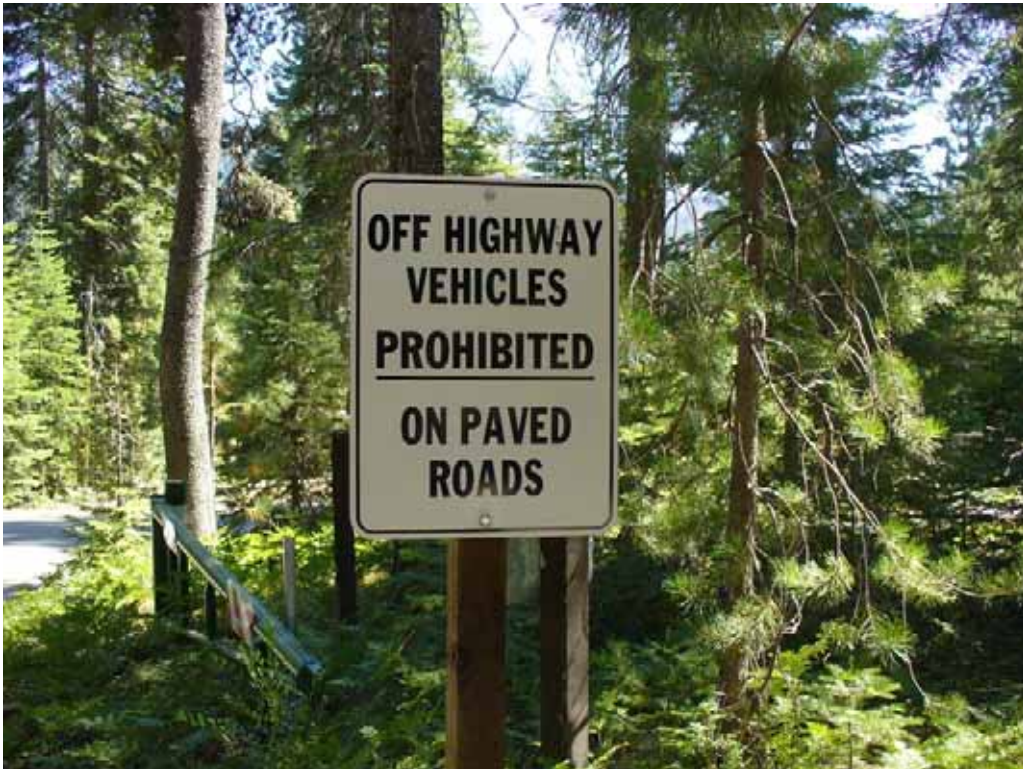
Photo K-2-2. Signage at Lewis Campground exit, good condition. (9/04/08)

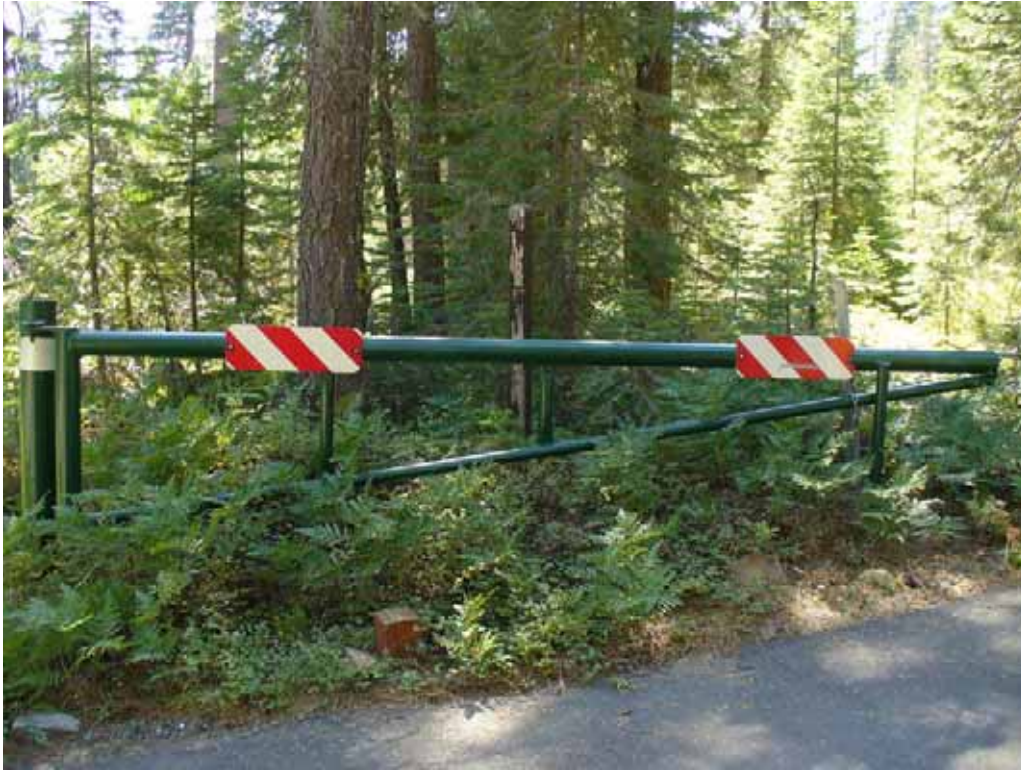
Photo K-2-3. Swing gate with reflective hazard signs located at entrance to Lewis Campground, good condition. (9/04/08)

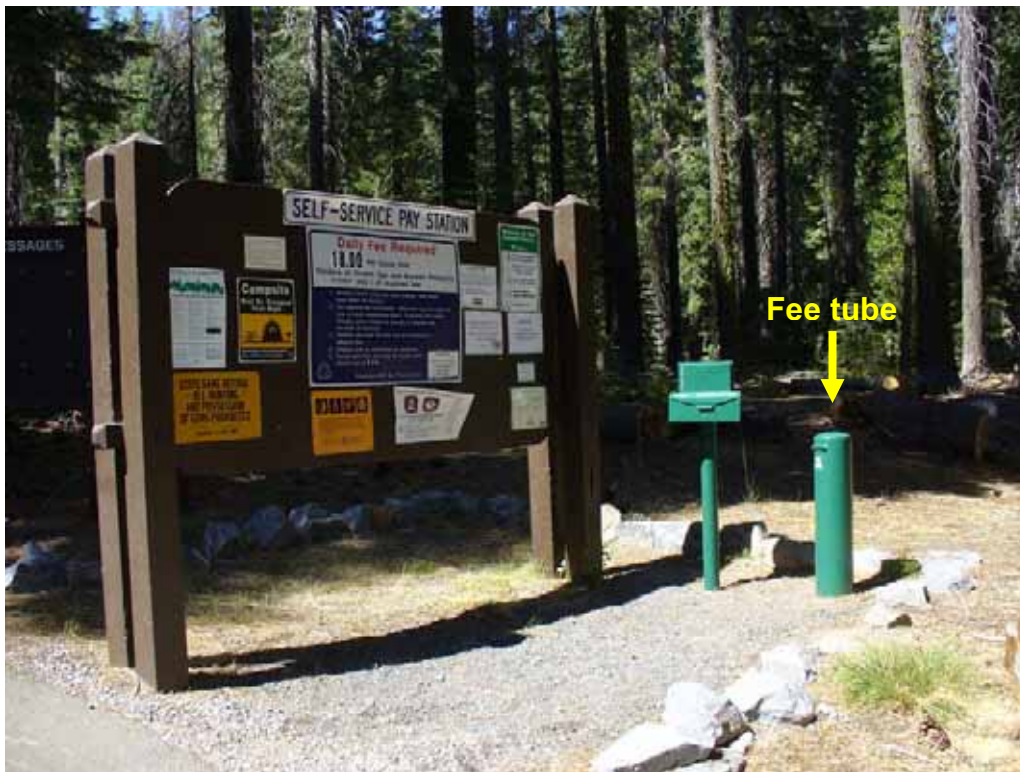
Photo K-2-4. Fee station at Lewis Campground located near entrance, all in good condition. (9/04/08)

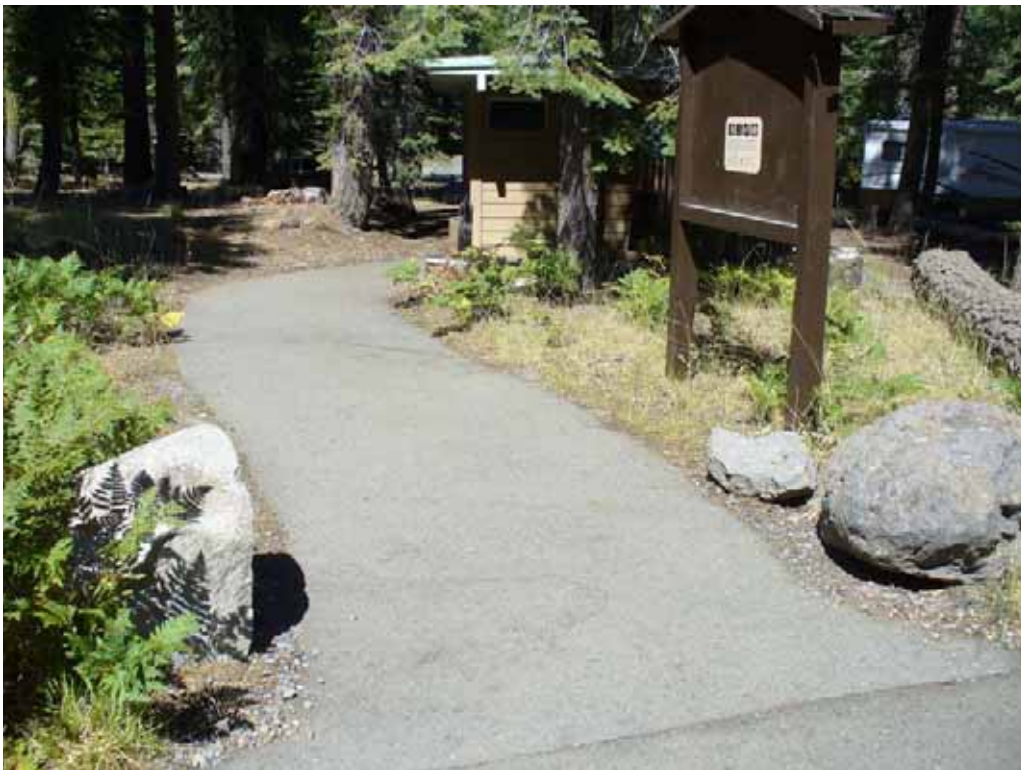
Photo K-2-6. Paved accessible pathway to accessible bathroom with information board, adjacent to host site. All in good condition. (9/04/08).

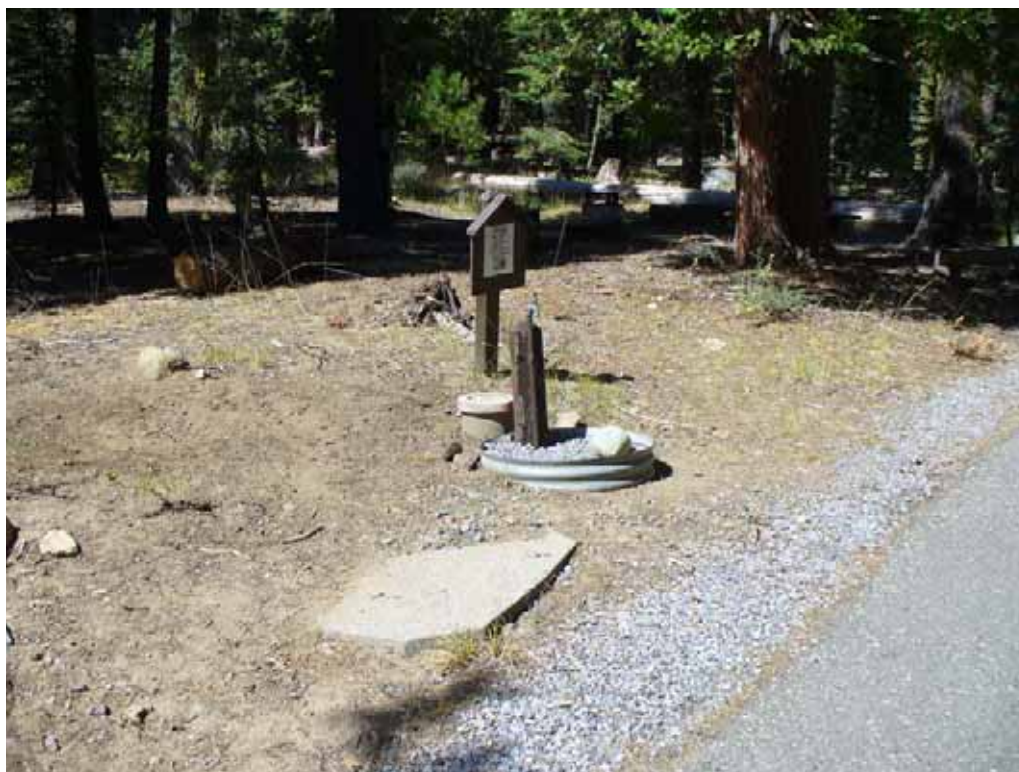
Photo K-2-8. Typical water faucet and information board located along loop roads, not accessible. (9/04/08)

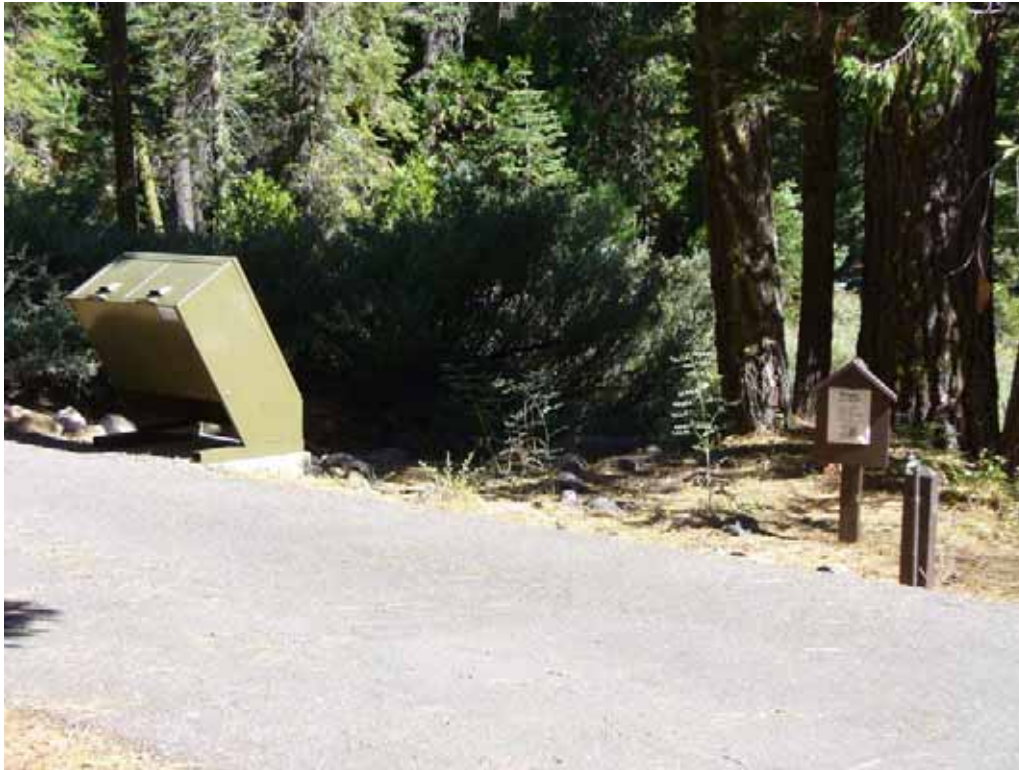
Photo K-2-9. Typical 2-bin, bear-proof garbage container, new and in good condition. Note water faucet and information board on right side of photograph. Faucet is not accessible. (9/04/08)

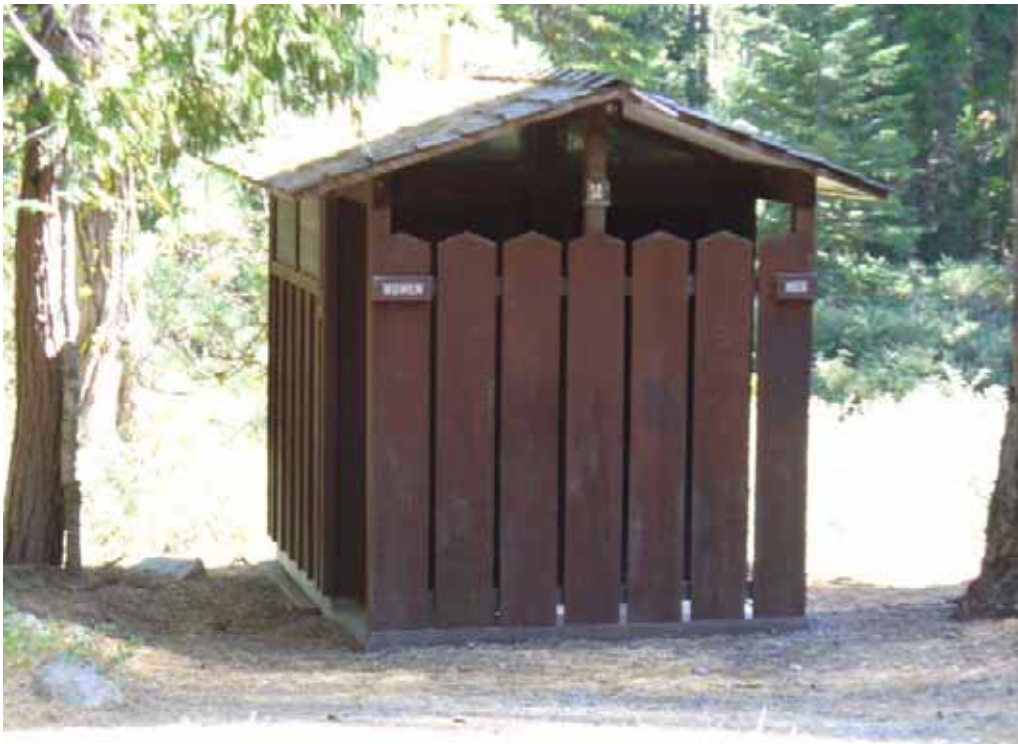
Photo K-2-10. Wood bathroom structure No. 2. This is a double unit vault toilet in fair condition. Not accessible. (9/04/08)

Bathroom	2	Two single units (M & F) side by side in middle of campground.	Painted wood	Pit	Poor	N						X	Outdated and in poor condition. Stalls are too high and narrow to meet accessibility standards. Recently shingled. Excess shingles on ground surrounding bathrooms.

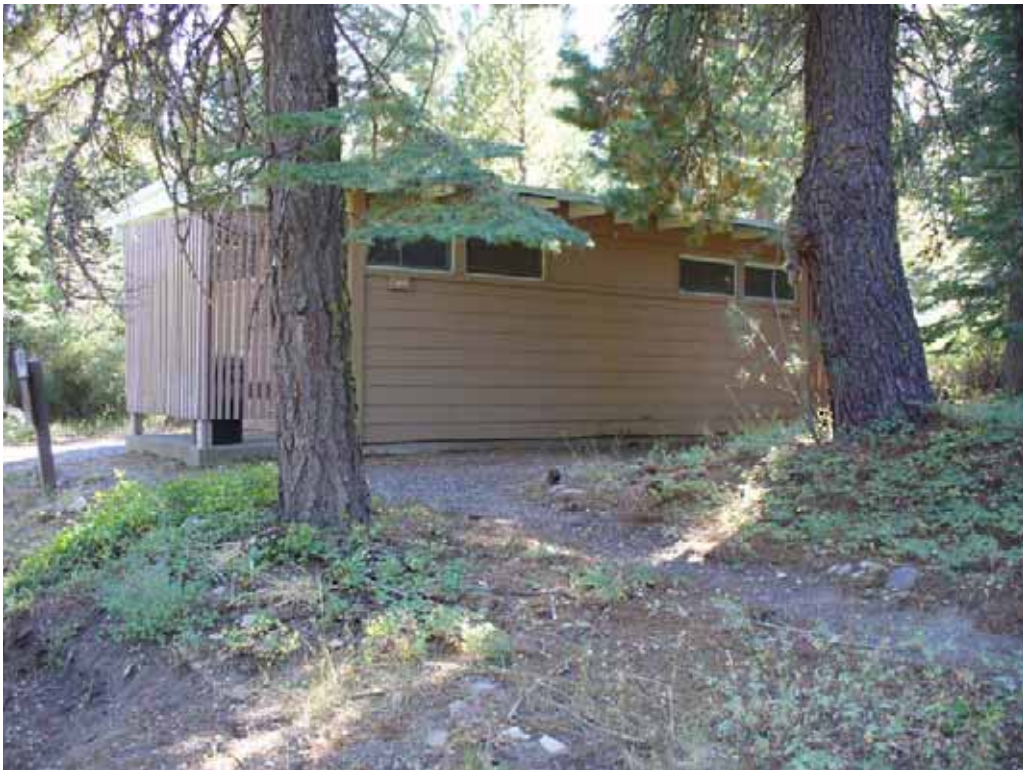
Photo K-2-12. Wood bathroom structure with flush toilets and sinks, not accessible. (9/04/08)

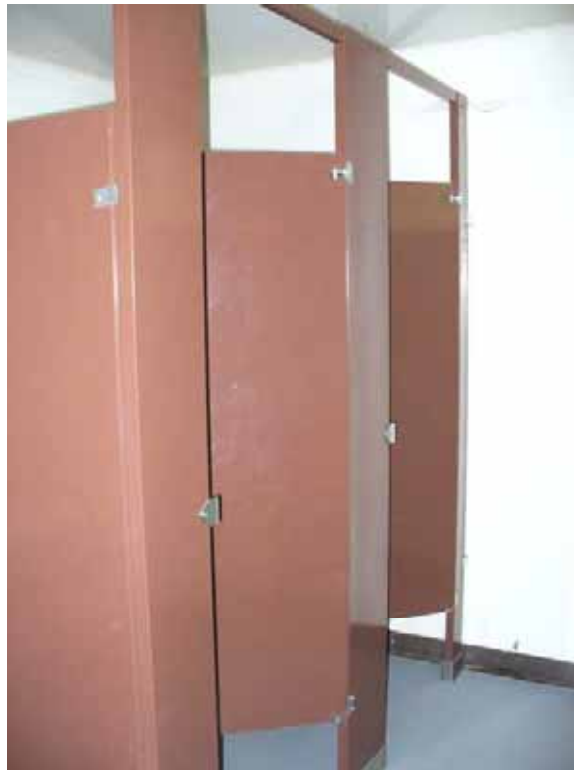
Photo K-2-14. Stalls inside of wood bathroom. These stalls are not accessible but this type of bathroom can be converted to meet accessibility standards. (9/04/08)

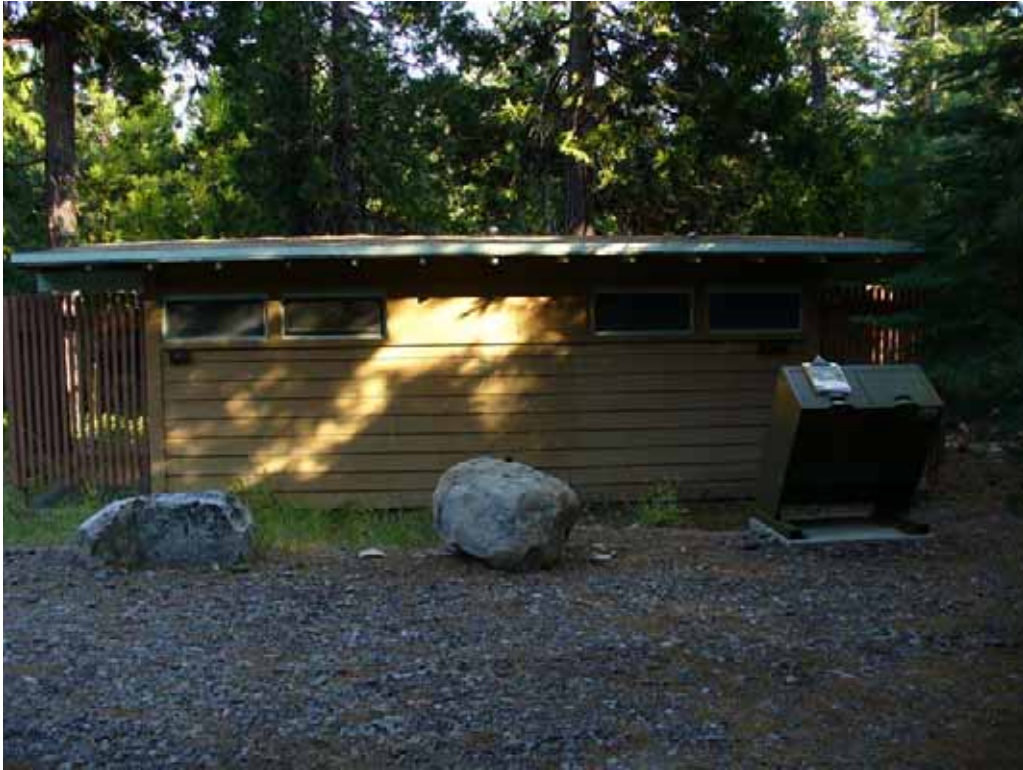
Photo L-2-3. Wood bathrooms with flush toilets and sinks adjacent to Poppy Trailhead parking. Not accessible. (7/23/08)

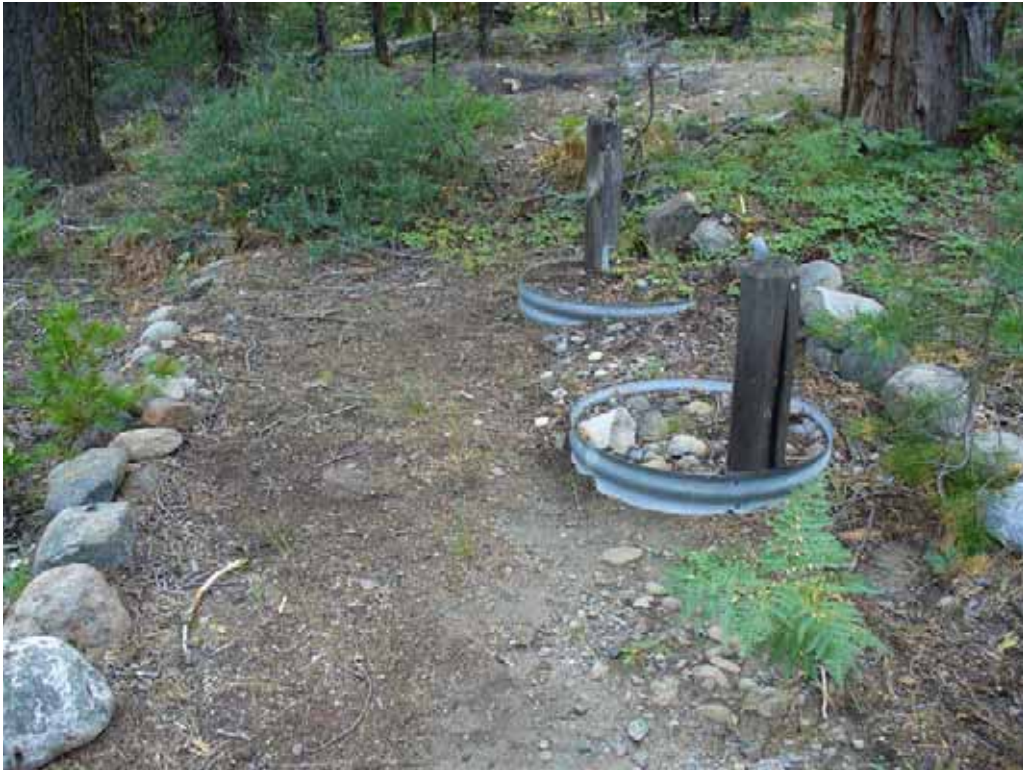
Photo L-2-5. Water faucets behind flush toilets. Not accessible. (7/23/08)

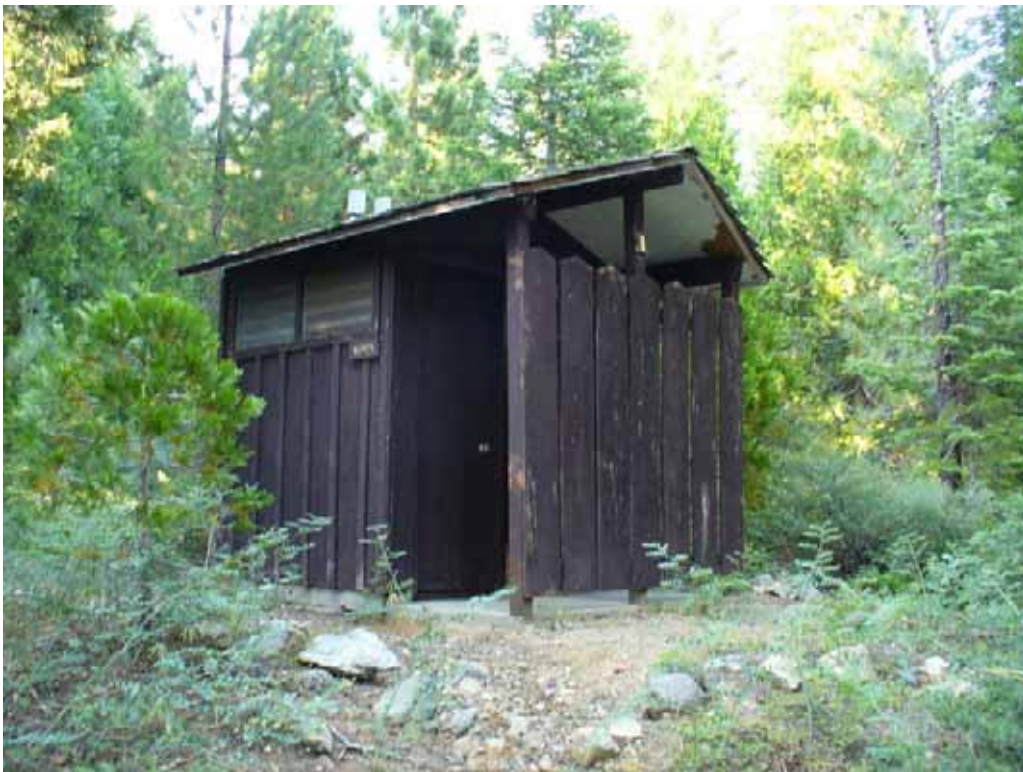
Photo L-2-6. Vault toilet near Poppy Trailhead parking. Not accessible. (7/23/08)

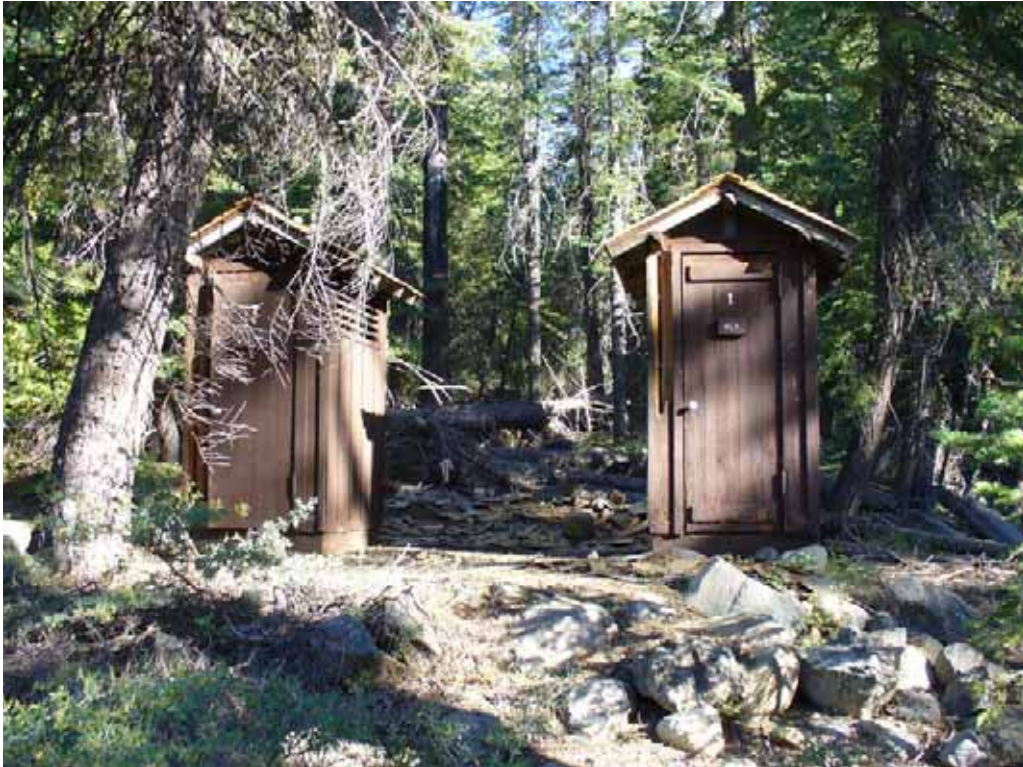
Photo L-2-14. Pit toilets in campground. No accessible. (7/24/08)

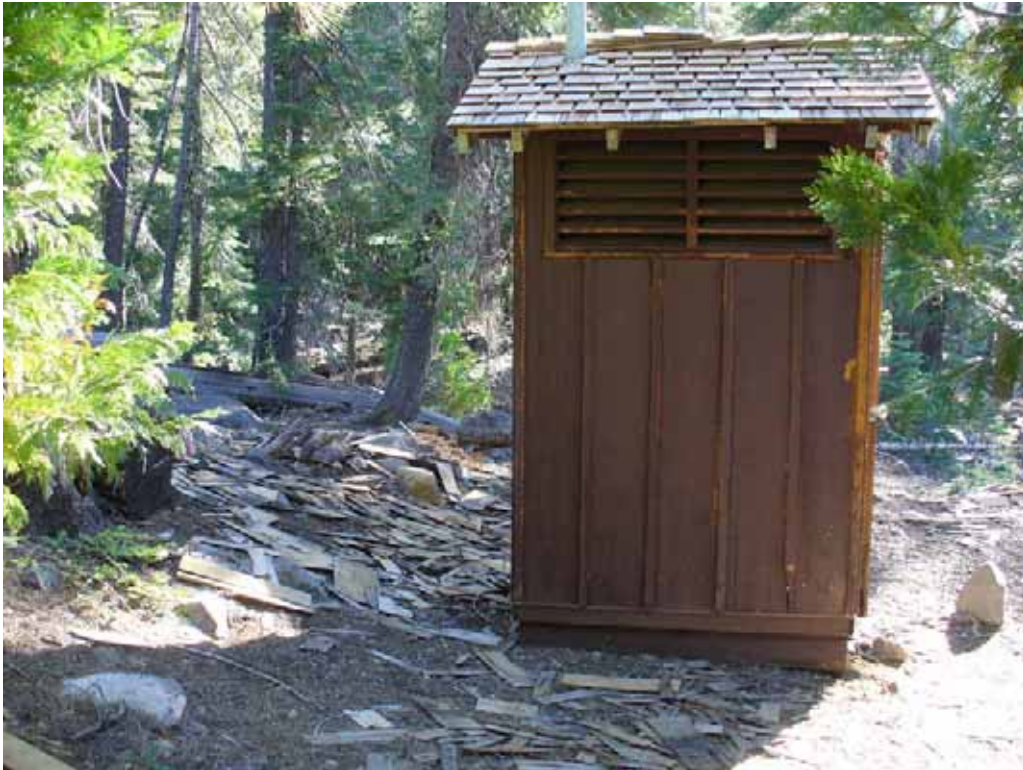
Photo L-2-15. Pit toilet side view. Note newly shingled roof and scrap shingles on ground. (7/24/08)

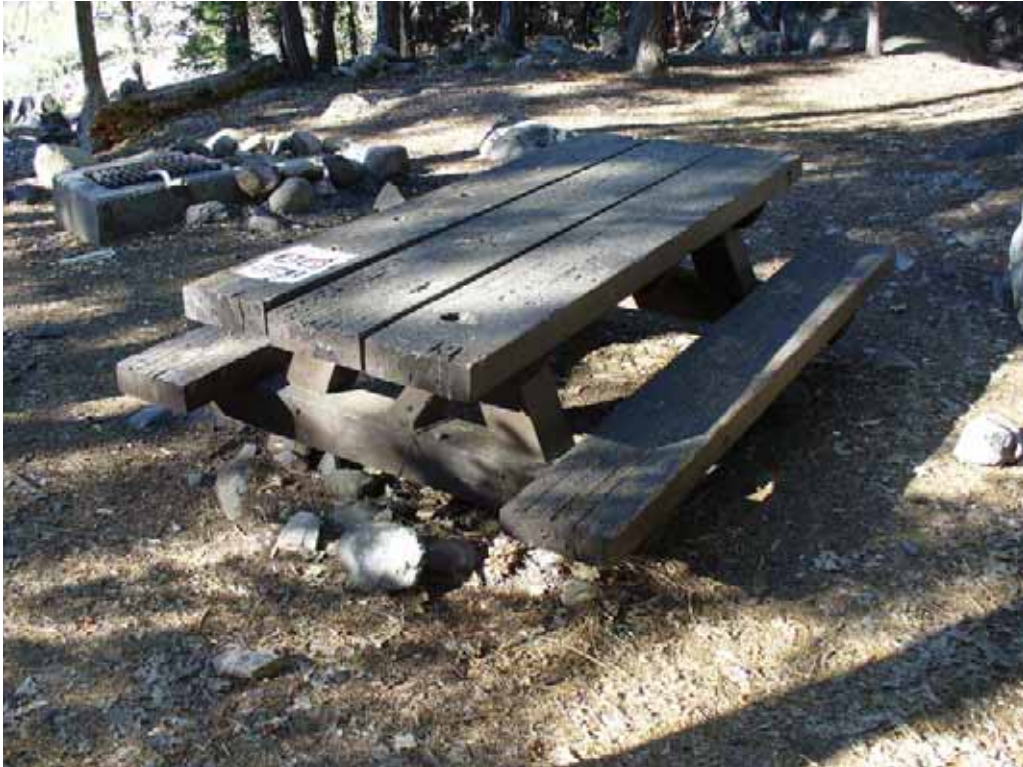
Photo L-2-16. Site 2. Typical site with heavy wood picnic table and concrete/steel grill. (7/24/08)

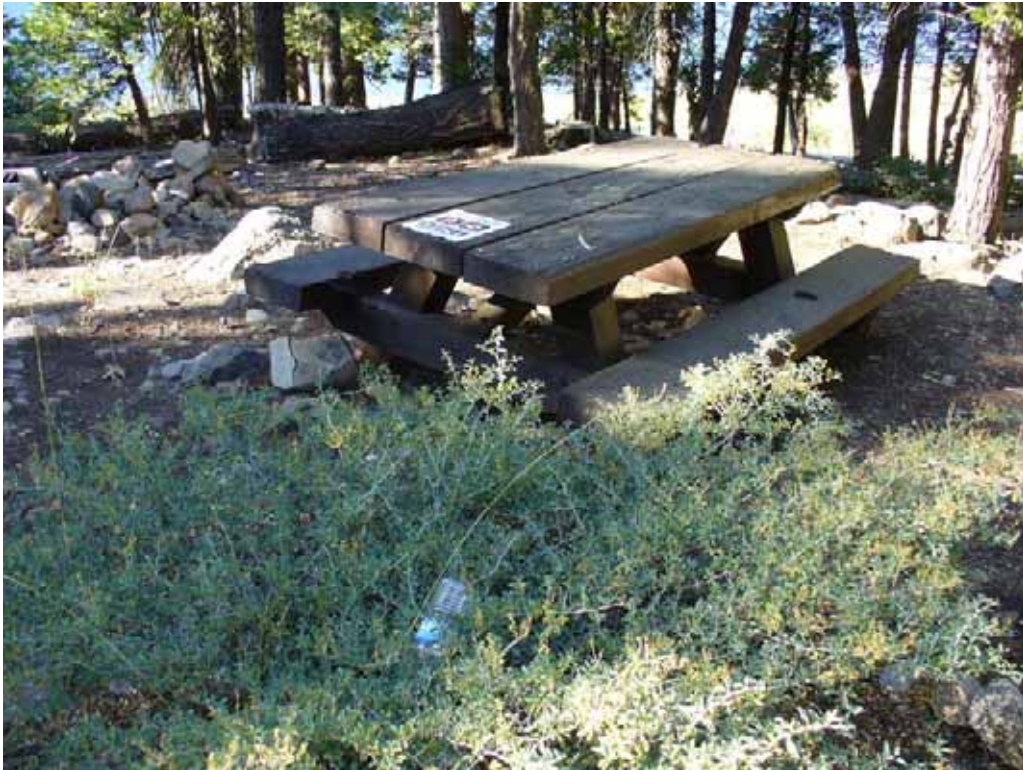
Photo L-2-17. Site 4. Note overgrown vegetation and obstacles around table. Concrete/steel grill in middle ground to left. French Meadows Reservoir in background. (7/24/08)

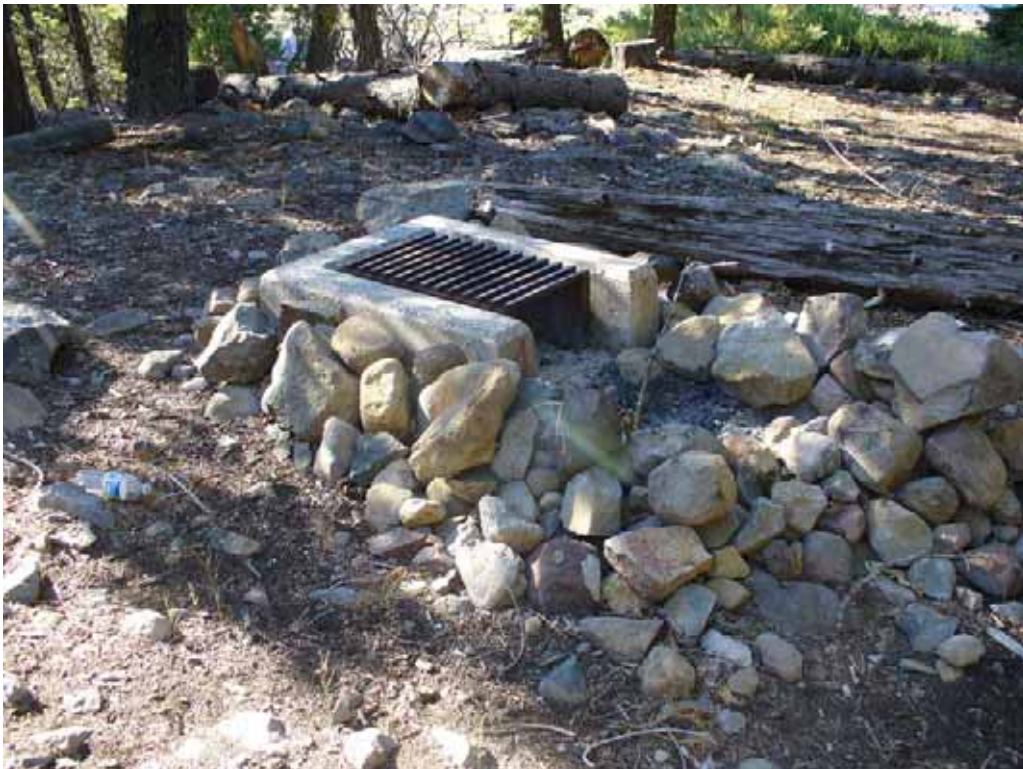
Photo L-2-18. Concrete/steel grill with user created rock enclosure. (7/24/08)

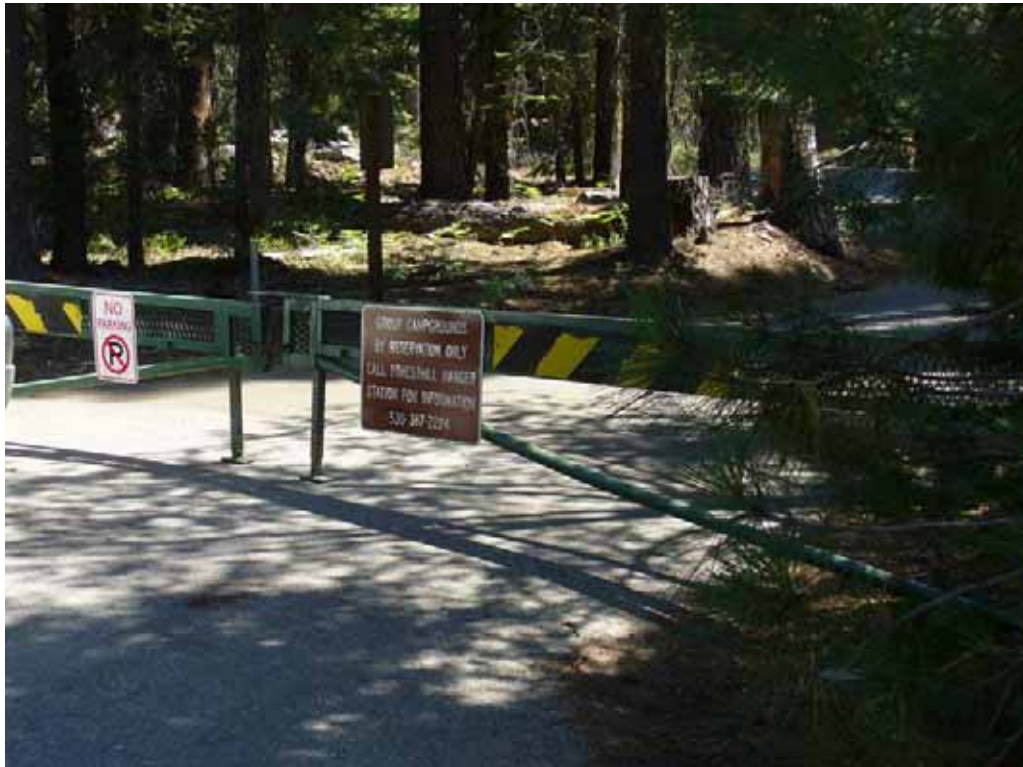
Photo M-2-2. Double swing gate at intersection of FR-96 and Little Wolf and Brush Wolf Main Access Road. This gate is closed and locked when none of the sites are reserved. (7/24/08)

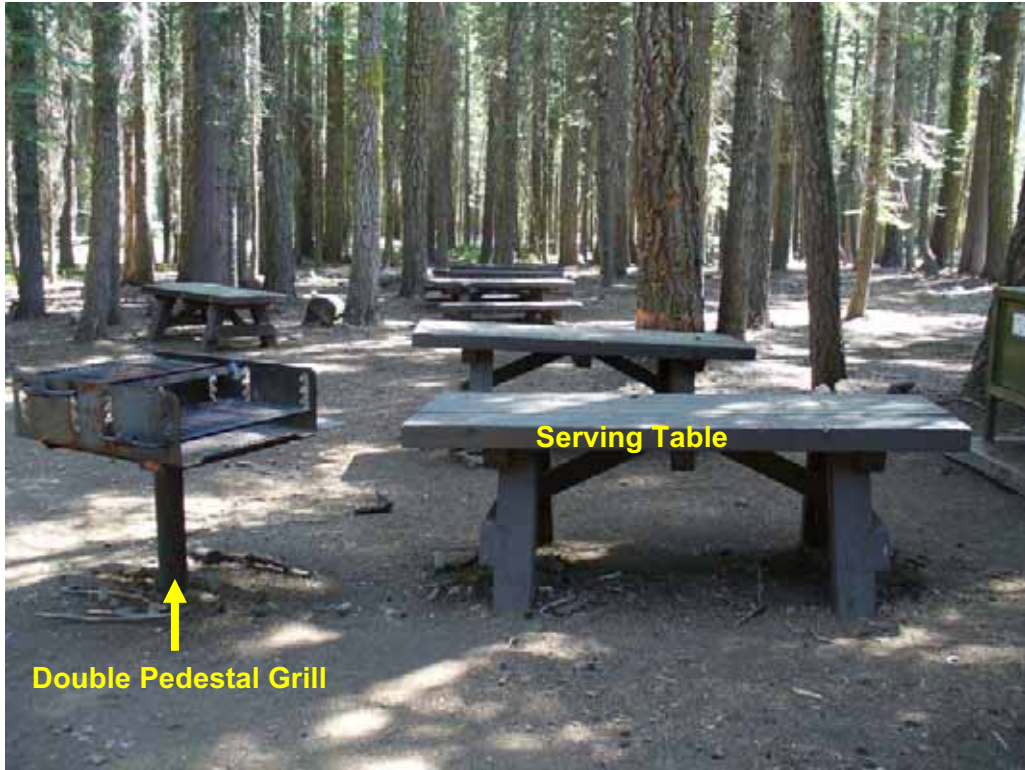
Photo M-2-5. Little Wolf kitchen and dining area. Note double pedestal grill, and heavy wood serving tables. Serving tables don't have benches like picnic tables. (7/24/08)

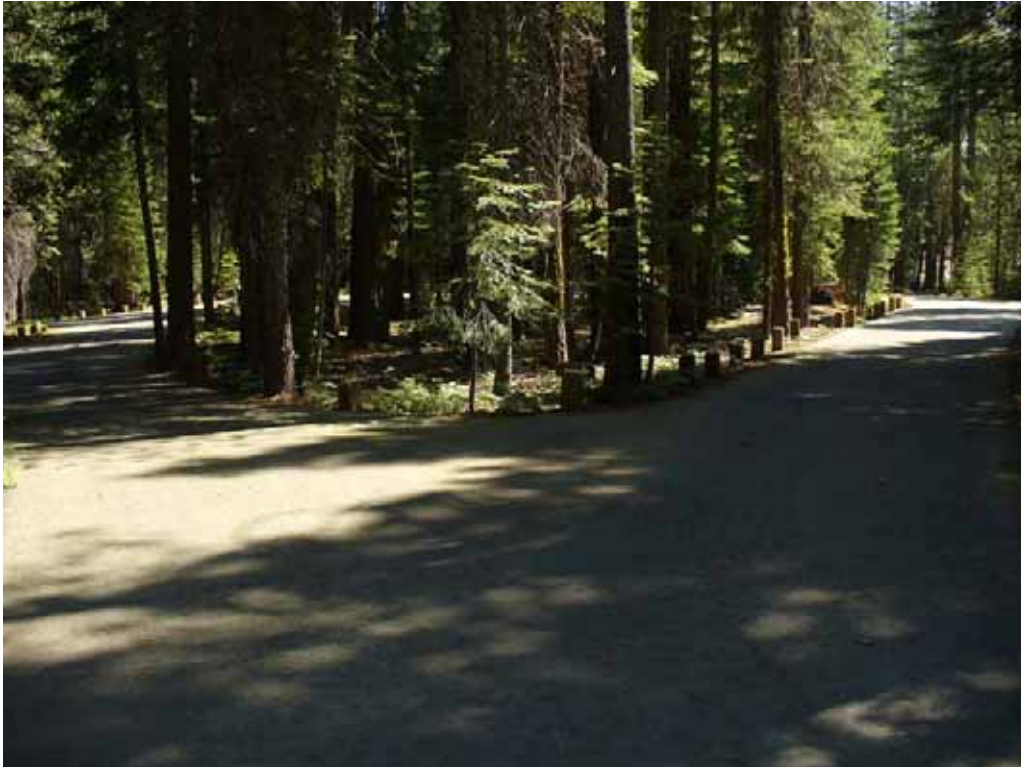
Photo M-2-8. Brush Wolf loop road. Note barrier post along edge of road way.

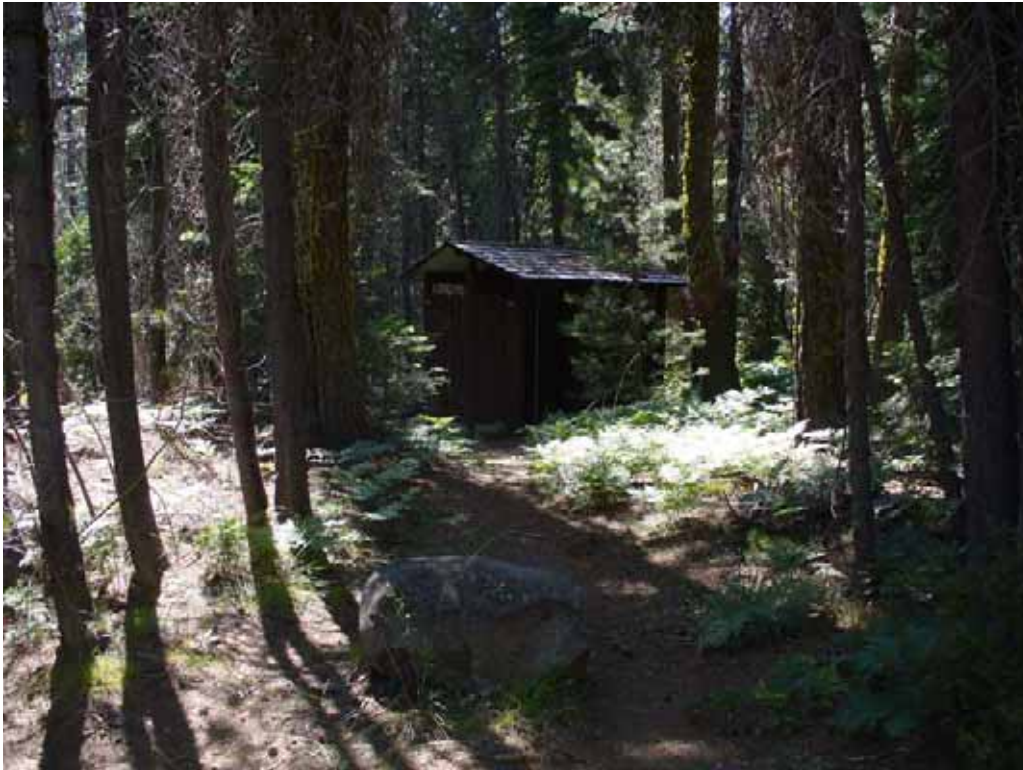
Photo M-2-15. Vault toilet building at Prairie Wolf. Note narrow entrance path. (7/24/08)

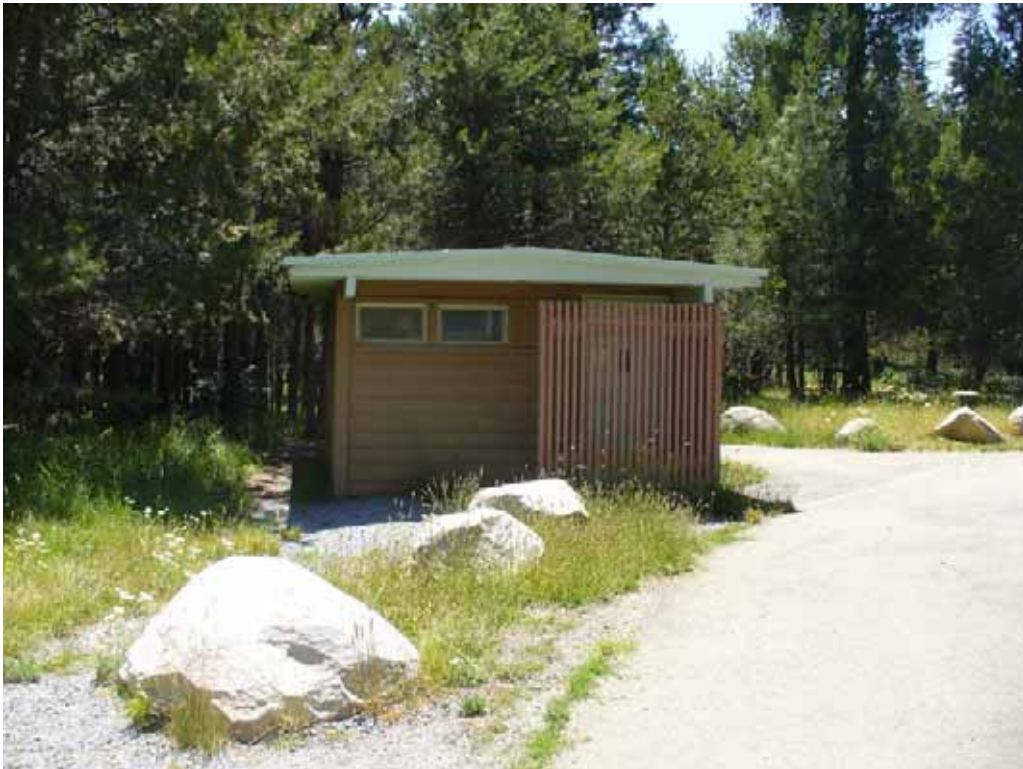
Photo M-2-20. Side view of bathroom at Black Bear from parking area. This bathroom has flush toilets and sinks and was retrofitted to meet accessibility standards. (7/24/08)

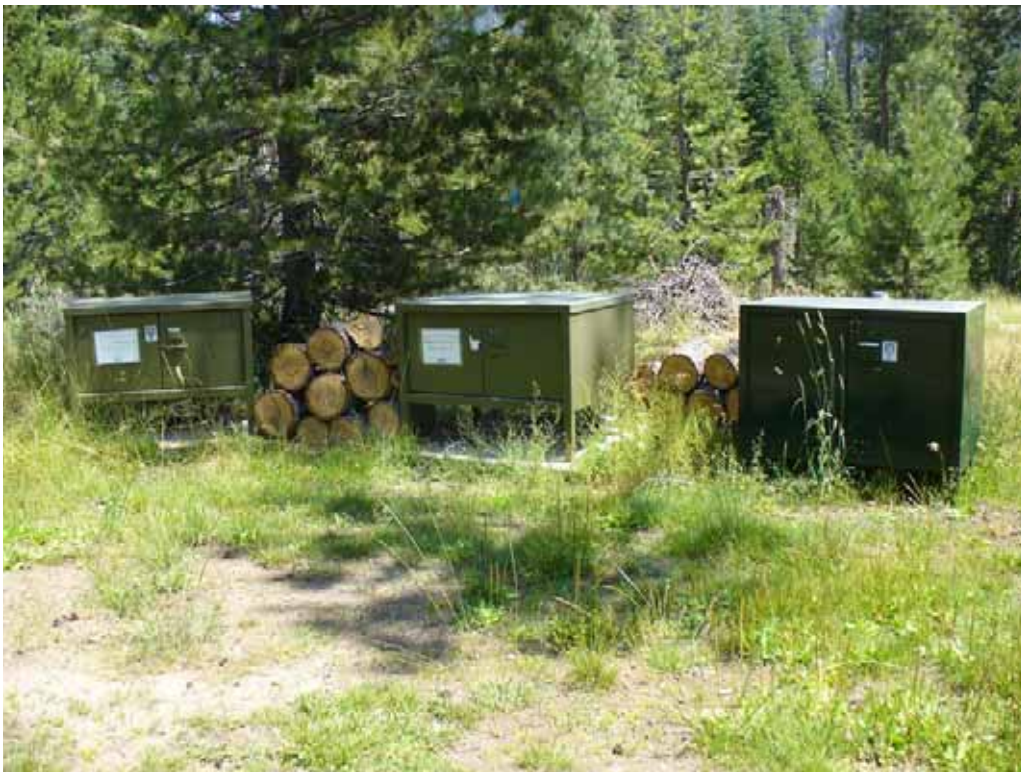
Photo M-2-22. Three bear boxes at Black Bear. Two on concrete pads. Stacked wood was left by fire crews who used this site as a staging area in 2008. Note vegetation. (7/24/08)
