**Placer County Water Agency
Middle Fork American River Project
(FERC No. 2079)**

**REC 1 – RECREATION USE AND FACILITIES
TECHNICAL STUDY REPORT**

Placer County Water Agency
P.O. Box 6570
Auburn, CA 95604

May 2010

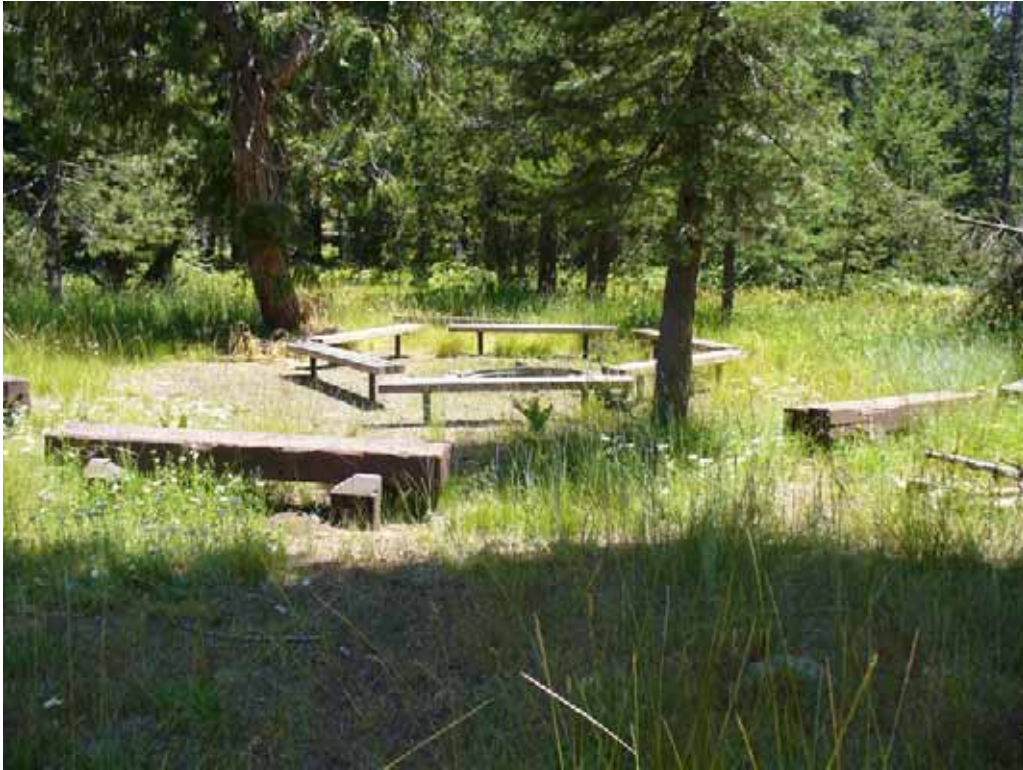
Photo M-2-23. Group fire ring with new and old style benches at Black Bear. Note vegetation. (7/24/08)

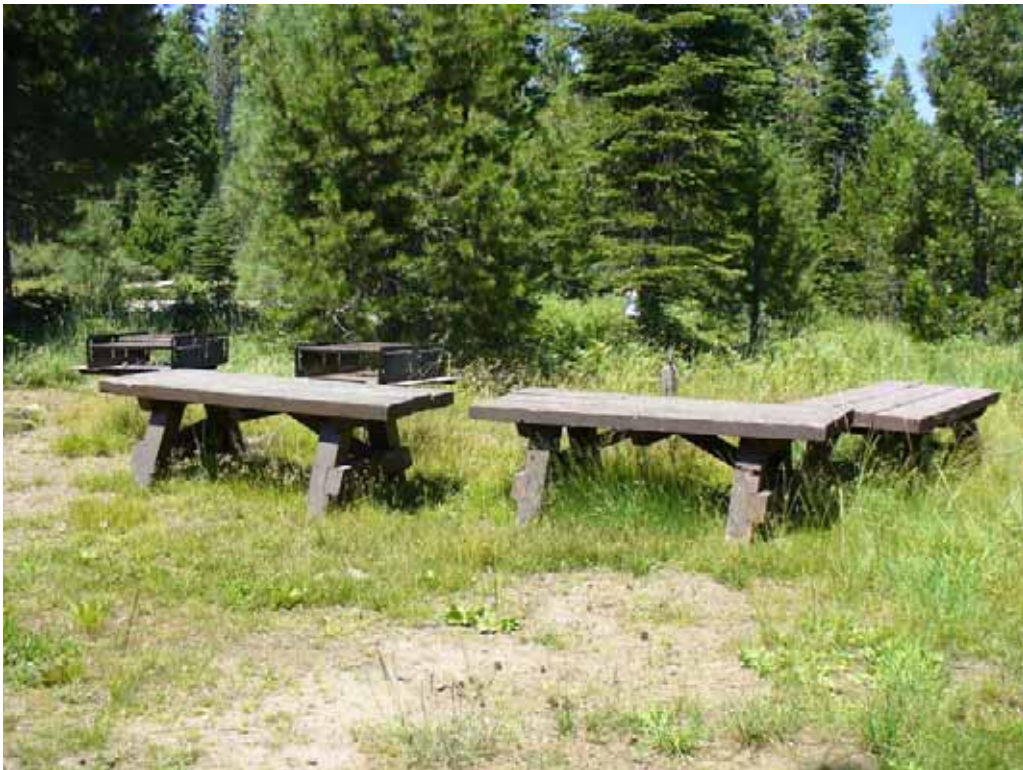
Photo M-2-24. Three serving tables and double pedestal grills at Black Bear. Note vegetation. (7/25/08)

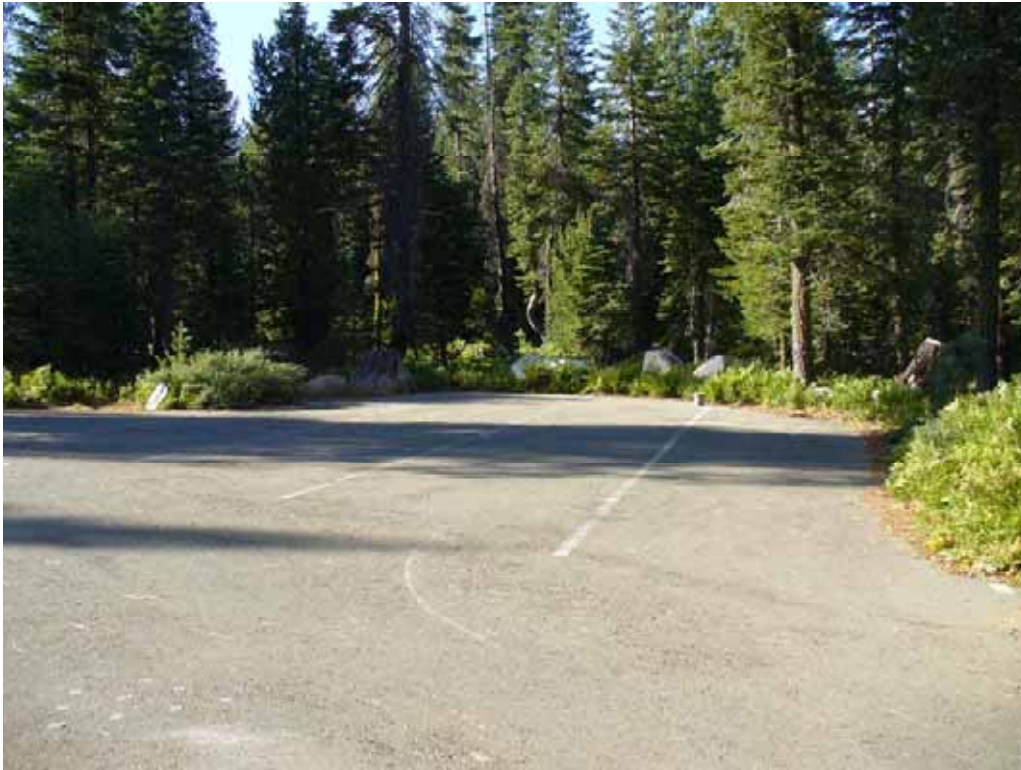
Photo N-2-7. Typical parking area at Gates Group Campground. This parking area is located at the entrance to Ponderosa. Note the striping and long stalls for trailers/RVs. Pavement is in good condition. (9/4/08)

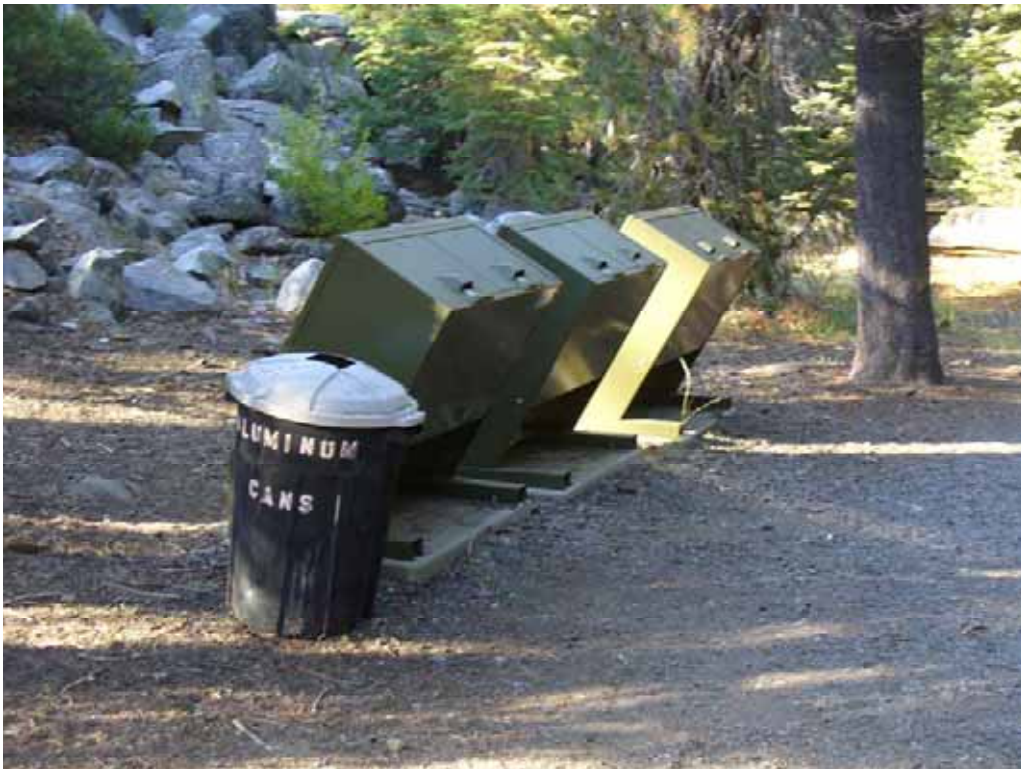
Photo N-2-8. Typical bear-proof garbage containers in the Gates Group Campground. These containers are located at the entrance to Ponderosa. (9/4/08)

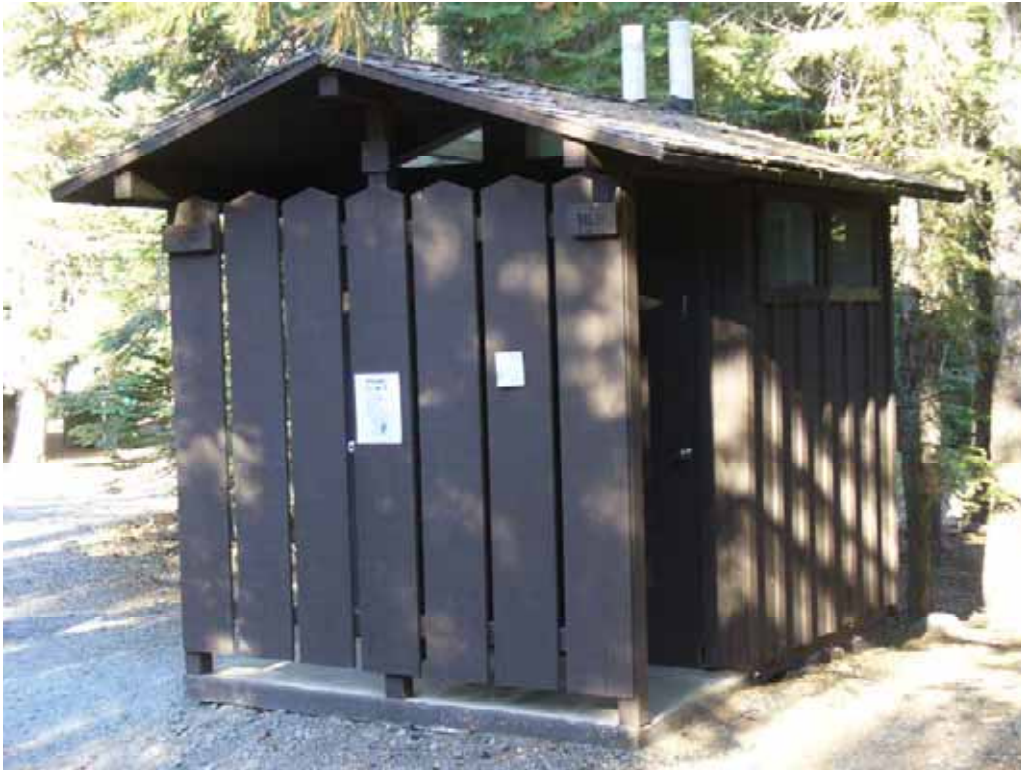
Photo N-2-9. Typical vault bathroom in Gates Group Campground. This bathroom is located in Ponderosa Campground. None of the bathrooms in the Gates Group Campground are accessible. (9/4/08)

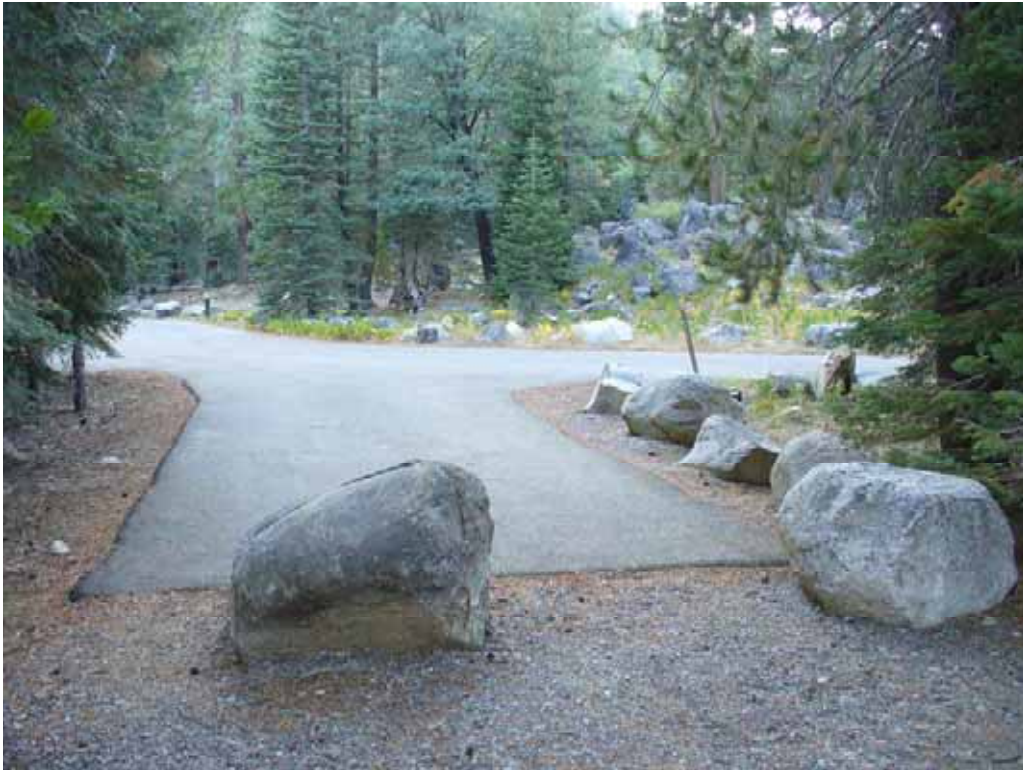
Photo N-2-15. Turn-around area at Lodgepole. Note pavement is in good condition. (9/4/08)

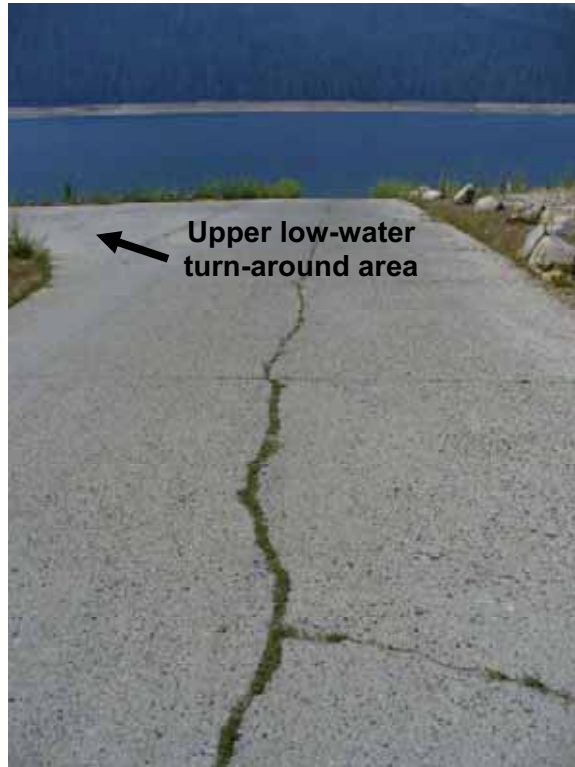
Photo O-2-2. Cracking in-filled with vegetation along French Meadows Boat Ramp, upper section. (7/23/08)

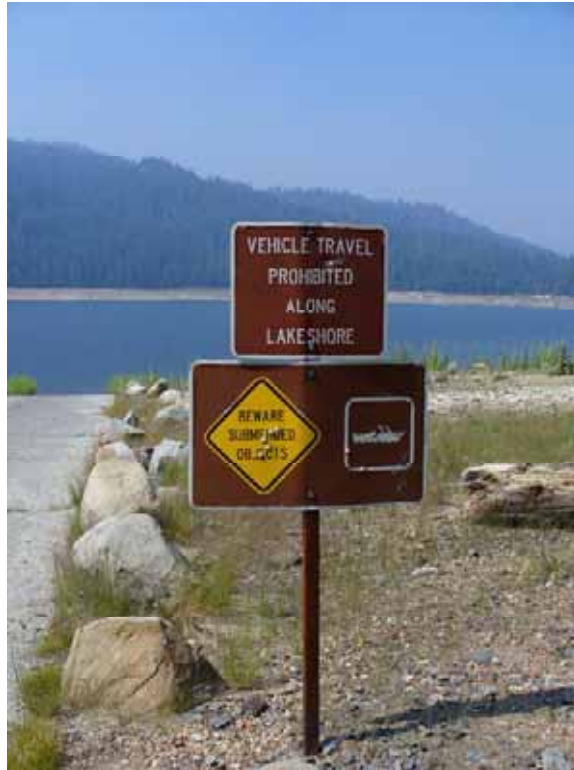
Photo O-2-3. Sign at upper end of French Meadows Boat Ramp. Sign is in good condition but paint is flaking. (7/23/08)

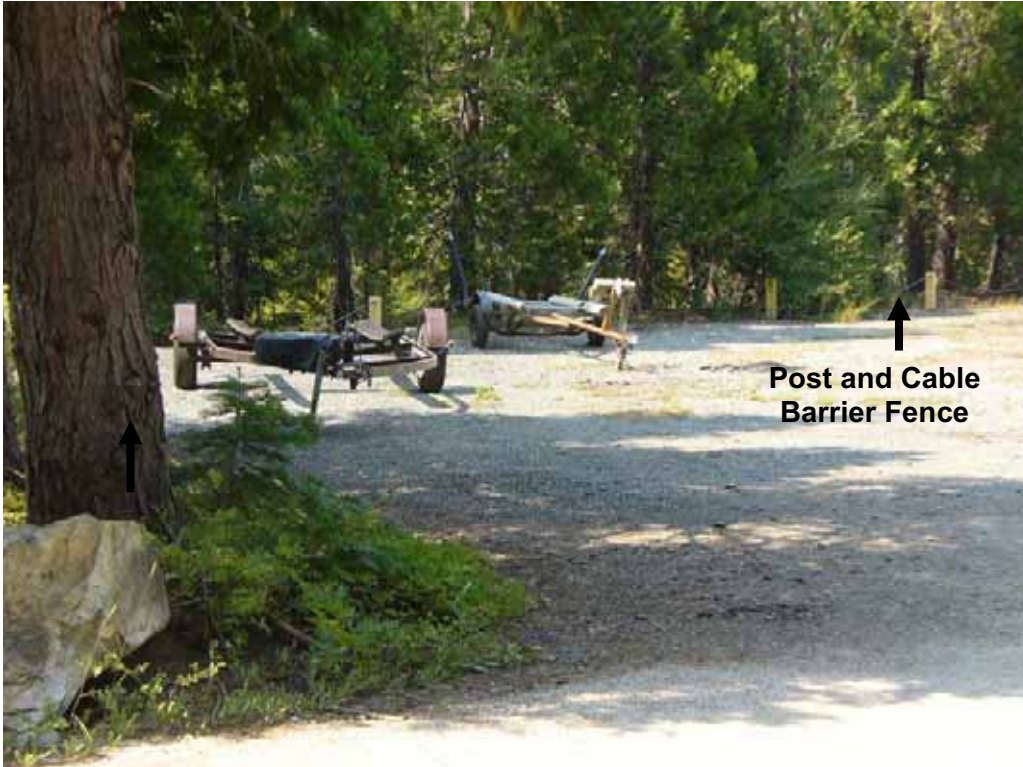
Photo O-2-6. French Meadows Boat Ramp Parking Area. Note post and cable barrier fence. (7/23/08)

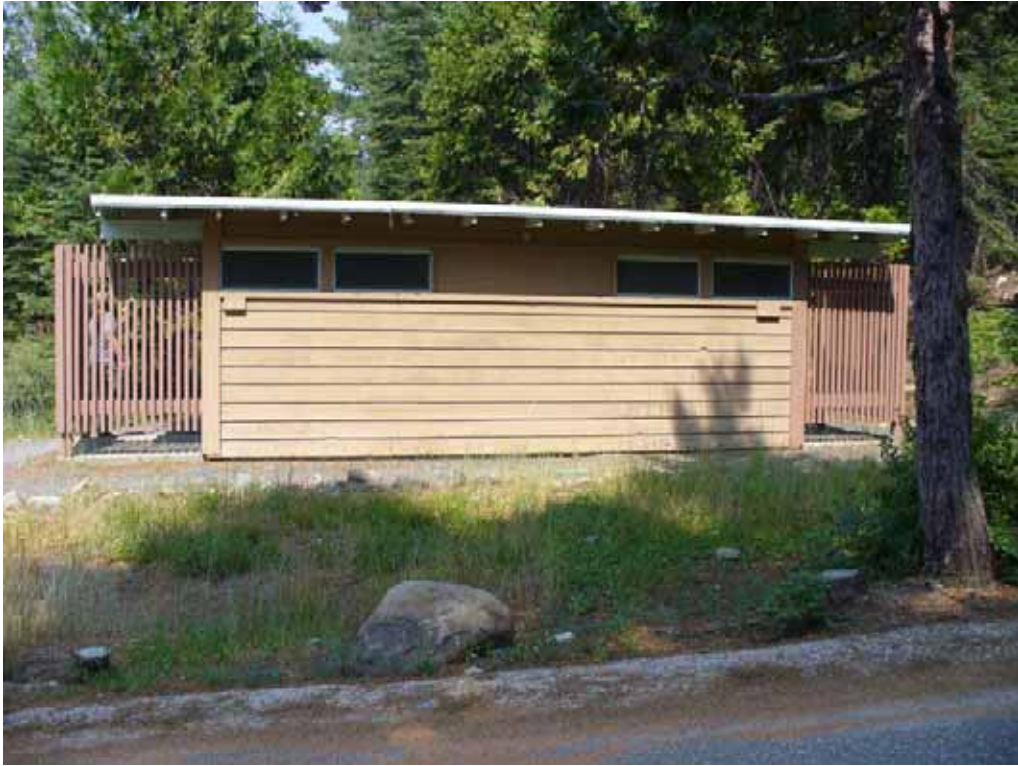
Photo O-2-9. Bathroom located along access road to French Meadows Boat Ramp. This bathroom has flush toilets and sinks but does not meet current USDA-FS condition or accessibility standards. (7/23/08)

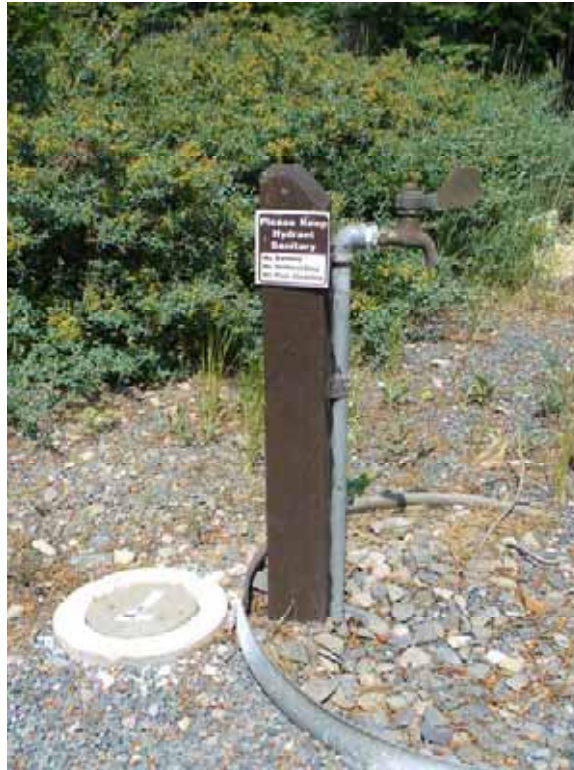
Photo O-2-11. Water faucet located adjacent to bathroom. Handle is considered disabled accessible. Approach is not disabled accessible due to insufficient clear space and changes in surface level. (7/23/08)

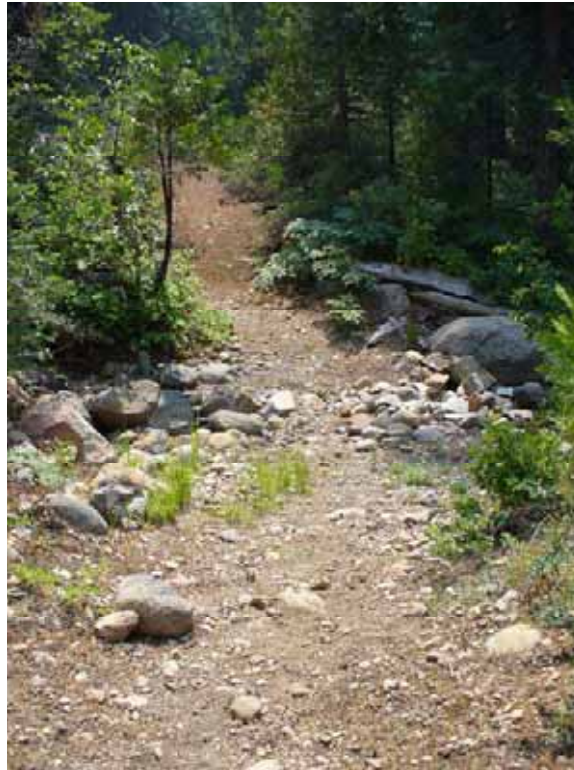
Photo O-2-15. Trail to French Meadows Parking Area. Trail is not considered disable accessible due to obstacles, level changes, excessive slope, and narrow width. (7/23/08)

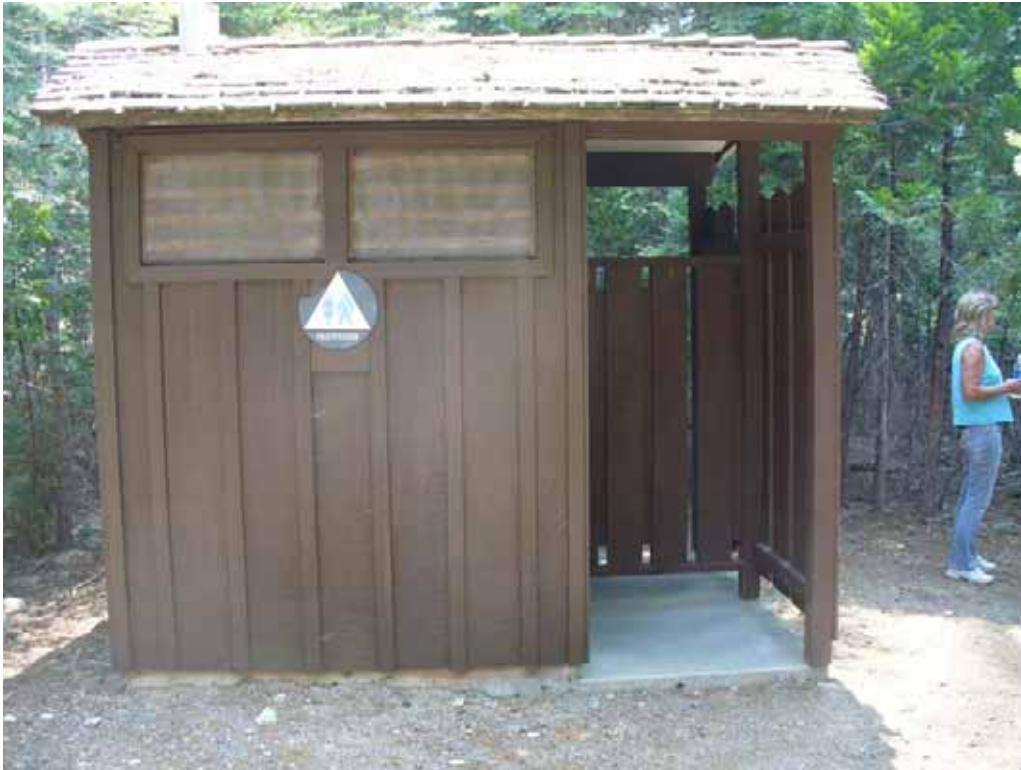
Photo O-2-17. Two-unit vault toilet located in French Meadows Picnic Area. This toilet does not meet accessibility standards due to narrow entrance width, level changes (e.g., concrete lip) and absence of hand rails. (7/23/08)

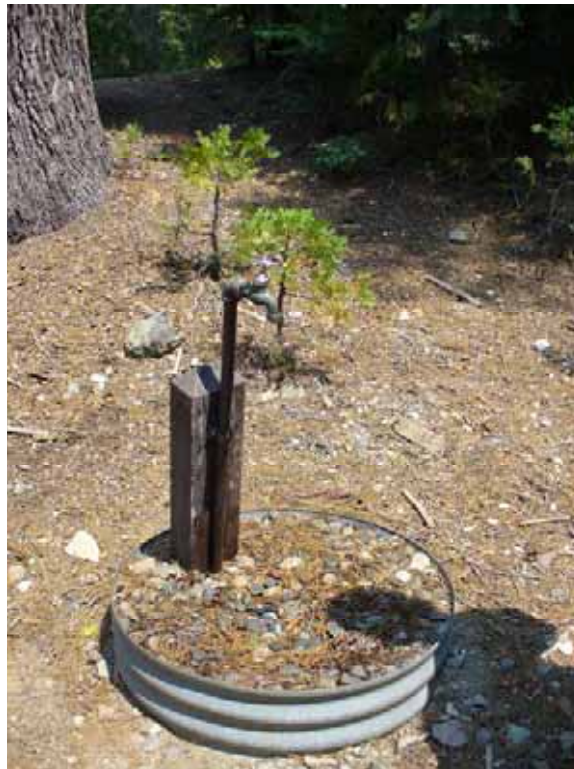
Photo O-2-18. Water faucet near vault toilet. Does not meet accessibility standards due to handle design, obstacles, and level changes. (7/23/08)

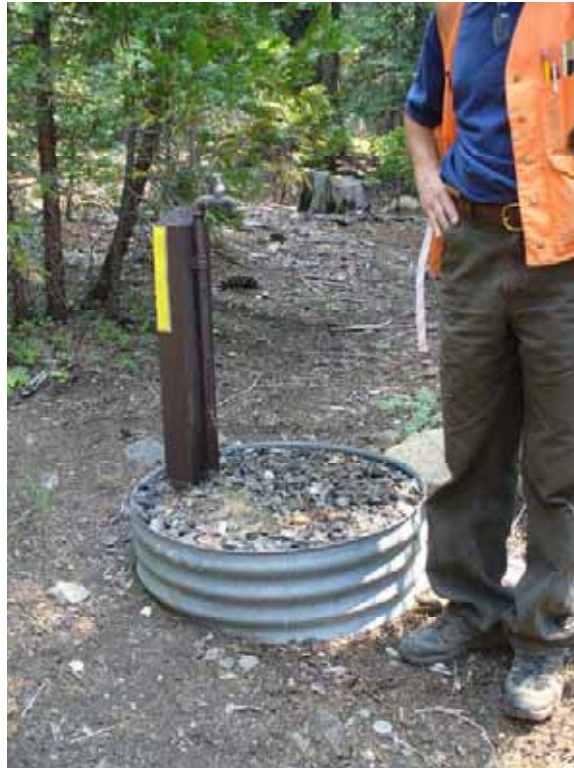
Photo O-2-19. Water faucet in picnic area. Does not meet accessibility standards due to handle design and level changes. (7/23/08)

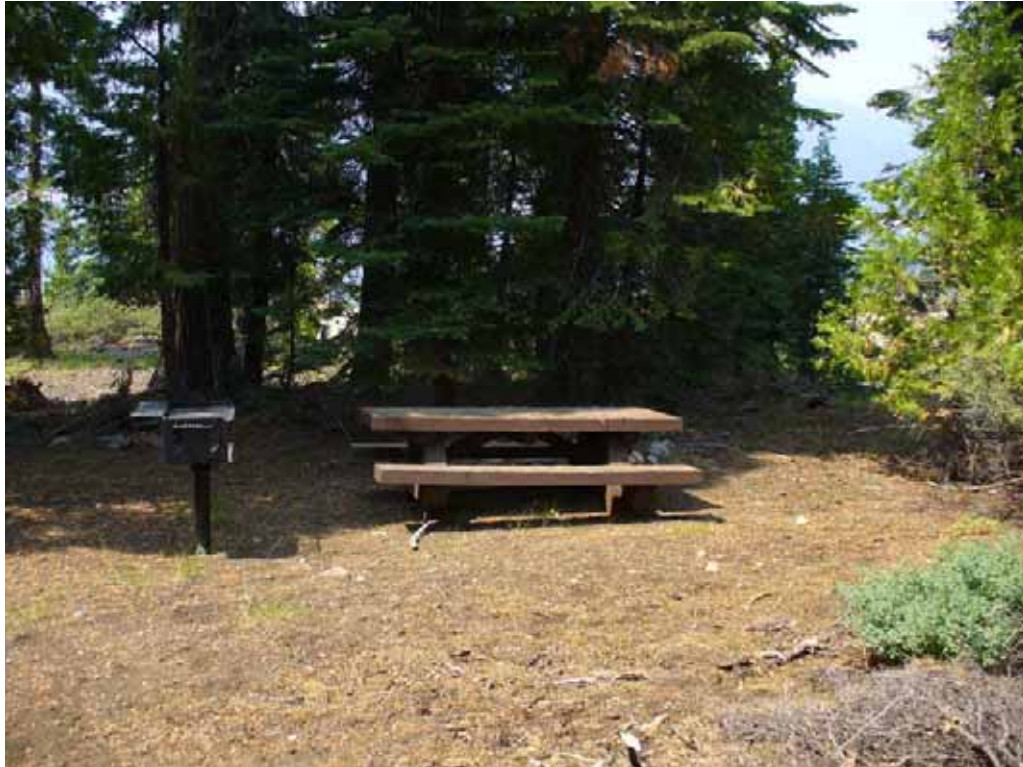
Photo O-2-20. Typical picnic site in the French Meadows Picnic Area. Note the pedestal grill and wood picnic table. Neither are disabled accessible. (7/23/09)

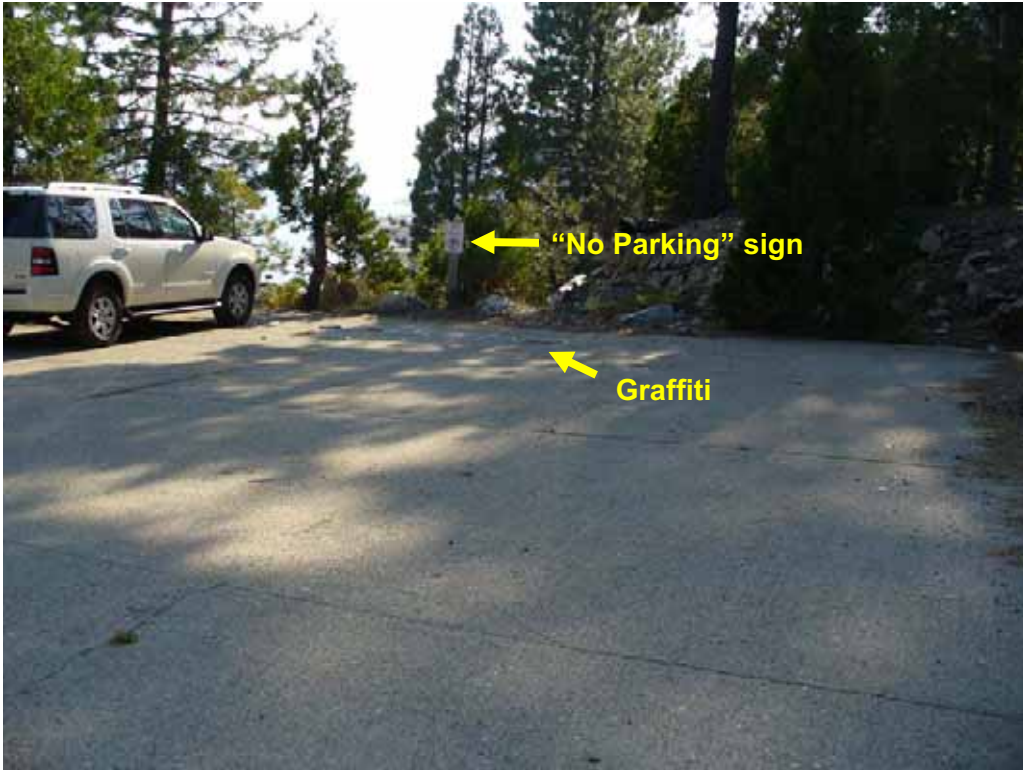
Photo P-2-3. High water turn-around and loading/unloading area. Note “no parking” sign and graffiti on surface. (7/23/08)

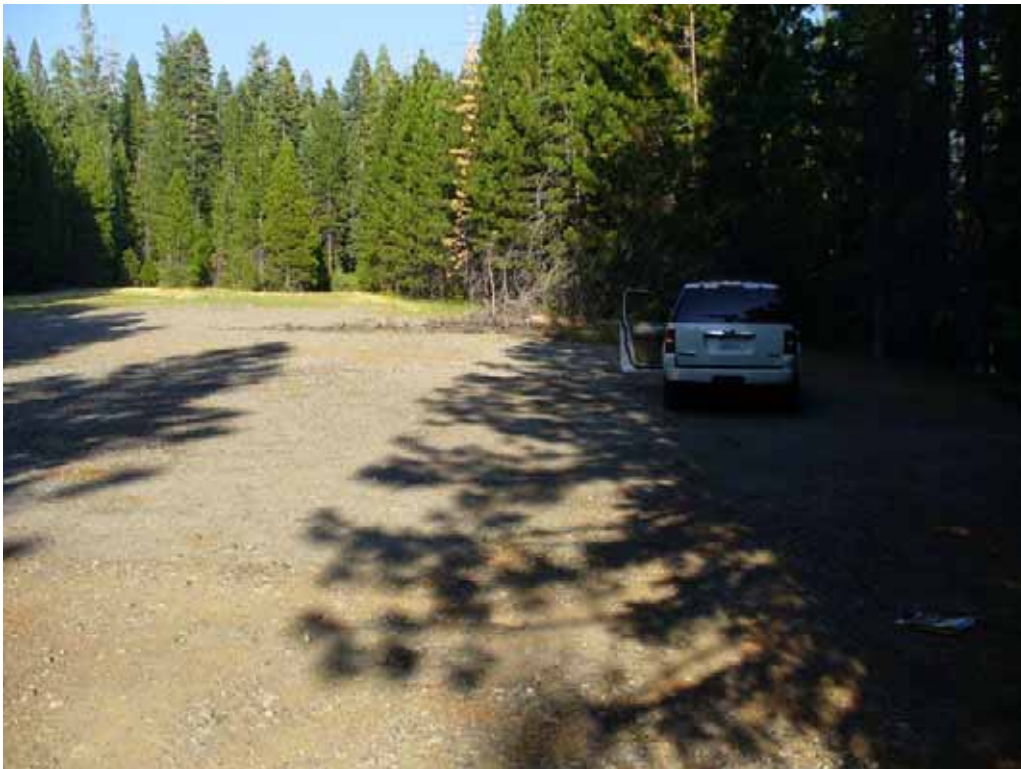
Photo P-2-6. McGuire Boat Ramp Parking Area – southeast lot. Surface has deteriorated to base rock and is in poor condition. (7/23/08)

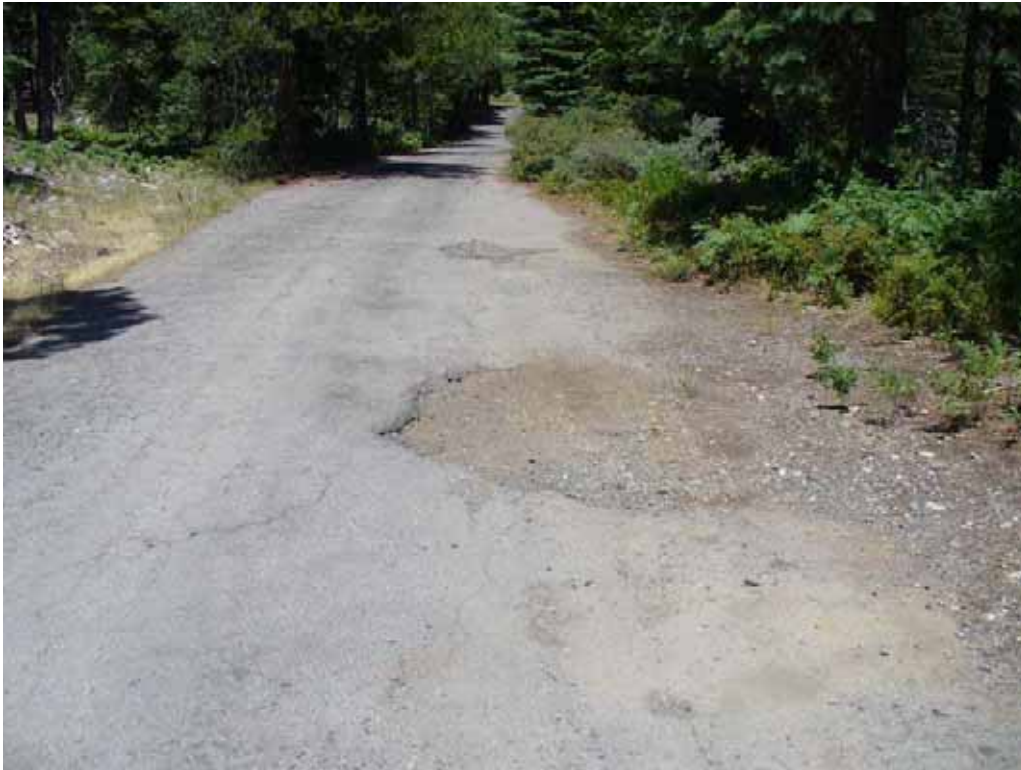
Photo Q-2-3. Potholes and damaged pavement along access road to McGuire Picnic Area, beach, and parking area. (7/24/08)

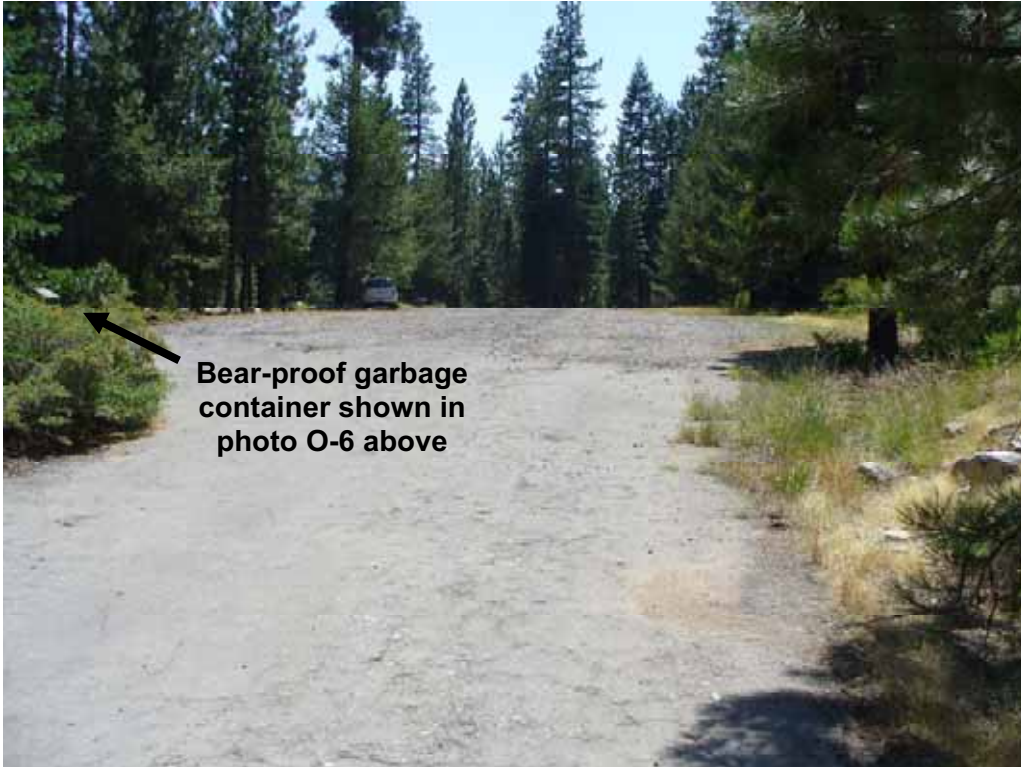
Photo Q-2-4. McGuire Picnic Area and Beach parking area. Note deteriorated asphalt surface. (7/24/08)

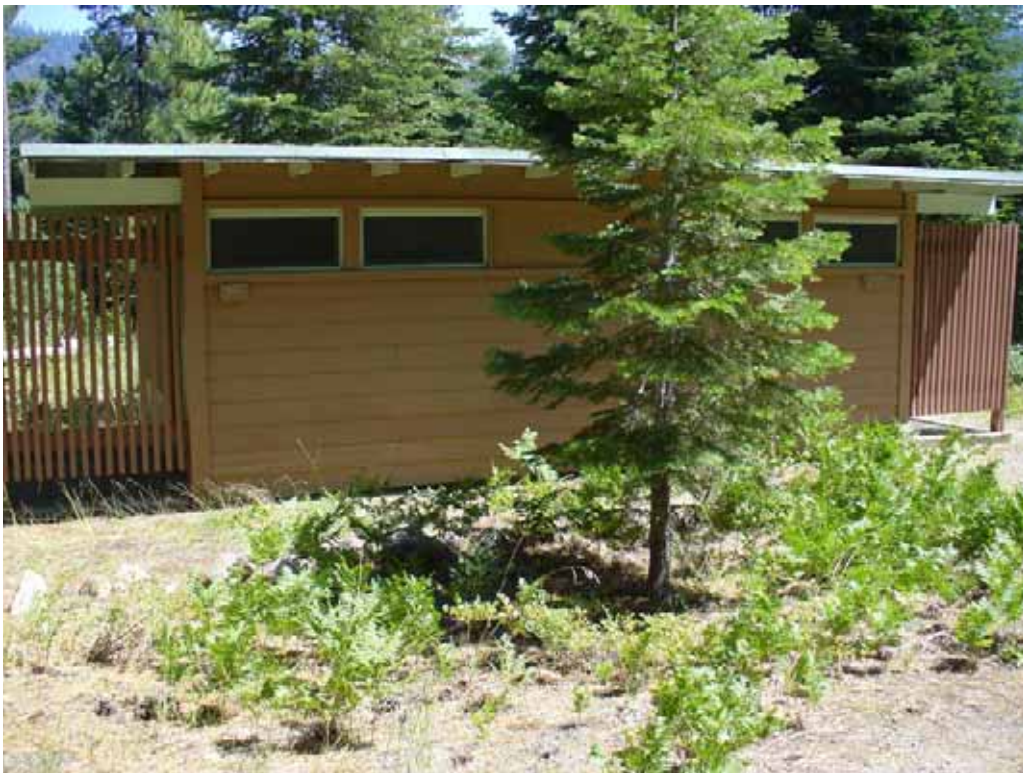
Photo Q-2-6. Bathroom located adjacent to parking area. Not disabled accessible. (7/24/08)

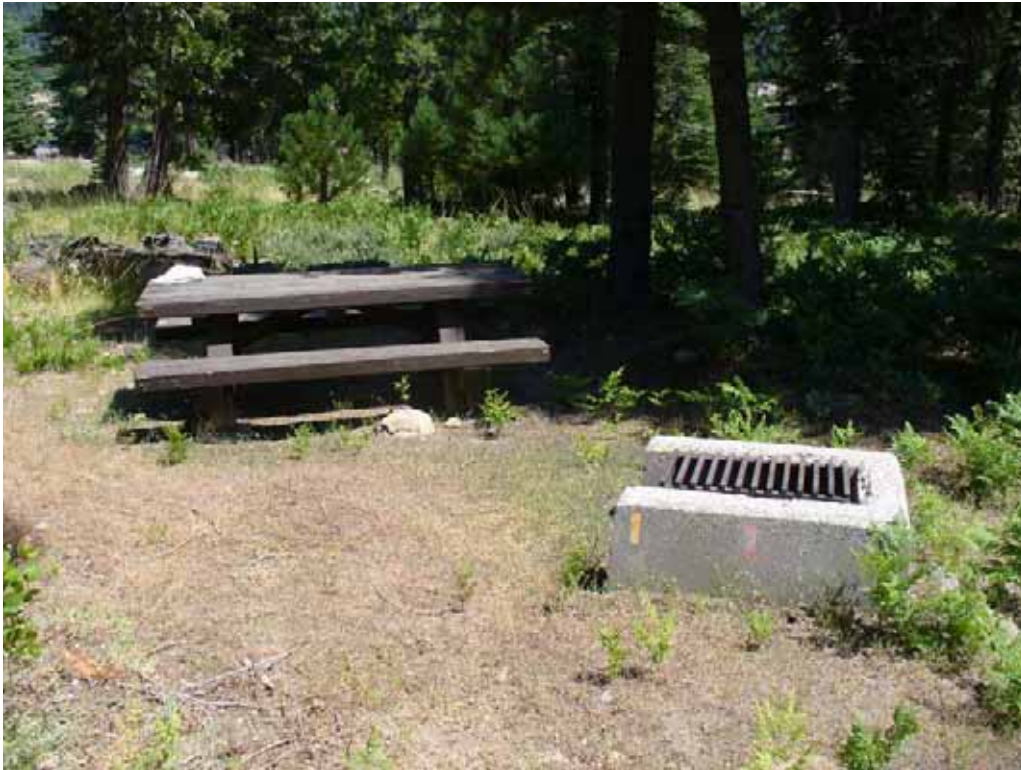
Photo Q-2-7. Typical picnic site at McGuire Picnic Area (Site 1). Note heavy wood table and concrete/steel cooking grill. Features are not disabled accessible, nor is the site due to obstacles (brush and rocks) and level changes. (7/23/08)

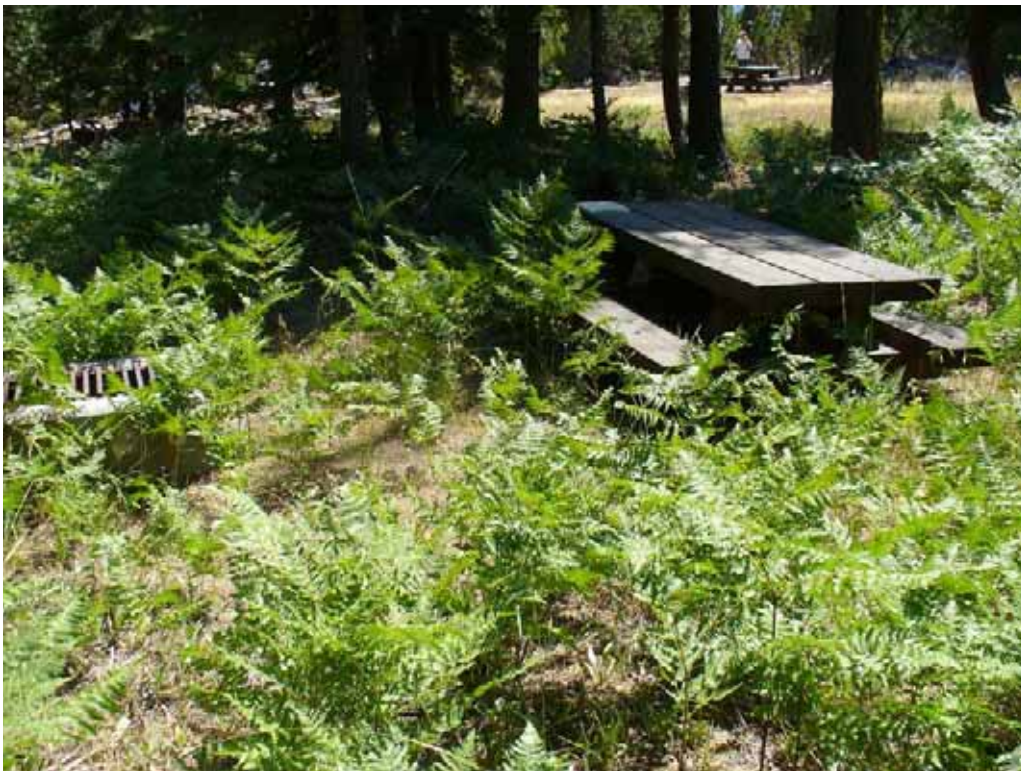
Photo Q-2-8. Overgrown picnic site at McGuire Picnic Area. Dense vegetation is due to lack of use and poor maintenance. (7/24/08)

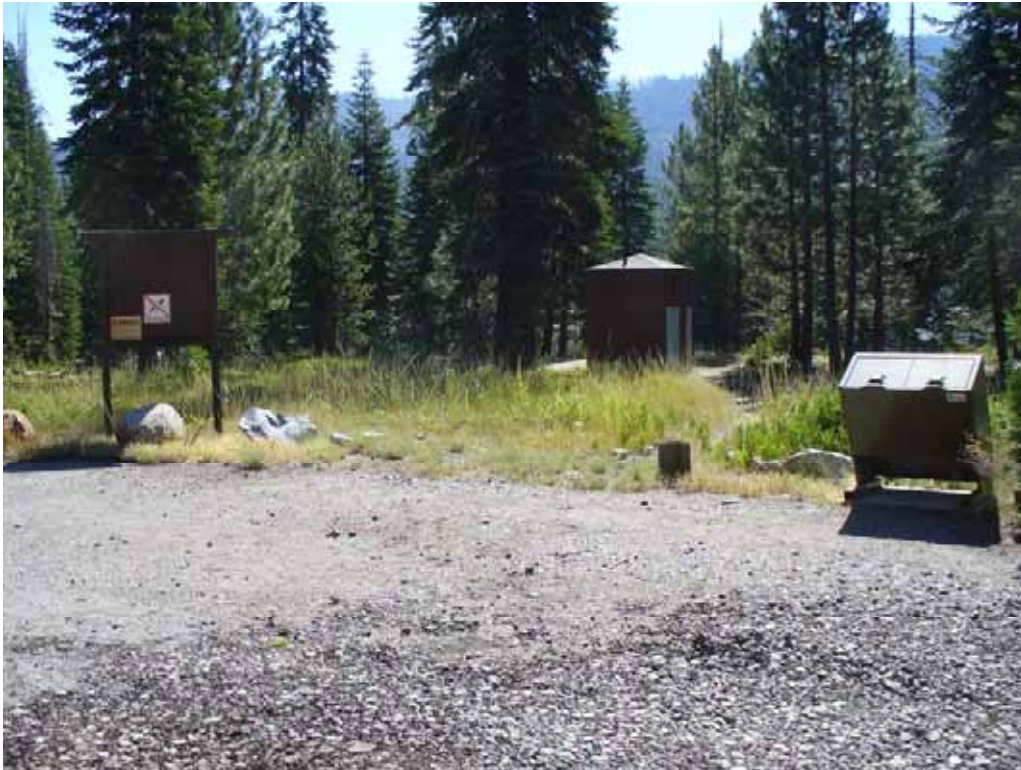
Photo Q-2-9. Entrance of trail to McGuire Beach as viewed from the parking area. Note bear-proof garbage container, information board, and deteriorated asphalt surface. (7/24/08)

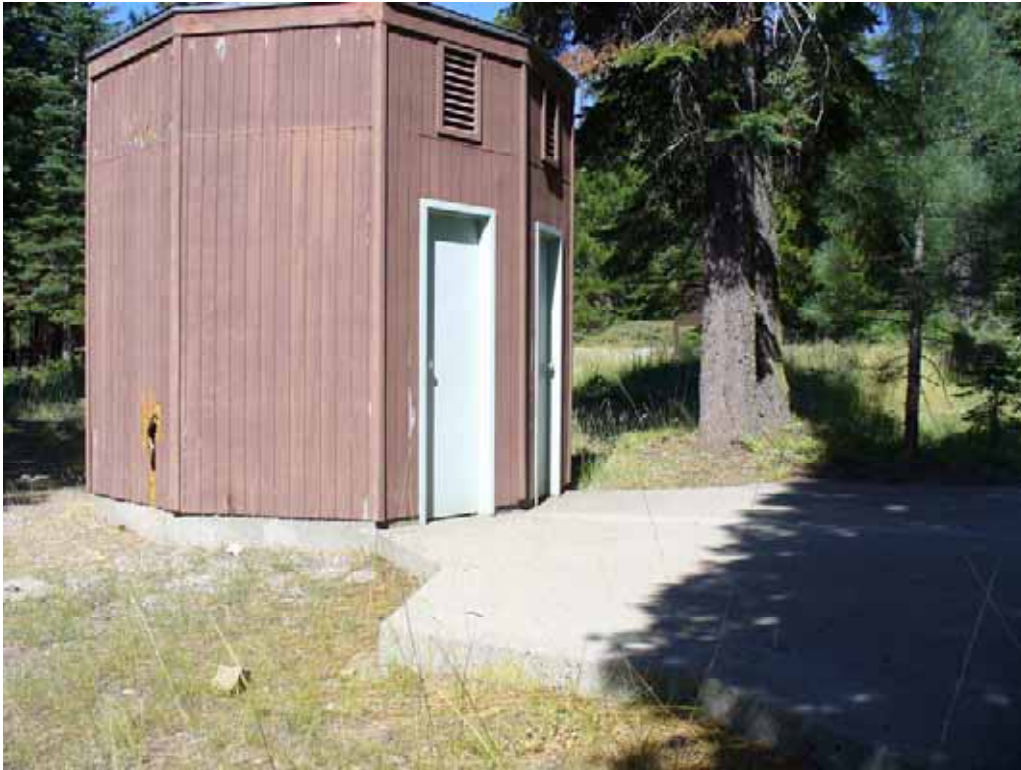
Photo Q-2-11. Backside of bathroom building. Space behind blue doors is now used for storage. Concrete pad was formerly a changing area. Note damage on building and large lip on concrete pad. (7/24/08)

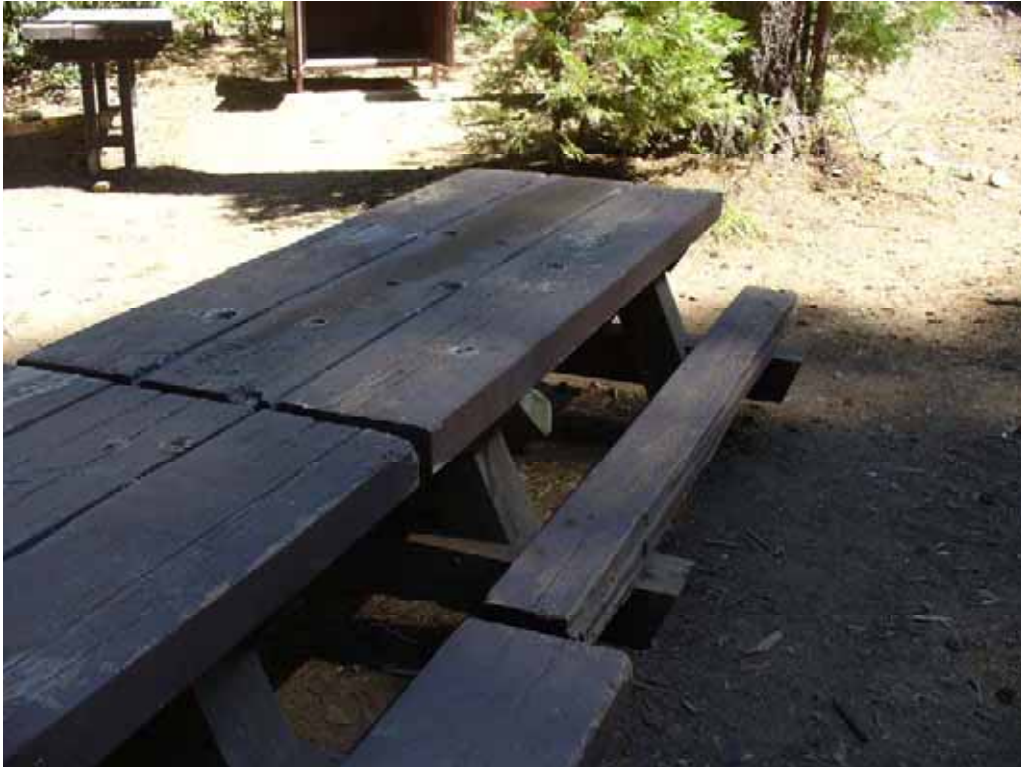
Photo R-2-12. Older picnic tables at Unit 1. All are in fair condition, with peeling paint and cracks. This one is in poor condition due to damage bench. (8/21/08)

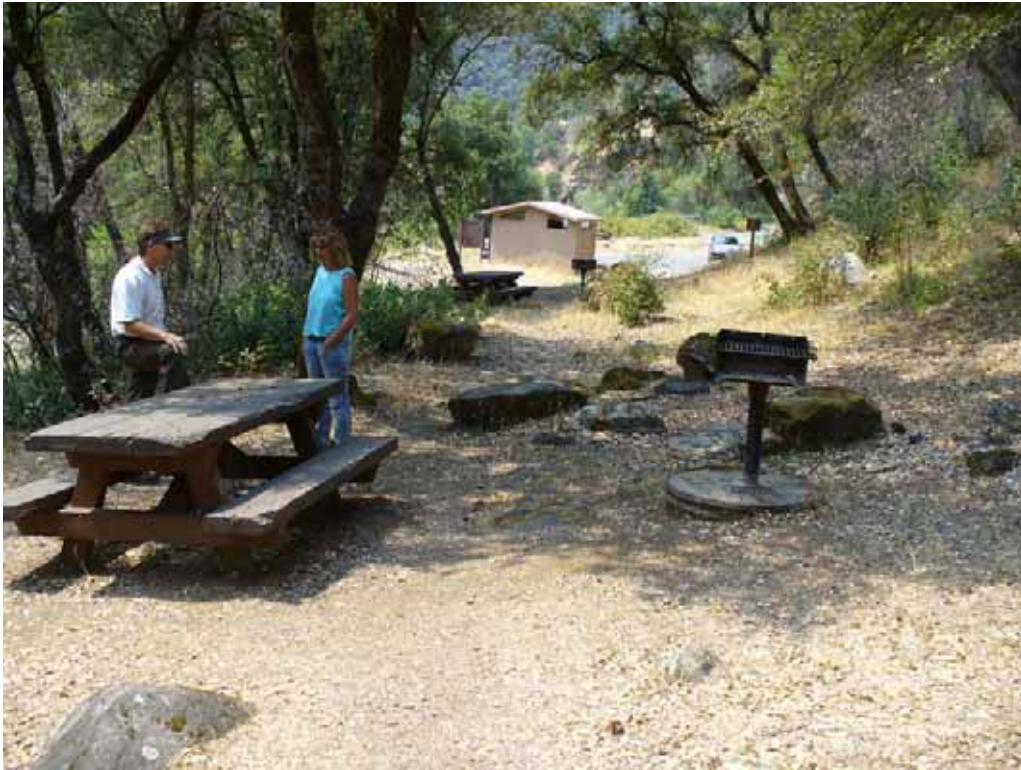
Photo S-2-5. Typical picnic sites at Ralston Picnic Area (Site 4 in foreground, Site 3 in background). These sites are not considered disabled accessible due to insufficient clear space, obstacles, and level changes. In addition, the tables and grills are not accessible.

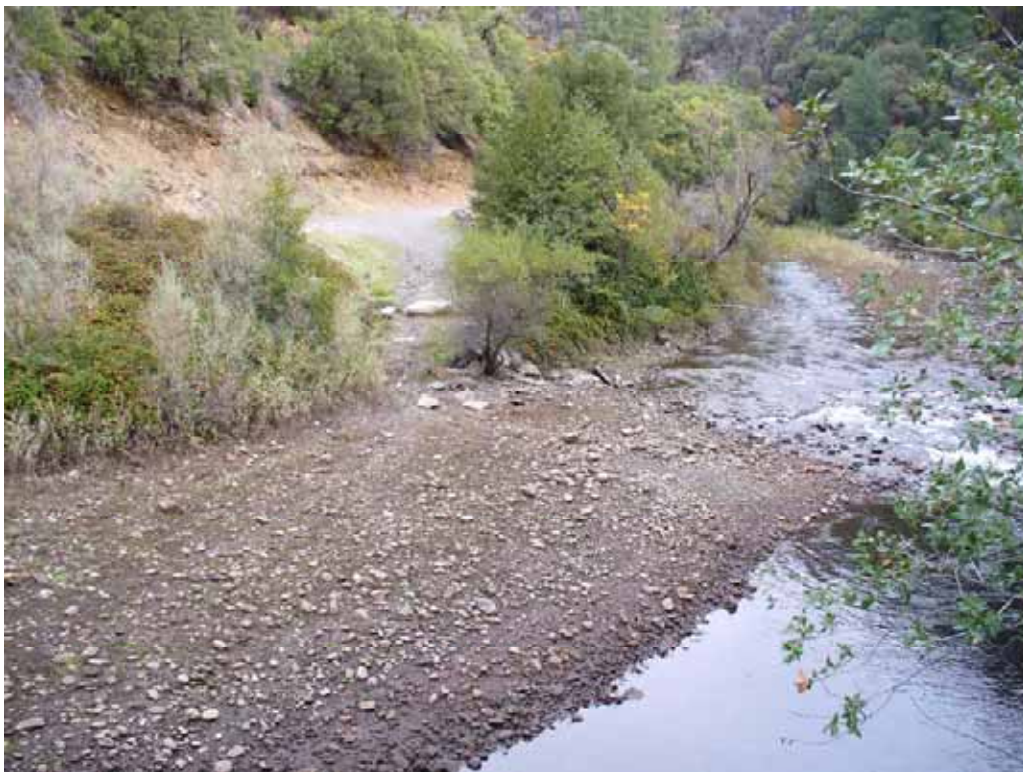
Photo S-2-8. Ralston Car Top Boat Ramp on November 12, 2008 at 10:33 A.M. This photograph was taken during PCWA's annual maintenance outage when the reservoir WSE was about 1,155 feet. Note the large rock in center of ramp.

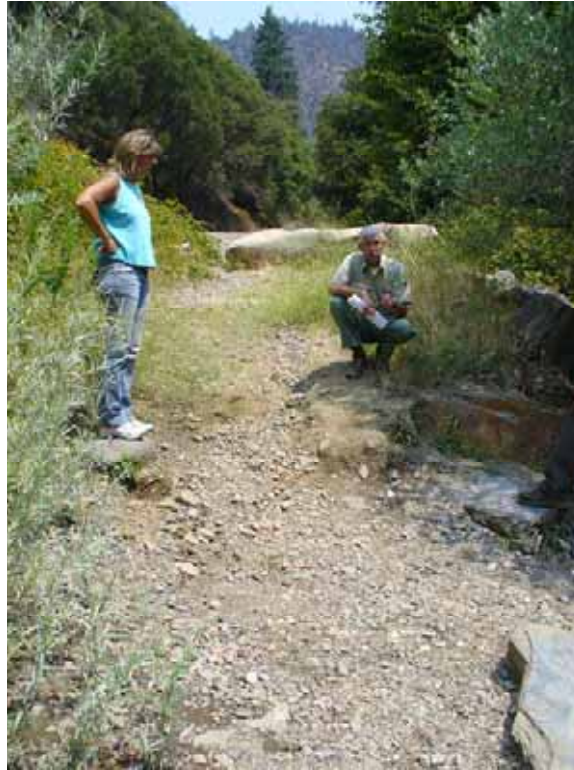
Photo S-2-9. Close up of Ralston Car Top Boat Ramp Note large rock in center of ramp. (7/23/08)

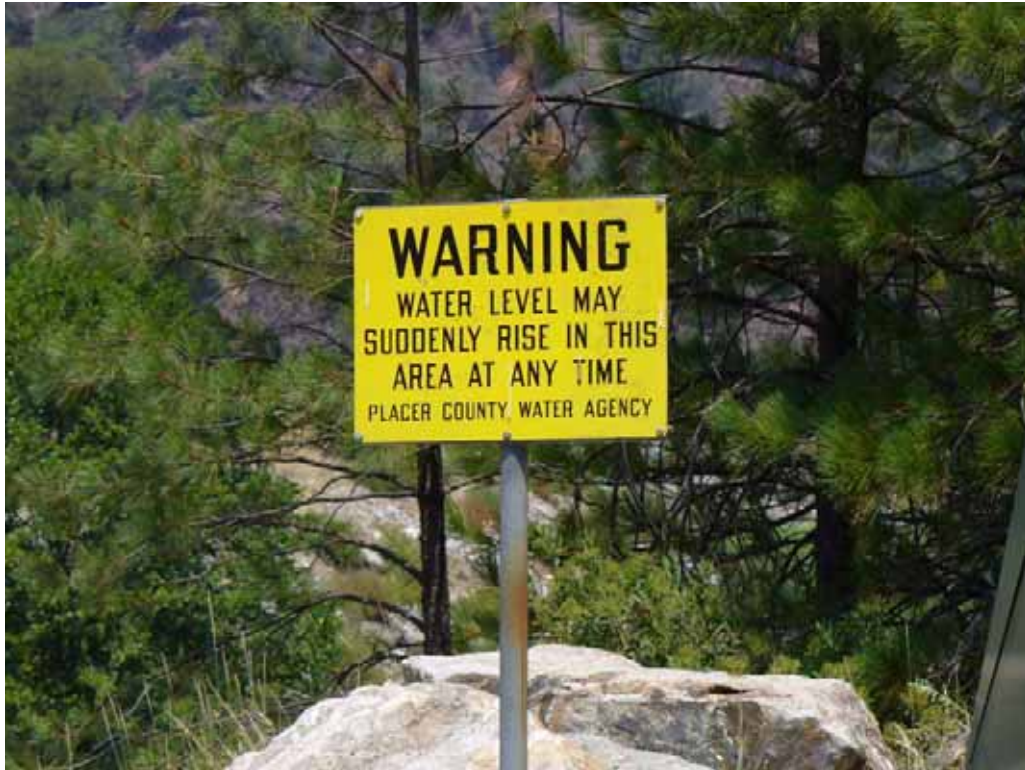
Safety	East side of boat launch, near boat launch toilet.	1	Painted aluminum signs on steel posts	Good	WARNING WATER LEVEL MAY SUDDENLY RIS IN THIS AREA AT ANY TIME PLACER COUNTY WATER AGENCY	Black lettering on yellow background. Post is slightly rusted.	
Safety	Near parking area, west of parking area toilet	1	Painted aluminum signs on steel posts mounted in barrier rock	Good	WARNING WATER LEVEL MAY SUDDENLY RIS IN THIS AREA AT ANY TIME PLACER COUNTY WATER AGENCY	Black lettering on yellow background. Post is slightly rusted.

Photo T-2-5. Warning sign adjacent to boat launch ramp. (7/21/08)

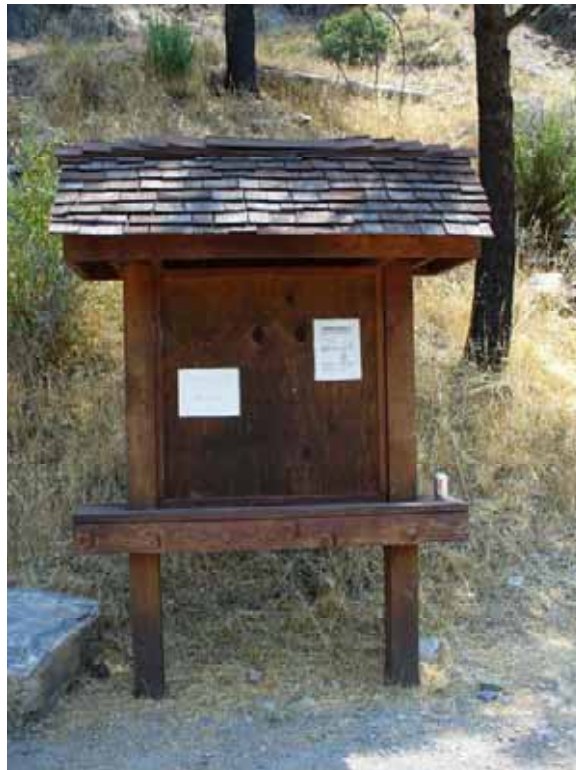
Photo T-2-10. Good condition information board adjacent to boat launch ramp. (7/23/08)
