**Placer County Water Agency
Middle Fork American River Project
(FERC No. 2079)**

**REC 1 – RECREATION USE AND FACILITIES
TECHNICAL STUDY REPORT**

Placer County Water Agency
P.O. Box 6570
Auburn, CA 95604

May 2010

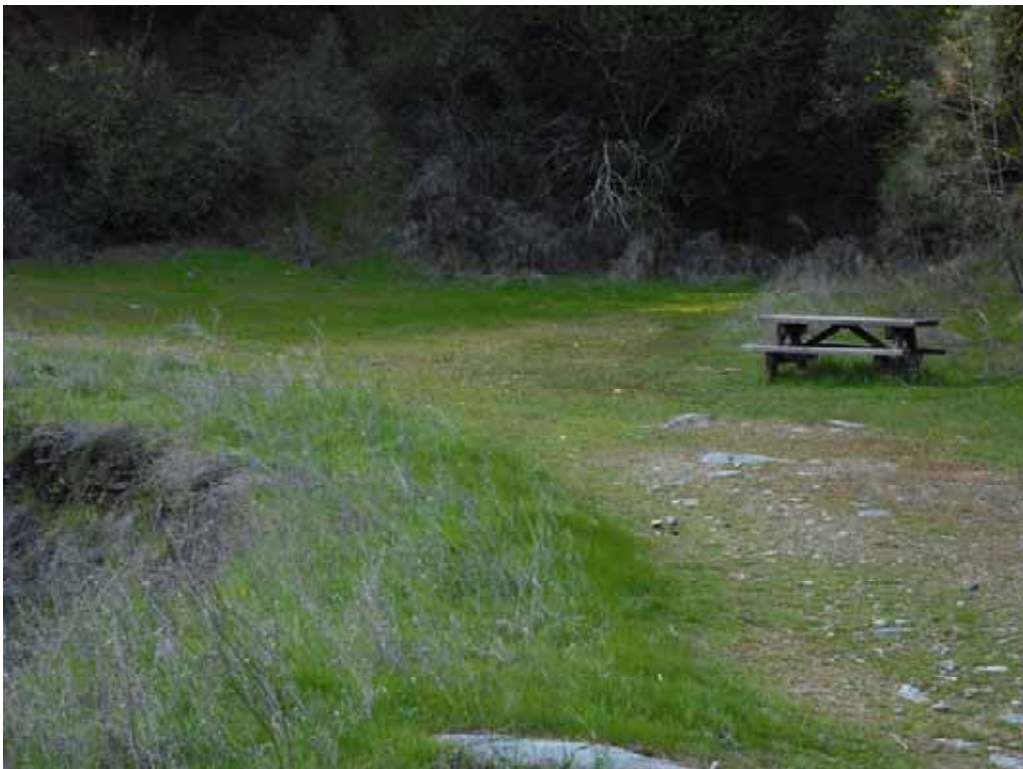
Feature	Quantity or Dimensions	Location or Description	Material	Cond	Accessibility						Comments
					Accessible (yes/no)	Needs Leveling	Obstacles present	Brush or hazard trees	Excessive Slope	Other	
Drivers Flat Road	Approx. 1.2 miles long (10-24 feet wide)	As measured from locked gate to terminus.	Native surface	Fair to Poor	Y	X	X				Accessible by high clearance vehicles, subject to erosion. See detailed road survey for additional information.
Parking Area/Turn-Around	Approx. 2,500 square feet, roughly triangular in shape	Northwest side of facility on north side of access road	Soil, grass, cobble	Fair	N		X	X			Soil erosion has uncovered large cobble and other obstacles. Lack of use has allowed for vegetation overgrowth. Not striped, can accommodate approx. 10-12 vehicles.

Photo U-2-2. The lack of use of the parking/turnaround area has allowed for vegetation overgrowth. (3/12/09)

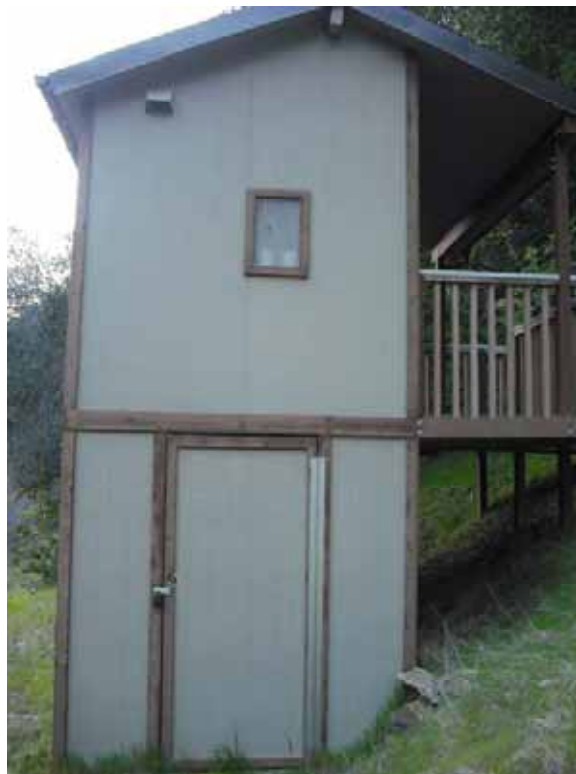
Feature	Quantity or Dimensions	Location or Description	Material	Type	Cond	Accessibility						Comments
						Accessible (yes/no)	Needs Leveling	Obstacles present	Brush or hazard trees	Excessive Slope	Other	
Bathroom	Two unit	On east side of facility near beach area. Includes 1 toilet, and 1 toilet paper roll dispenser.	Painted wood exterior	Compost	Good	N	X		X	X		Good overall condition not accessible due to location.
Picnic Table	1 table, seats approx. 8-10 people	Located on northwest upper end of facility in parking area	Treated wood	Heavy	Fair	N			X		X	Picnic table is not accessible design. In fair condition due to lack of use but is covered in old graffiti. Difficult to access and use due to vegetation along pathway and under table.

Photo U-2-6. Compost toilet located on the east side of the facility. (3/12/09)

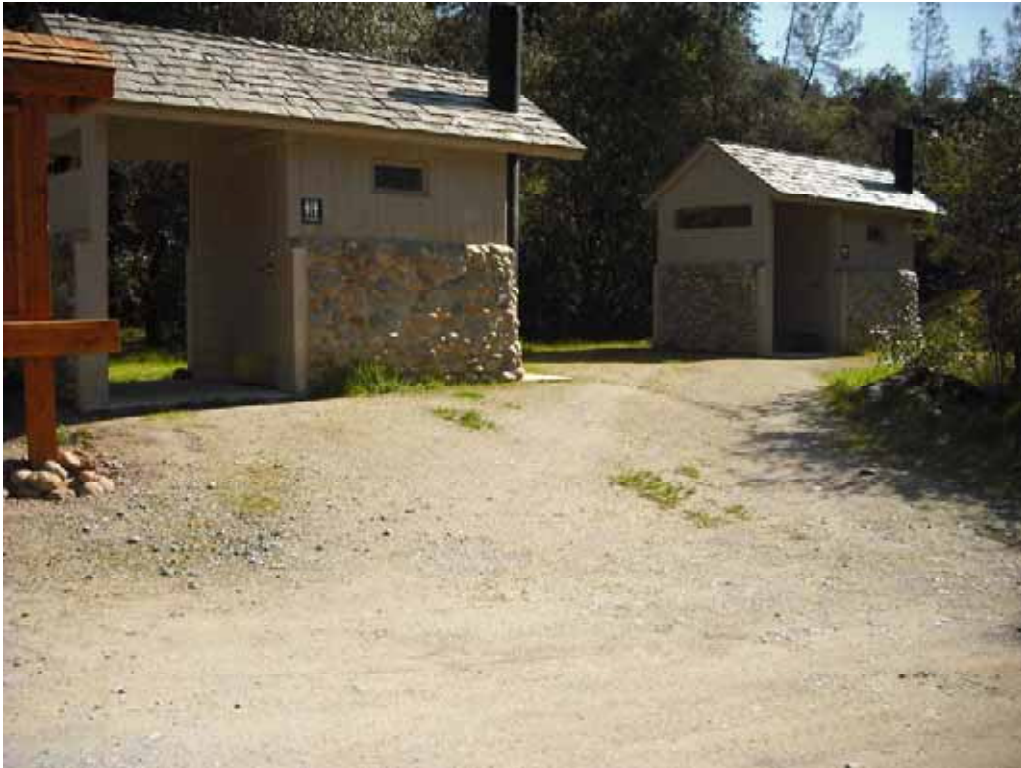
Photo V-2-3. Two coed bathrooms located in Northwest Parking Area. Disabled accessible and in good condition. (3/12/09)

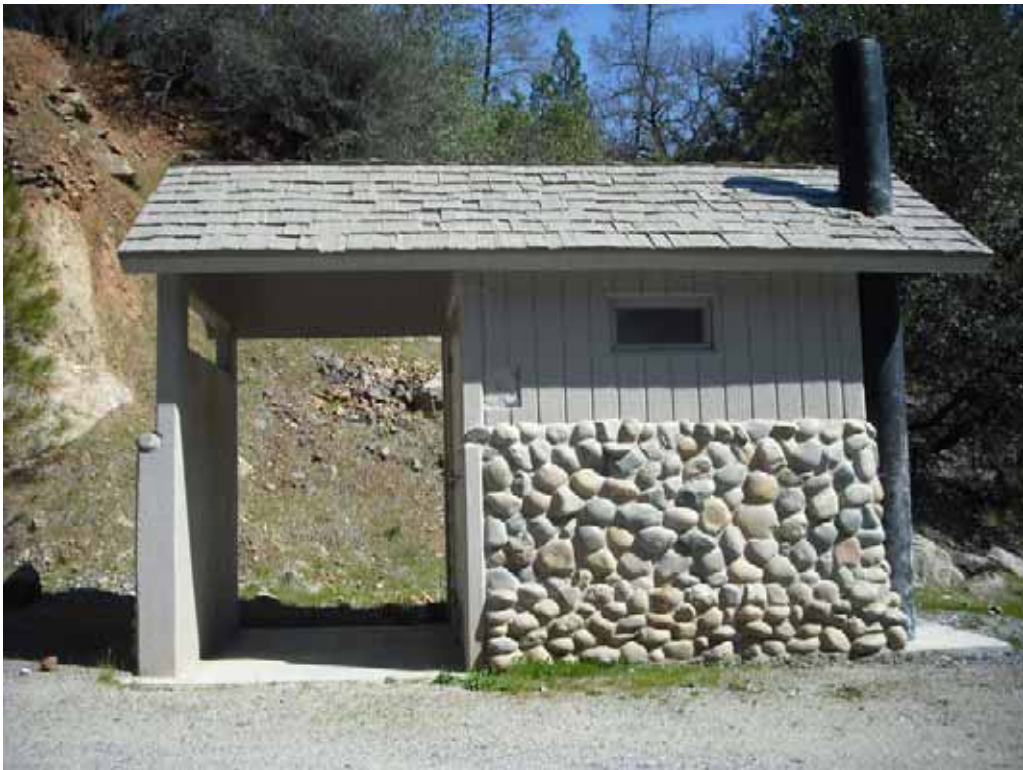
Bathroom	Single unit	On east side of NW parking area, adjacent to garbage containers.	Wood and cobble exterior, cement foundation	Vault	Good	Y							Includes 1 toilet, 1 toilet paper roll dispenser, and 2 support rails. Good overall condition but in need of cleaning.

Photo V-2-10. Vault bathroom in good condition located in the Southeast Parking Area. (3/12/09)

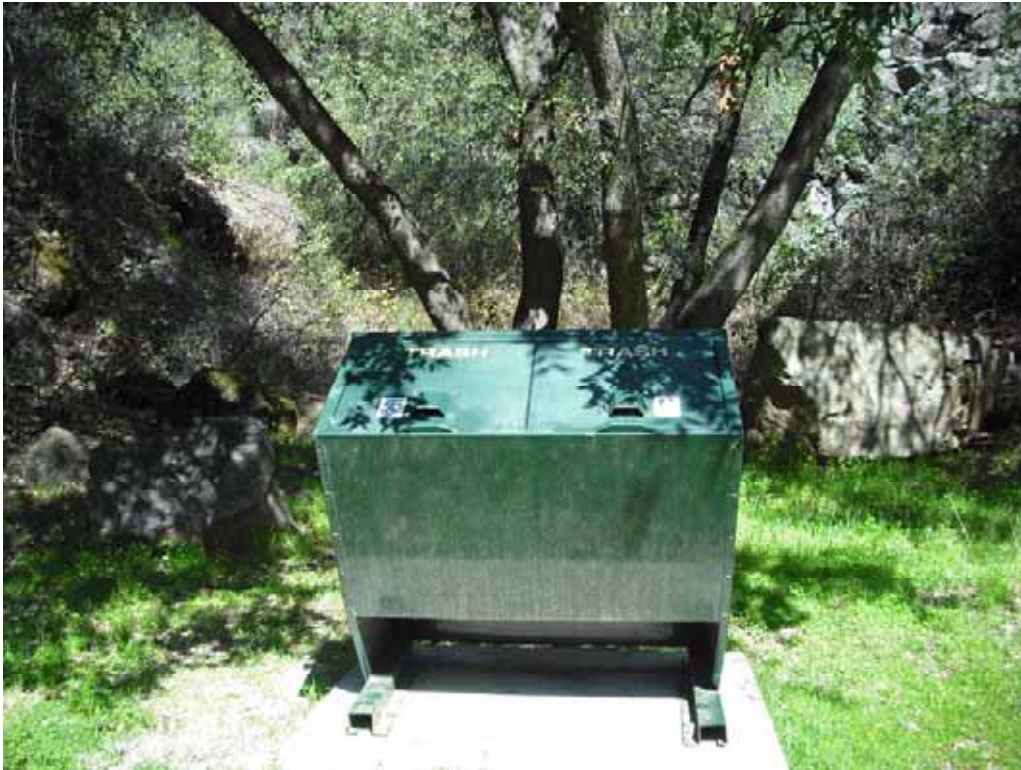
Photo V-2-11. Bear-proof garbage container in good condition located in the Southeast Parking Area. (3/12/09)

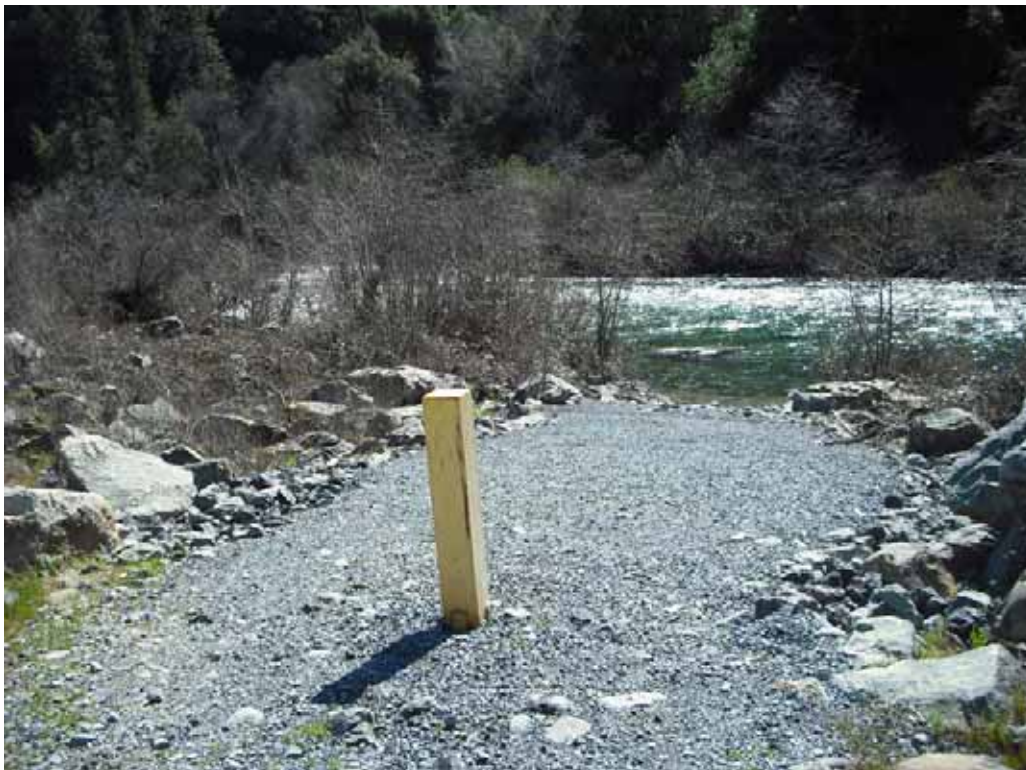
Feature	Quantity or Dimensions	Location or Description	Material	Type	Cond	Accessibility						Comments	
						Accessible (yes/no)	Needs Leveling	Obstacles present	Brush or hazard trees	Excessive Slope	Other		
West Boat Ramp	Approx. 75 feet long by 12 feet wide	Gravel and cobble walk-in car-top ramp extending from turnoff of access road before Campsite #5 to edge of water. Wide enough for foot traffic only.	Gravel and cobble	Car-top	Good	N		X			X		Ramp does not meet accessibility standards due to excessive slope and the presence of large cobble. Top of ramp contains painted steel post in center of ramp to deter motor vehicles.
East Boat Ramp	Approx. 120 feet long by 12 feet wide	Gravel and cobble walk-in car-top ramp extending from turnoff of access road before SE parking area to edge of water. Wide enough for foot traffic only.	Gravel and cobble	Car-top	Good	N					X		Ramp does not meet accessibility standards due to excessive slope. Top of ramp contains painted steel post in center of ramp to deter motor vehicles.

Photo V-2-14. The West Boat Ramp at Ruck-a-Chucky used by commercial and private whitewater rafters. (3/12/09)

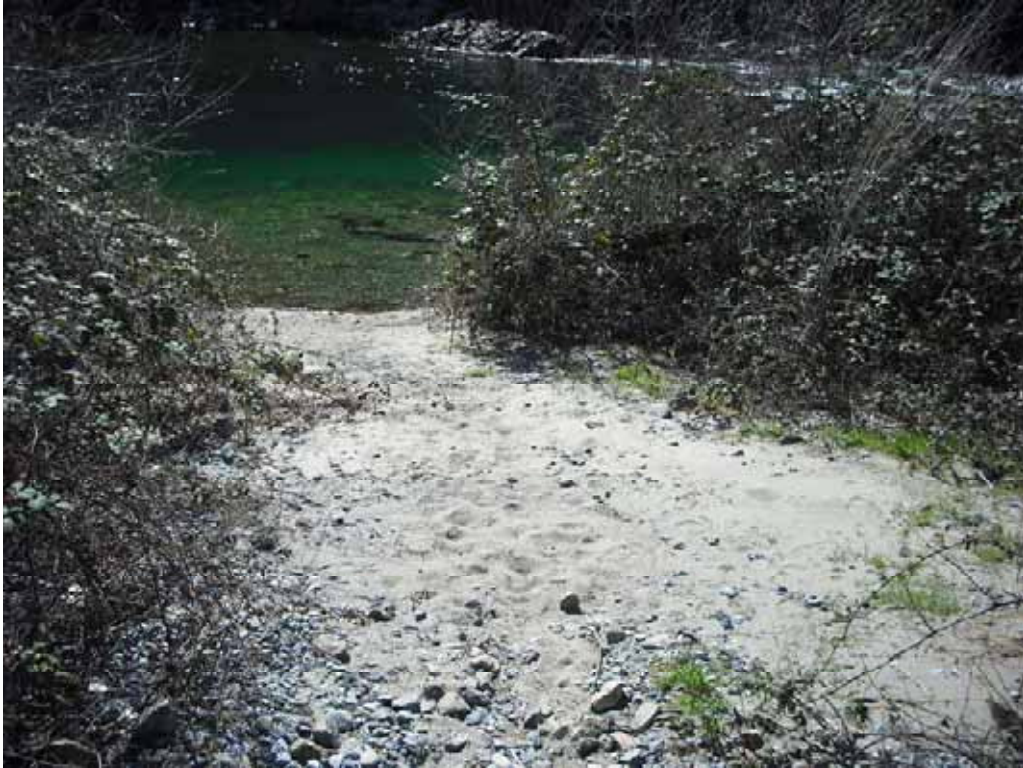
Feature	Quantity or Dimensions	Location or Description	Material	Cond	Accessibility						Comments
					Accessible (yes/no)	Needs Leveling	Obstacles present	Brush or hazard trees	Excessive Slope	Other	
Boat Ramp Access Road	Approx. 180 feet long by 12-foot wide (single lane)	As measured from Drivers Flat Road to beginning of beginning of Boat Ramp Parking Area.	Aggregate	Good	Y						Connects main access road and west boat ramp.
River Access Stairway	Approx. 90 feet long by 8 feet wide, consists of 24 stairs	South side of main access road, just below the southeast parking area.	Boulders with sand and gravel	Poor	N		X		X	X	Connects the southeast parking area to the river. Some stairs unstable, needs updating.
Boat Ramp River Access Path	Approx. 55 feet long by 6 feet wide	West side of boat ramp parking area, just below boat ramp access road	Sand	Good	N					X	Unstable footing due to sand, connects boat ramp parking area to river

Photo V-2-15. Boat Ramp River Access Path located on the west side of the Boat Ramp Parking Area. (3/12/09)

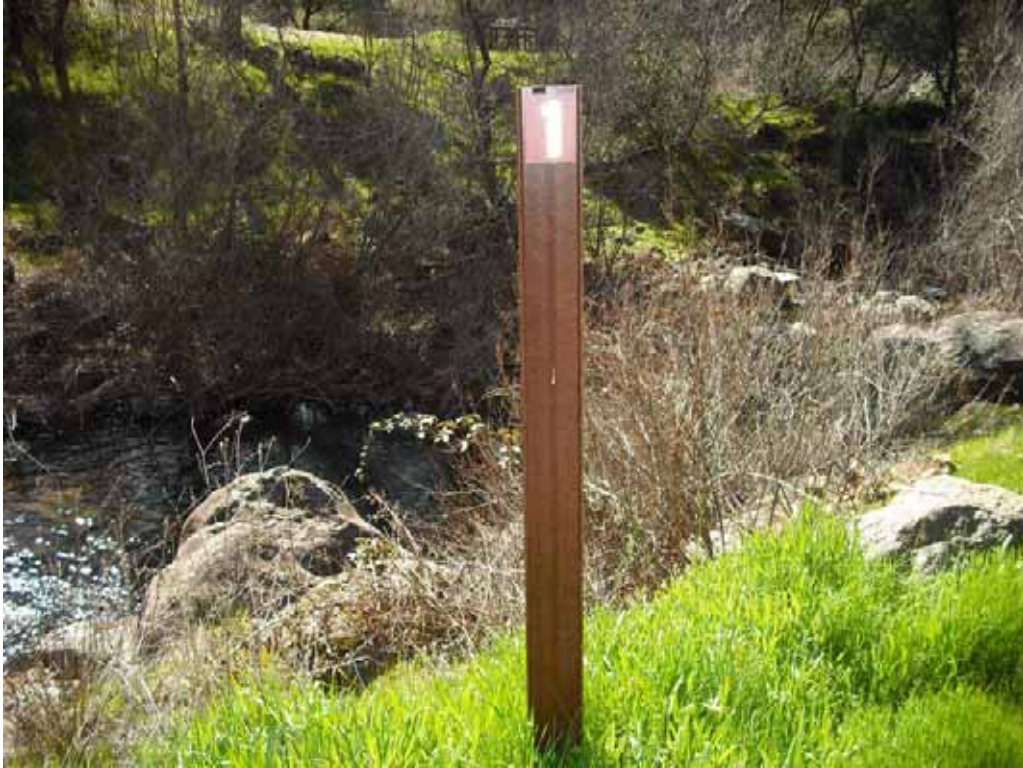
Photo V-2-27. Example of carsonite site marker located at the entrance of each campsite. (3/12/09)

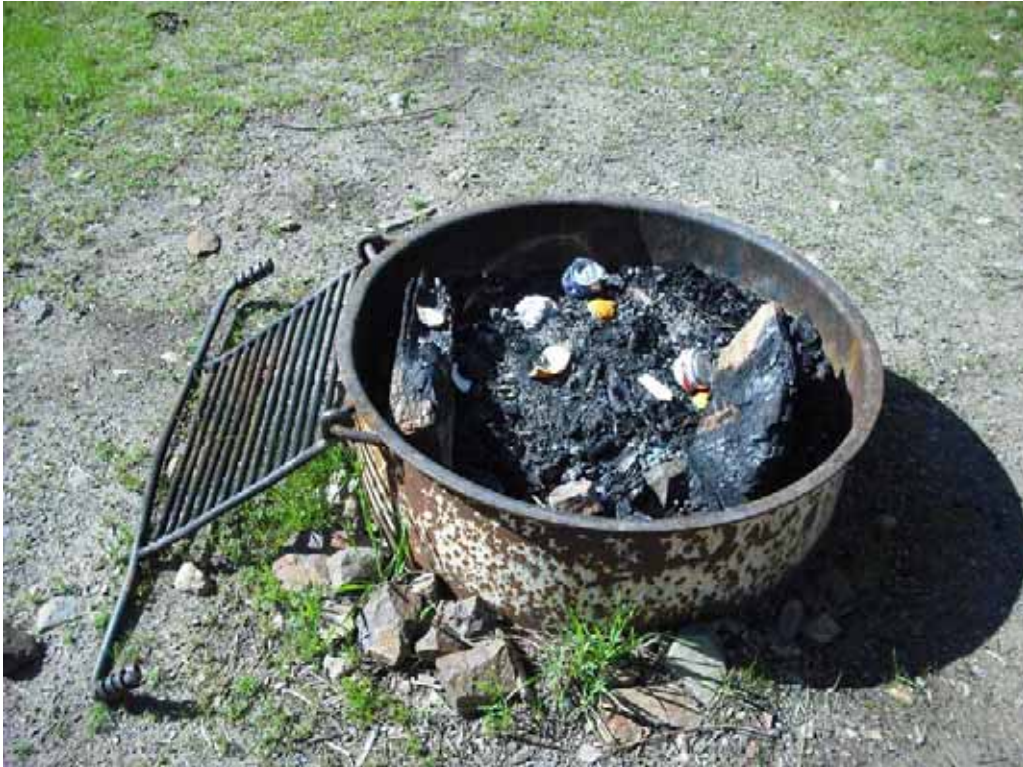
Photo V-2-28. Example of fire ring with steel grill located at each of the campsites. (3/12/09)

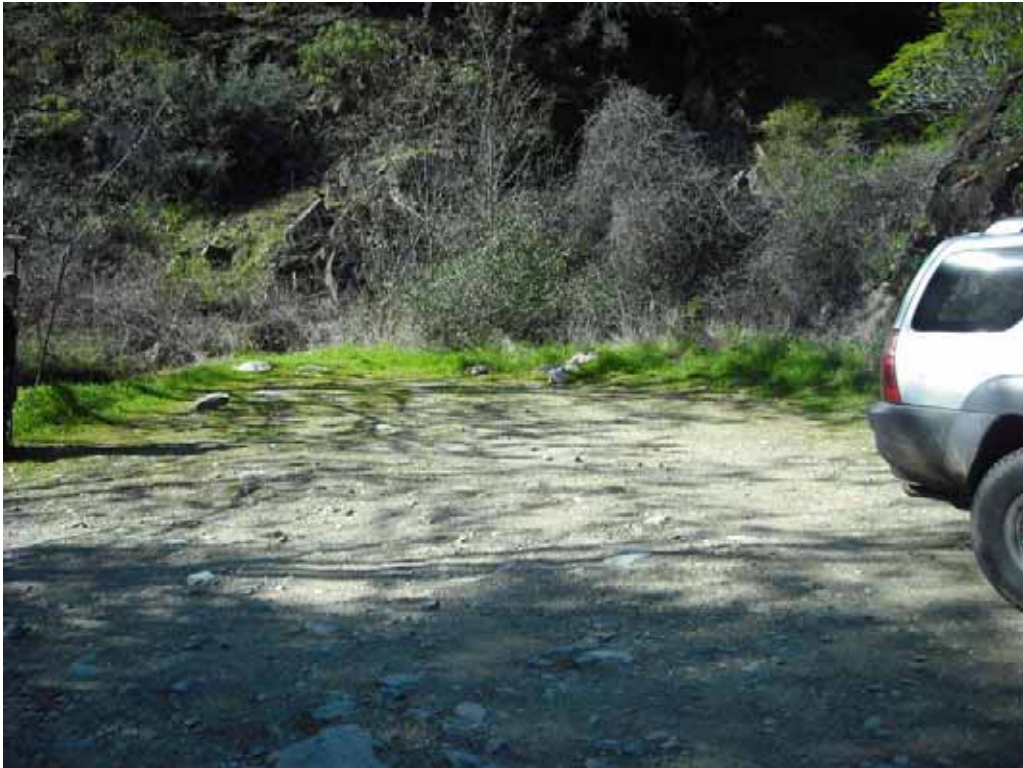
Photo V-2-29. Turn-out located on north side of Drivers Flat Road, east of Southeast Parking Area. (3/12/09)

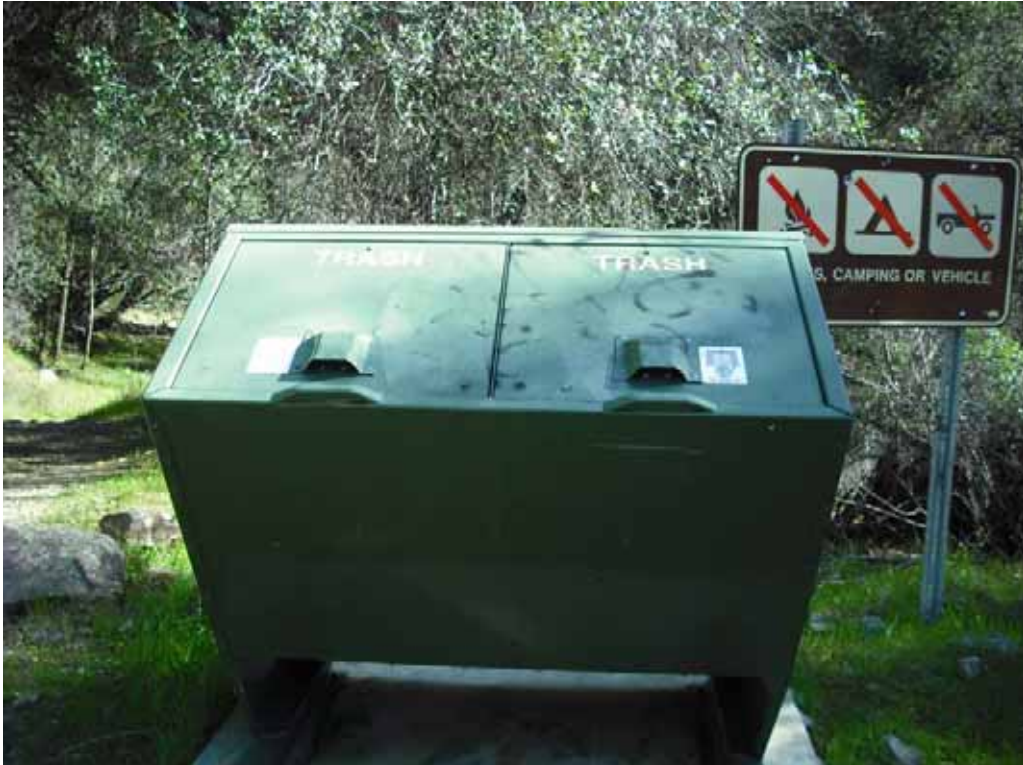
Photo V-2-30. Bear-proof garbage container and signage located on the south side of Drivers Flat Road, across from turn-out. (3/12/09)

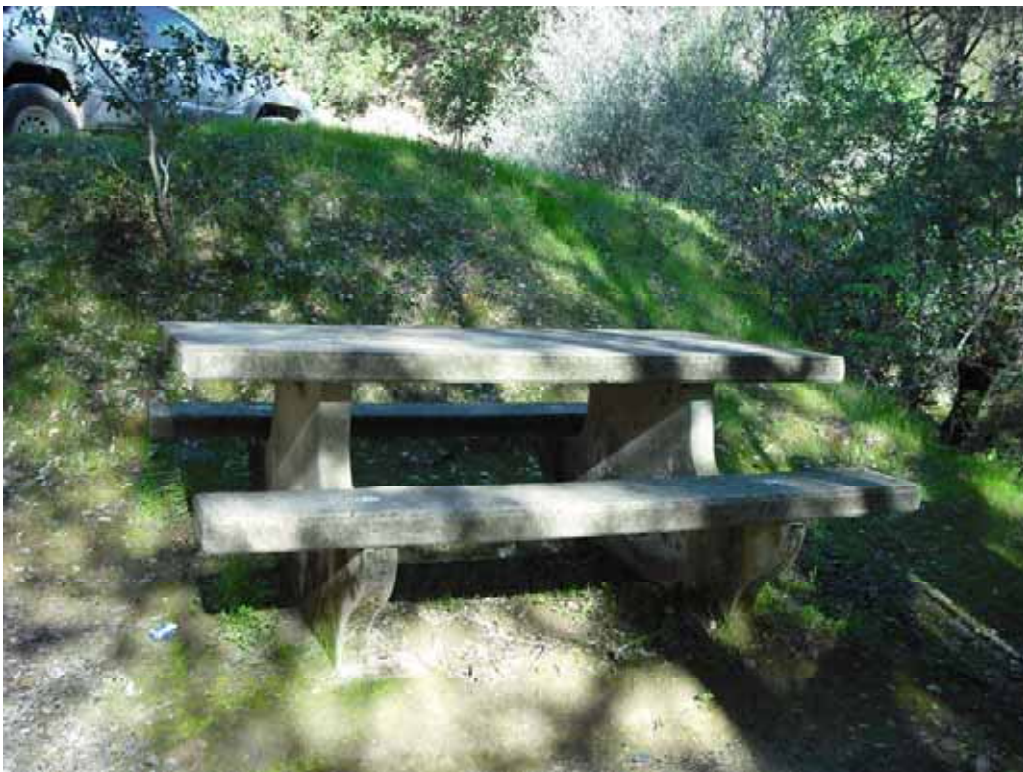
Photo V-2-32. A picnic area located on the south side of Drivers Flat Road just west of locked gate. (3/12/09)

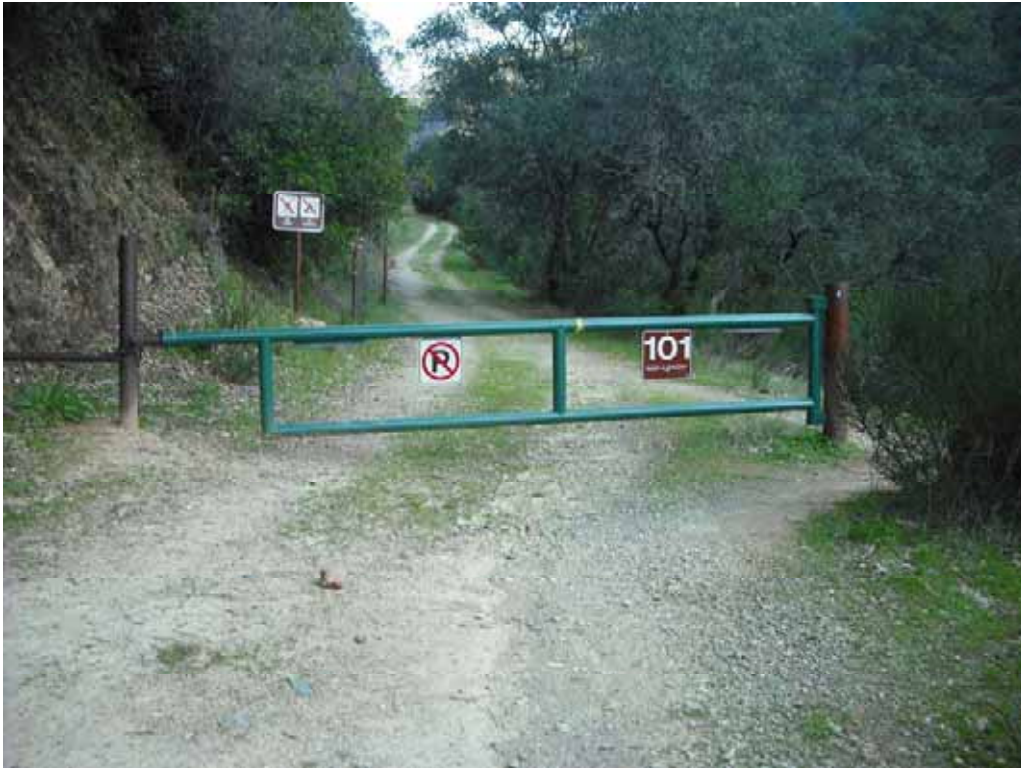
**Photo V-2-33. Locked gate located along Drivers Flat Road west of Canyon Creek.
(3/12/09)**

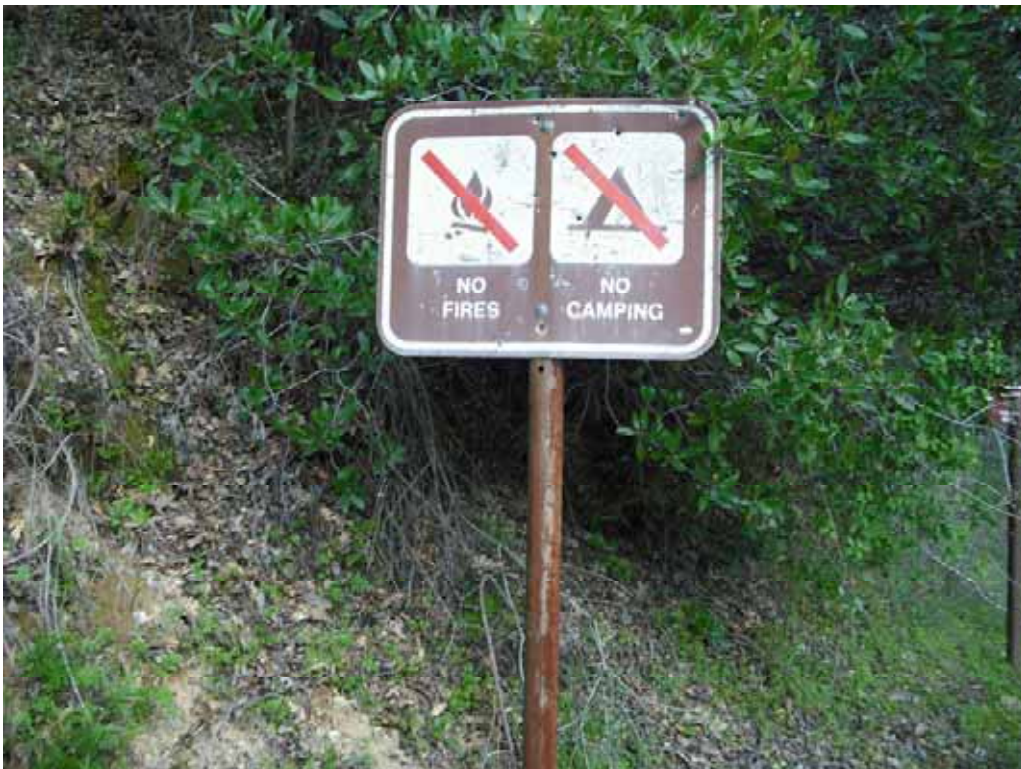
**Photo V-2-34. A regulatory sign in poor condition located adjacent to the locked gate.
(3/12/09)**

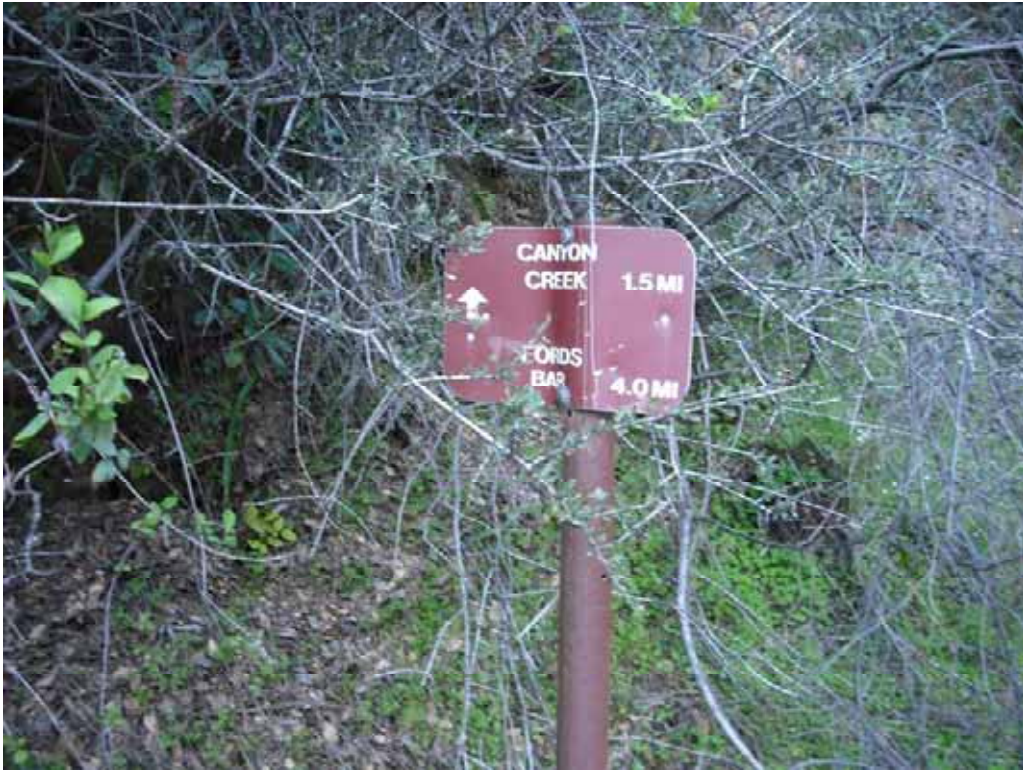
Photo V-2-35. A directional sign located adjacent to the locked gate. (3/12/09)
