Placer County Water Agency

Re: FERC Project No. 2079-CA; NATDAM No. CA00856
Ralston Afterbay Dam, State of California No. 1030-4, Placer County

September 20, 2004

Ralston Afterbay Spillgate Incident Investigation

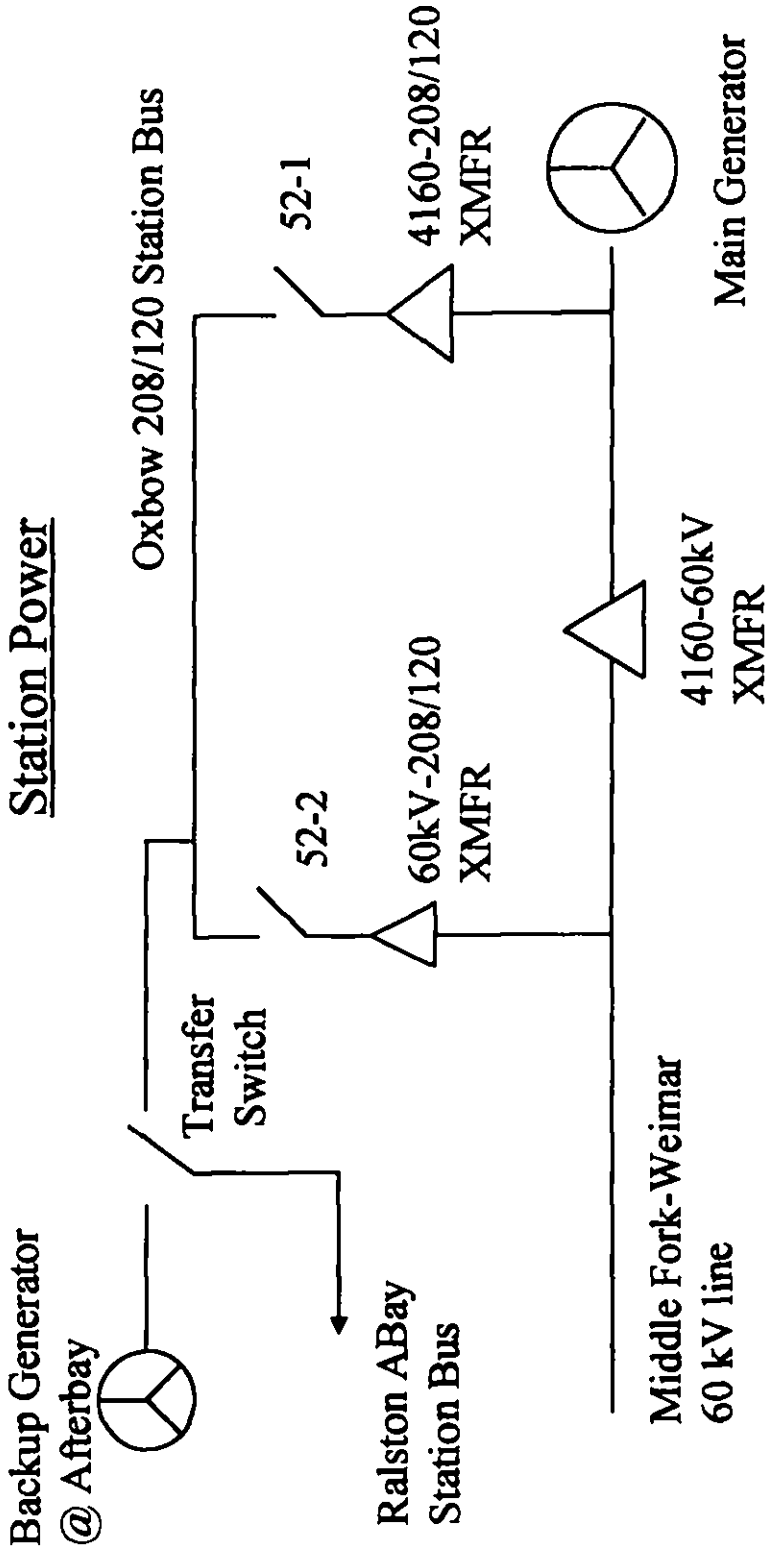
Placer County Water Agency
Oxbow Powerhouse / Ralston Afterbay

- 1. All equipment shown is powered by from the same AC source, the Ralston ABay station service bus fed from the powerhouse.
- 2. Float well 1 and 3 are mismarked 3 and 1 at the dam.
