Page
8.11 Aesthetic Resources Environmental Effects.....	8.11-1
8.11.1 Compatibility of Project Facilities with USDA-FS Visual Quality Objectives	8.11-2

Figure 8.11-1. Existing dam and spillway with current maximum normal operating WSE (No-Action Alternative).

Figure 8.11-2. Existing dam and spillway with 6-foot raise in current maximum normal operating WSE, plus new spillway gates, gatehouse and powerlines (Proposed Action).

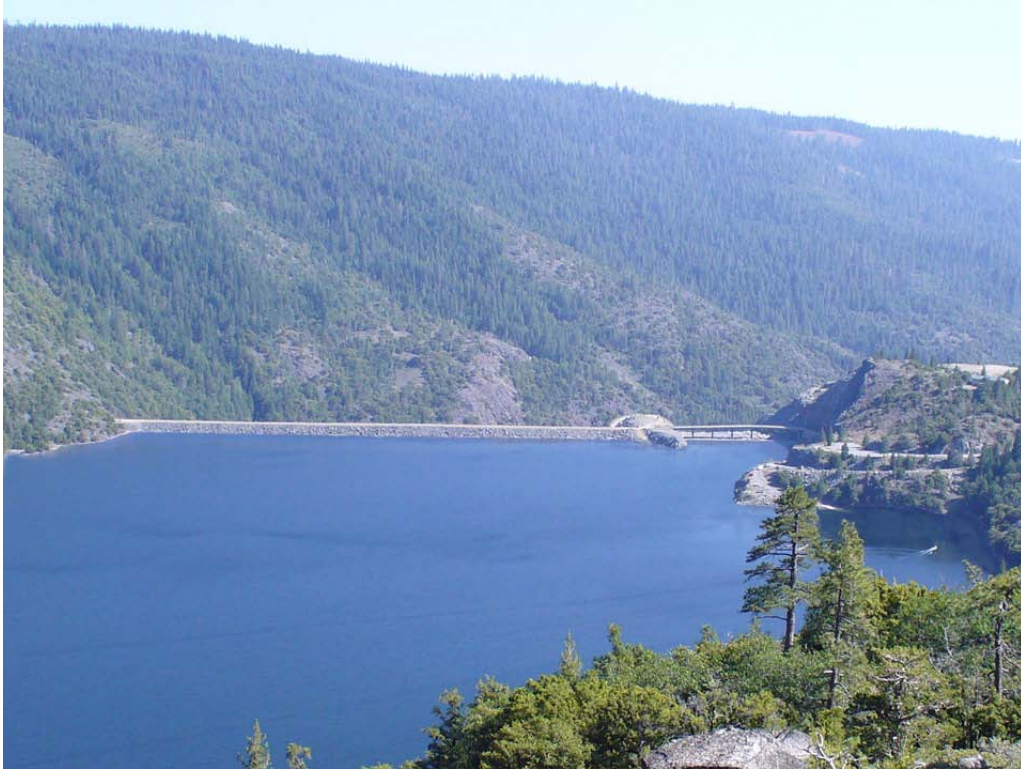
Hell Hole Dam and Spillway Area as seen from Hell Hole Vista

Figure 8.11-1. Existing dam and spillway with current maximum normal operating WSE (No-Action Alternative).

PCWA prepared photo simulations showing the Hell Hole Dam and Spillway area under the No-Action Alternative (Figure 8.11-1) and the Proposed Action (Figure 8.11-2), as viewed from one Key Observation Point (KOP) selected in consultation with an ENF landscape architect. This KOP is located at the Hell Hole Vista, from which most of the reservoir, the dam, and spillway are visible. Figure 8.11-1 shows the existing structures with the current maximum normal operating WSE as viewed from Hell Hole Vista (No-Action Alternative). Figure 8.11-2 shows the existing structures with a 6-foot raise in the

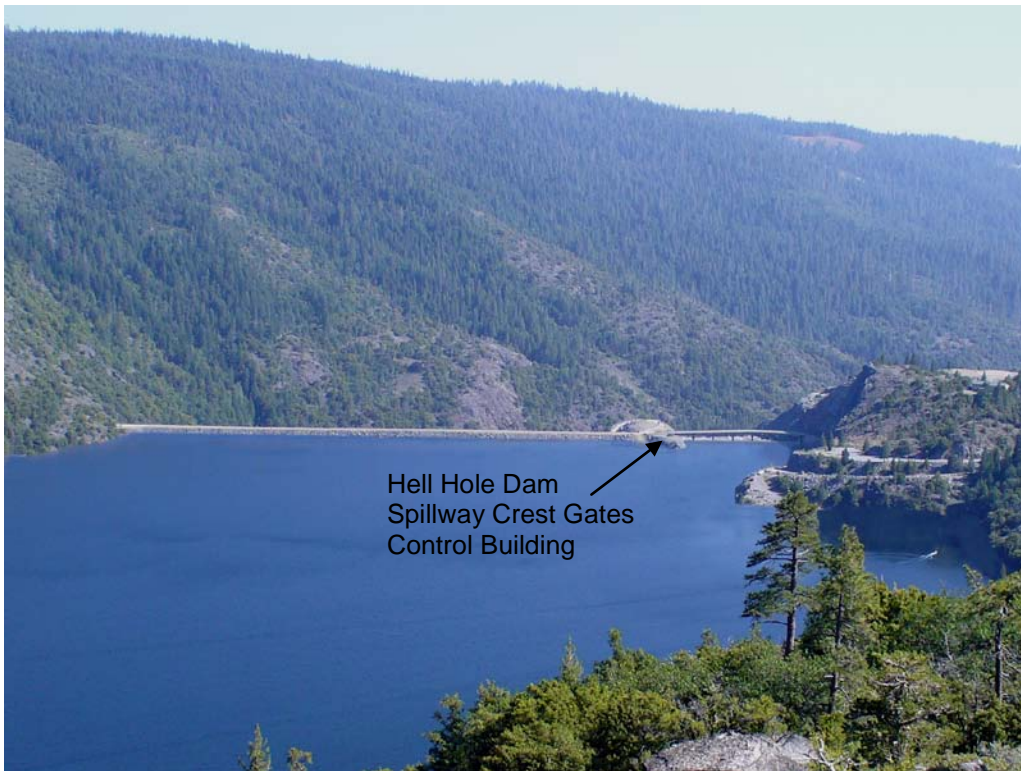
Figure 8.11-2. Existing dam and spillway with 6-foot raise in current maximum normal operating WSE, plus new spillway gates, gatehouse and powerlines (Proposed Action).

Note that the existing power lines are not discernable under the No-Action Alternative. Similarly, neither the existing nor the new power lines are discernable under the Proposed Action.

As shown in Figure 8.11-2, the crest gates would not be noticeable from Hell Hole Vista (or anywhere on the reservoir) when in operation because they would be covered or nearly covered by water. The gates would be lowered when the reservoir level recedes and would lay flat (horizontal) on the spillway when not in use. Similarly, the gates would not be visible from Hell Hole Reservoir, or from the Hell Hole Boat Ramp and associated parking, both USDA-FS managed viewsheds. Therefore, installation of the Hell Hole Dam Spillway Crest Gates would not change the existing visual conditions relative to the No-Action Alternative.

The new control building and powerline are shown on Figure 8.11-2. As indicated, the control building will be visible from Hell Hole Vista, but will not be noticeable due to the viewing distance and due to the small size of the feature relative to the dam and spillway. The powerline will traverse relatively barren bedrock and will not be noticeable from Hell Hole Vista due to the distance between the vista and powerline, and because the powerline will be obscured by bedrock outcrops and shadows.
