## 8.0 GEOMORPHOLOGY

This section summarizes the existing information regarding channel geomorphology and associated fluvial processes in the bypass and peaking reaches (or study streams) associated with the Middle Fork American River Project (MFP or Project). Channel geomorphology is a description of the channel form (morphology) including dimensions, gradient, planform, and pattern. Fluvial processes refer to the flow, sediment supply, and sediment transport characteristics that create and maintain the channel morphology. The Federal Energy Regulatory Commission (FERC or Commission) does not specifically require a chapter on geomorphology; however, this information is integral to understanding channel maintenance processes and the distribution and availability of aquatic and riparian habitat.

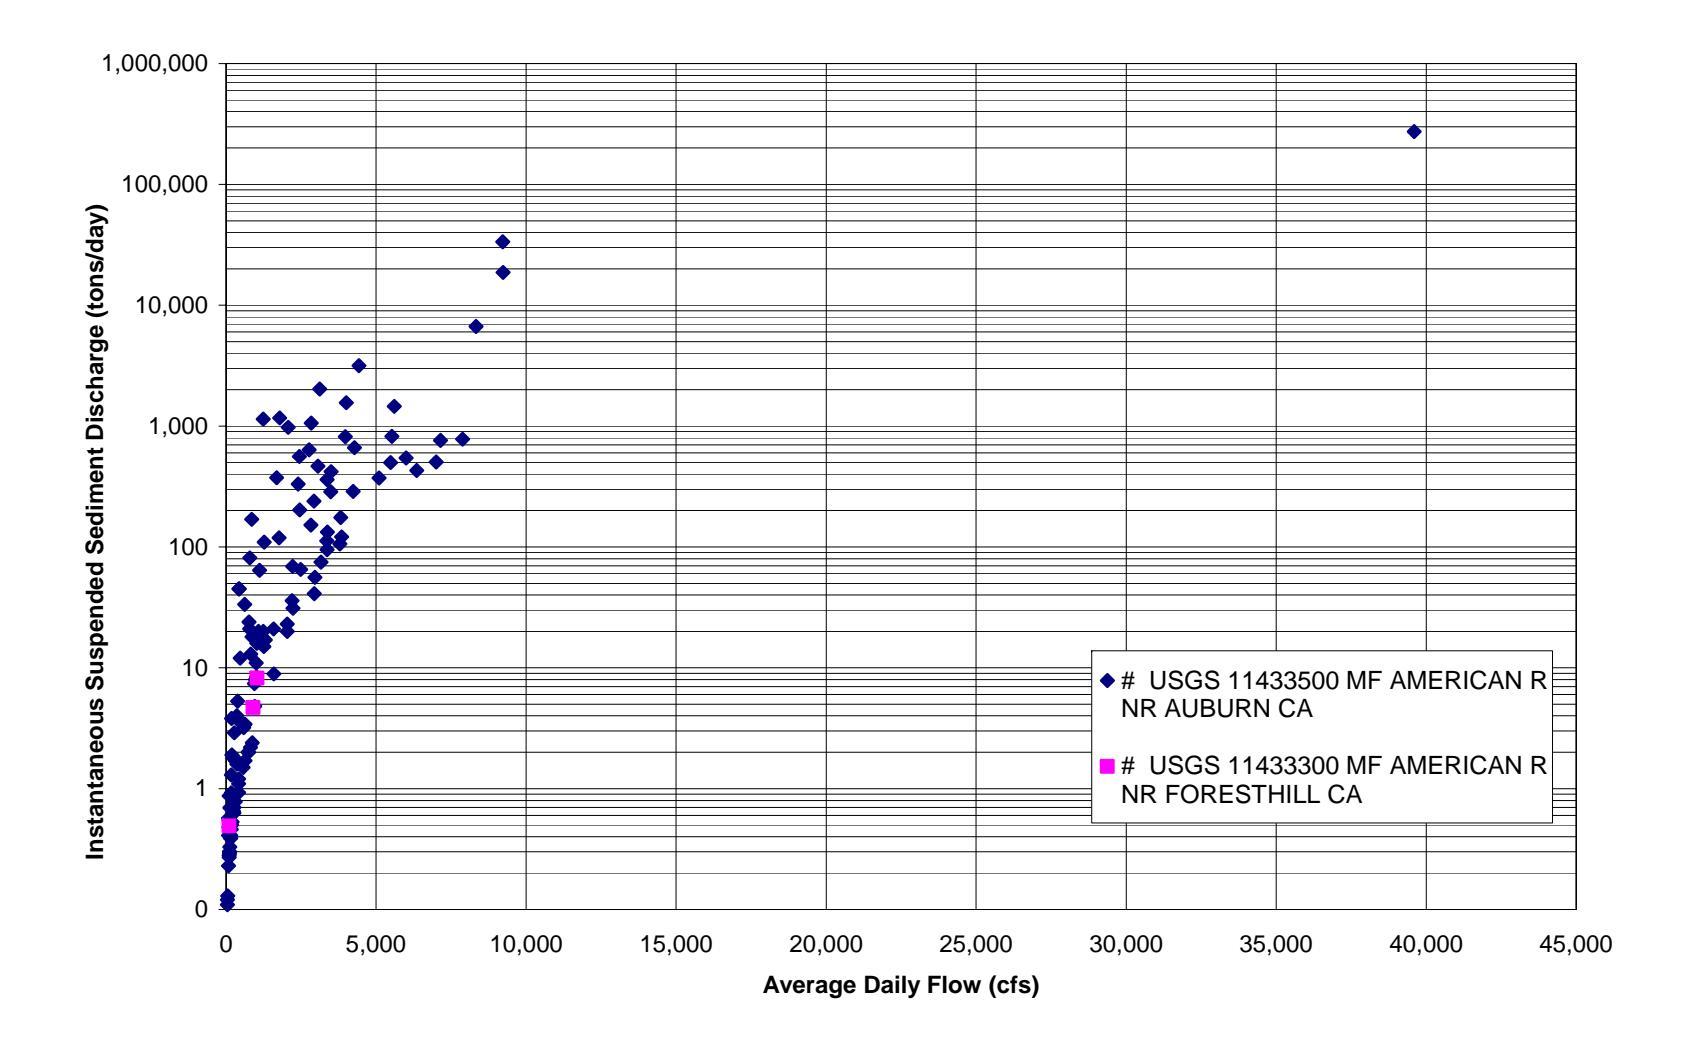
Figure 8-1. Suspended Sediment Discharge Lower Middle Fork American River (1956-1979).

Suspended sediment has periodically been collected by the USGS at two gaging stations within the peaking reach. The two gaging stations are Middle Fork American River near Foresthill (USGS No. 11433300), which is just below Oxbow Powerhouse, and Middle Fork American River near Auburn (USGS No. 11433500), which is between Mammoth Bar and the confluence with the North Fork American River. The suspended sediment sampling performed by the USGS consisted of grab samples that were used to calculate tons per day (tpd) of suspended sediment discharge (SSD). Most of the data were collected after PCWA hydroelectric facilities became operational. The grab samples at the Middle Fork American River near Foresthill gage were collected in March, July, and October 1979. At the Middle Fork American River near Auburn gage, suspended sediment was collected periodically from October 1956 through September 1967, with an average of eight samples per year, and three times in 1979 during the same months as the upstream gage. The SSD data is displayed on Figure 8-1. In general, higher suspended sediment loads occur during high flow events, while lower flow events transport relatively low suspended sediment loads. Typical for suspended sediment load measurements and SSD calculations, there is a fairly large amount of scatter in the data on the Middle Fork American River. For example, over 18,000 tpd of sediment was measured for a flow of 9,000 cubic feet per second (cfs) (1.5-year unregulated flow event,) on March 7, 1960, while on March 7, 1967 33,500 tpd was measured for a flow of 9,200 cfs. The highest SSD measured was on December 23, 1964, following the Hell Hole Dam failure and flood surge, with an estimated 273,000 tpd, which occurred prior to the completion of the MFP facilities. In 1979, similar suspended sediment loads were measured at both stream gages for similar flows.

Since the data set from the SSD sampling at these two gages is small, the conclusions that can be drawn from the data are limited. The boundaries at which the lowest discharge will mobilize and transport suspended sediment or the highest suspended sediment load carried in this reach can not be determined. However, the data record does indicate that there is a suspended sediment load, and that there is some sediment transport which is occurring under the present-day flow regime.
