**Placer County Water Agency
Middle Fork American River Project
(FERC No. 2079)**

**REC 1 – RECREATION USE AND FACILITIES
TECHNICAL STUDY REPORT**

Placer County Water Agency
P.O. Box 6570
Auburn, CA 95604

May 2010

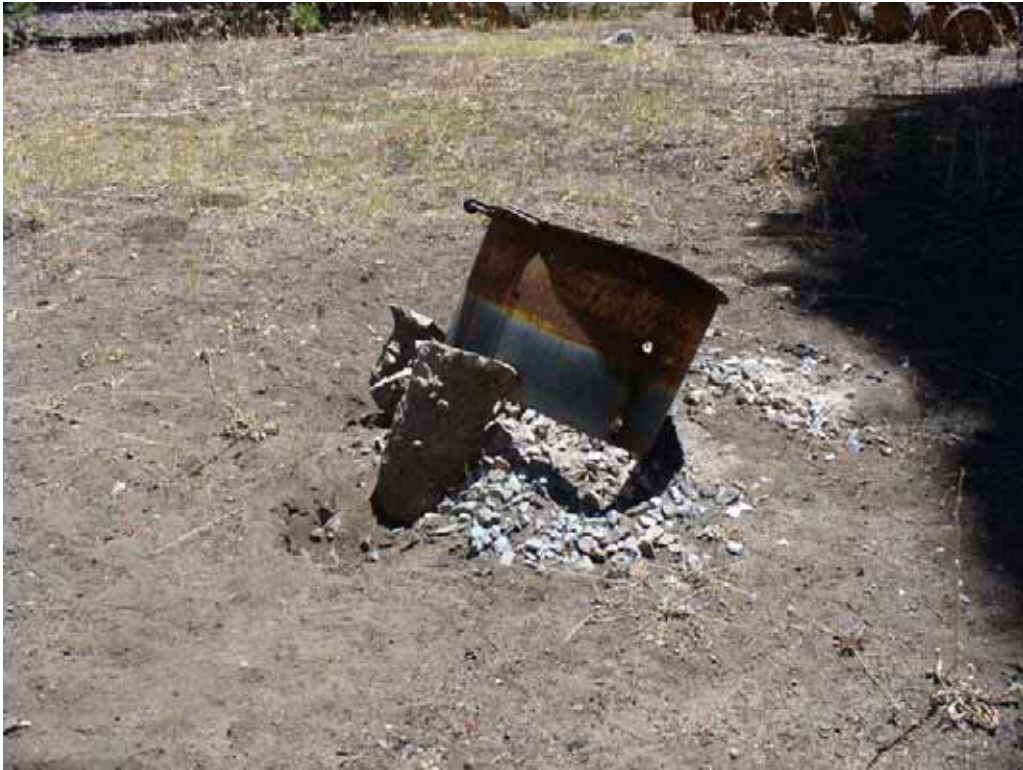
Photo D-2-13. Vandalized fire ring (Site 27). (8/21/08)

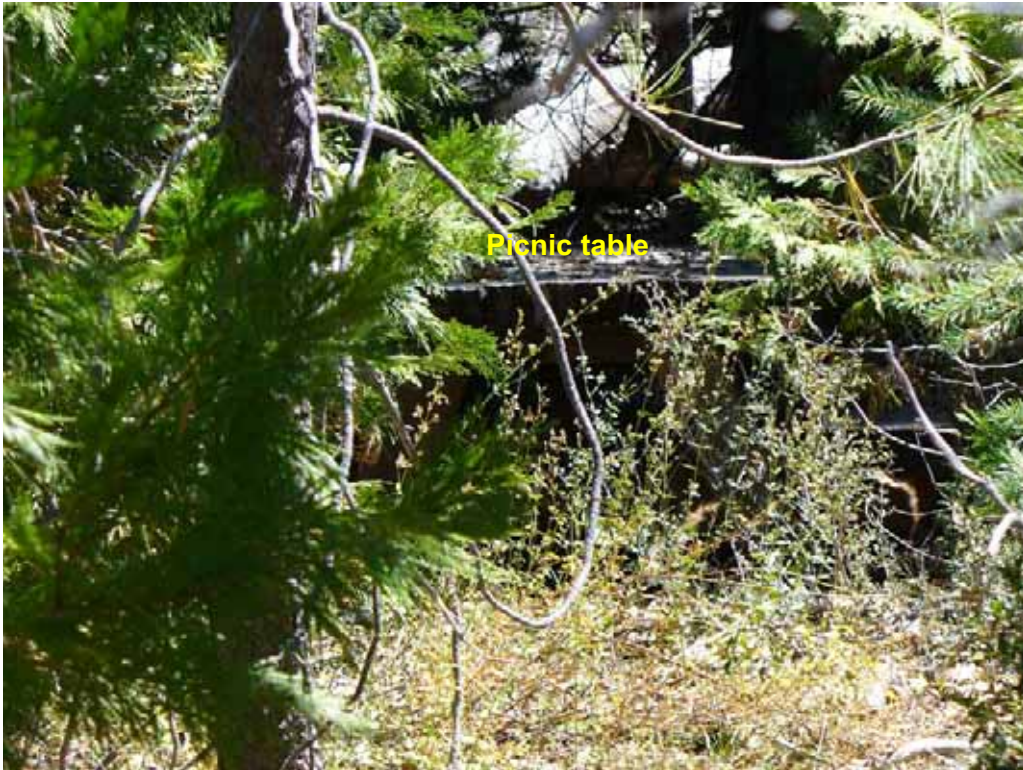
Photo F-2-19. Overgrown table at Site 13. (8/4/08)

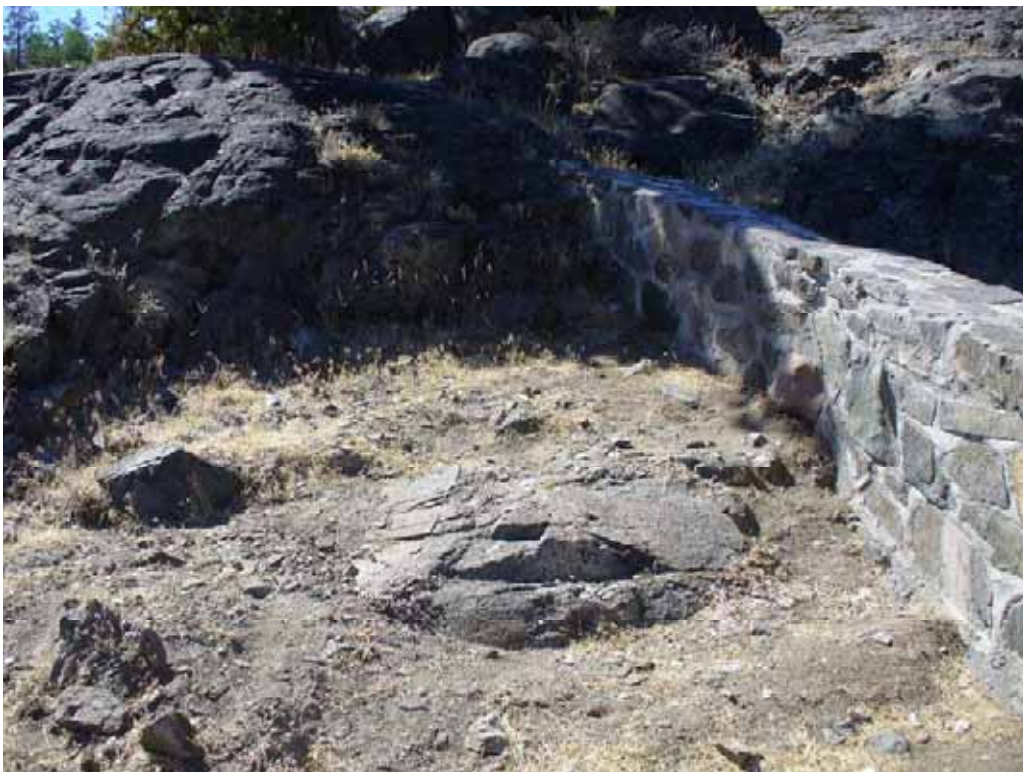
Photo G-2-10. Unlevel surface in Hell Hole Vista. (8/20/08)

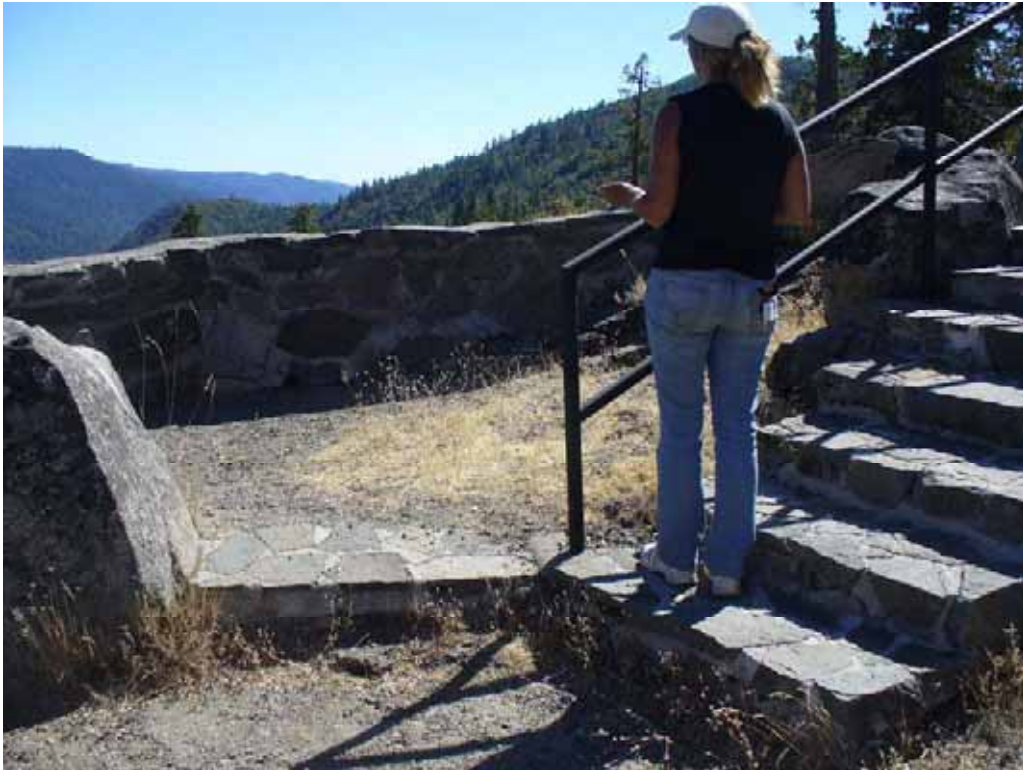
Photo G-2-11. Surface and level changes in Hell Hole Vista. (8/20/08)

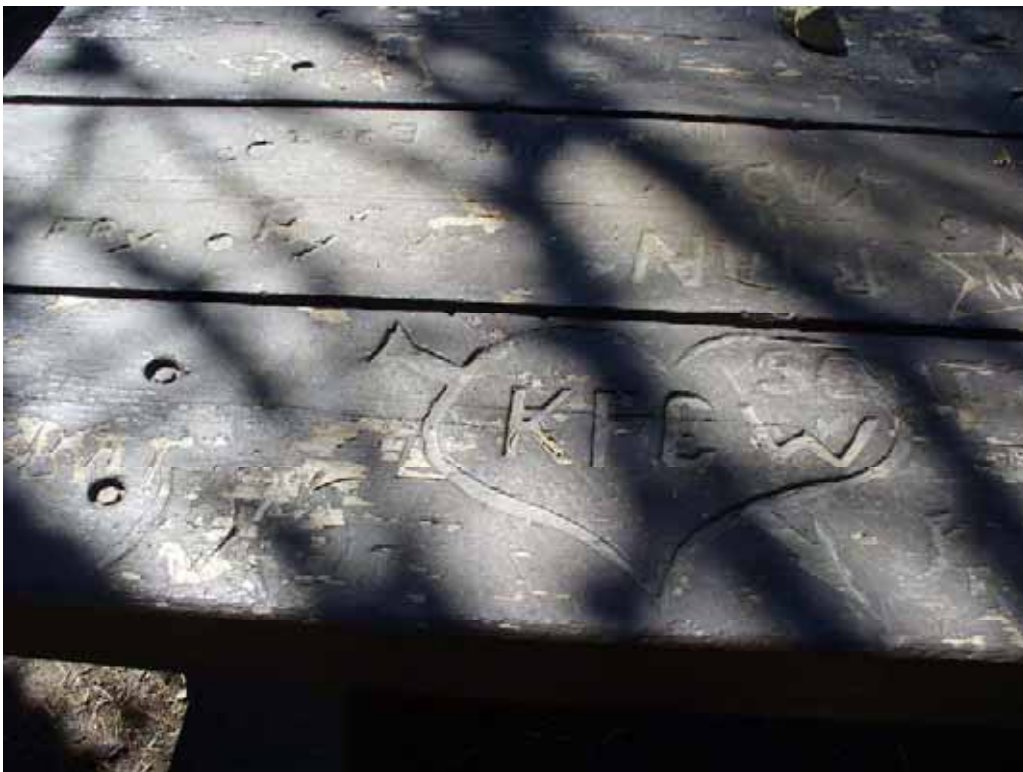
Photo I-2-12. Typical heavy wood table with graffiti. (9/04/08)

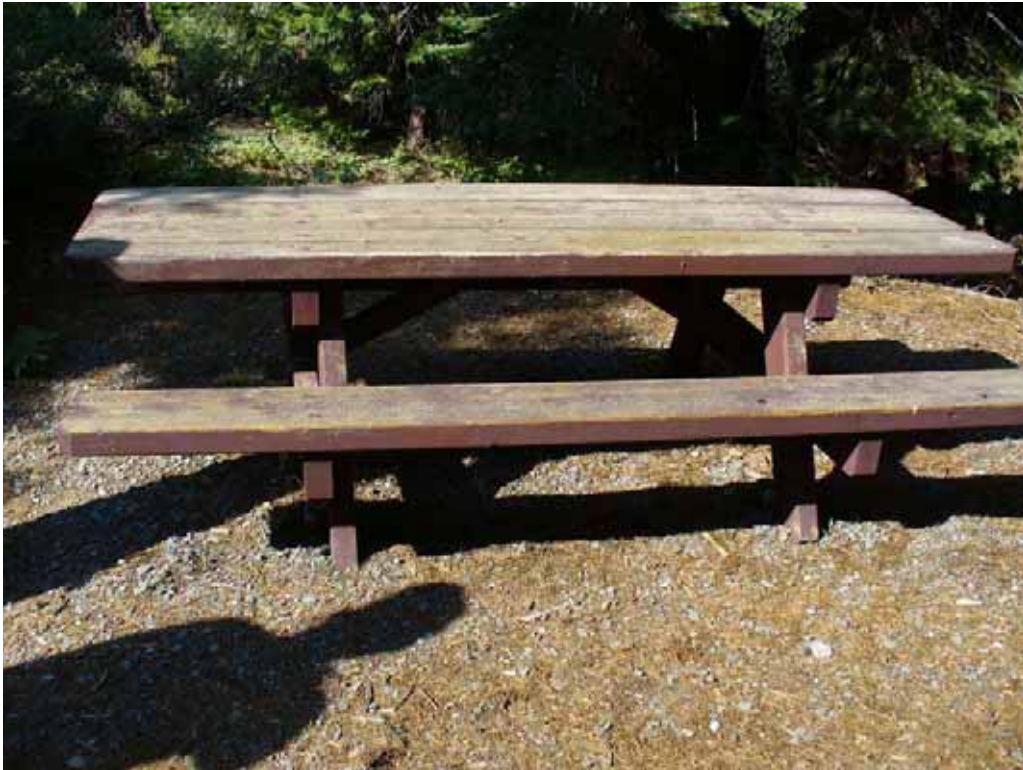
Photo J-2-13. Example accessible wood picnic table. (7/24/08)

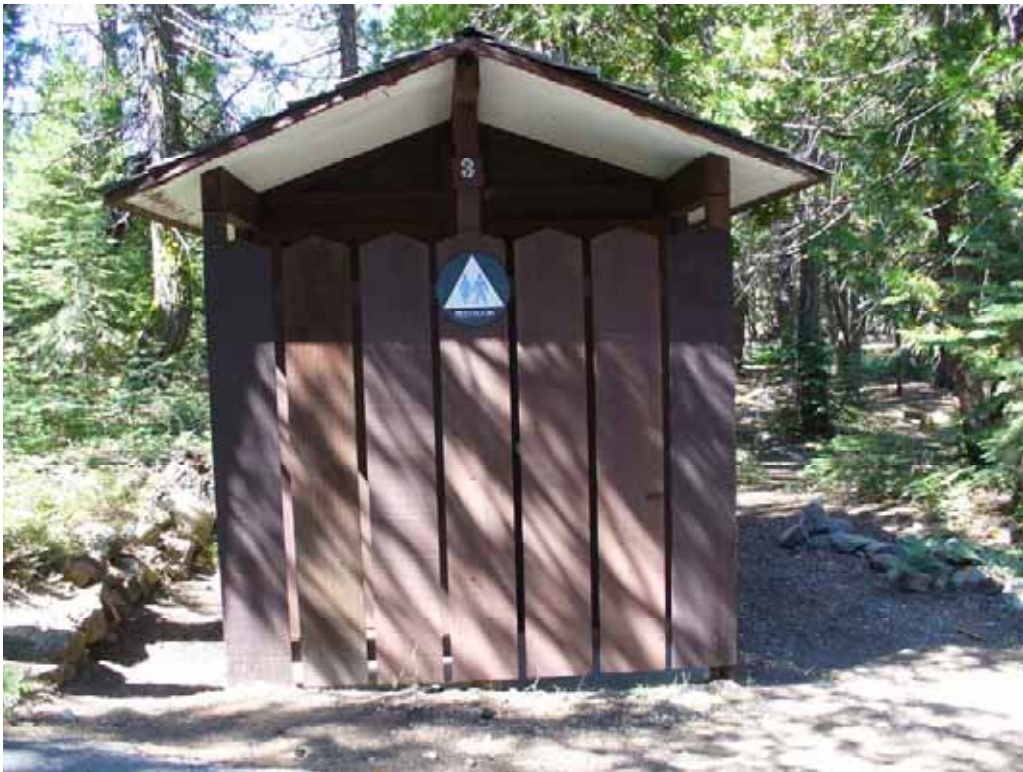
Photo J-2-14. Example double unit wood bathroom #3, not accessible. (7/24/08)

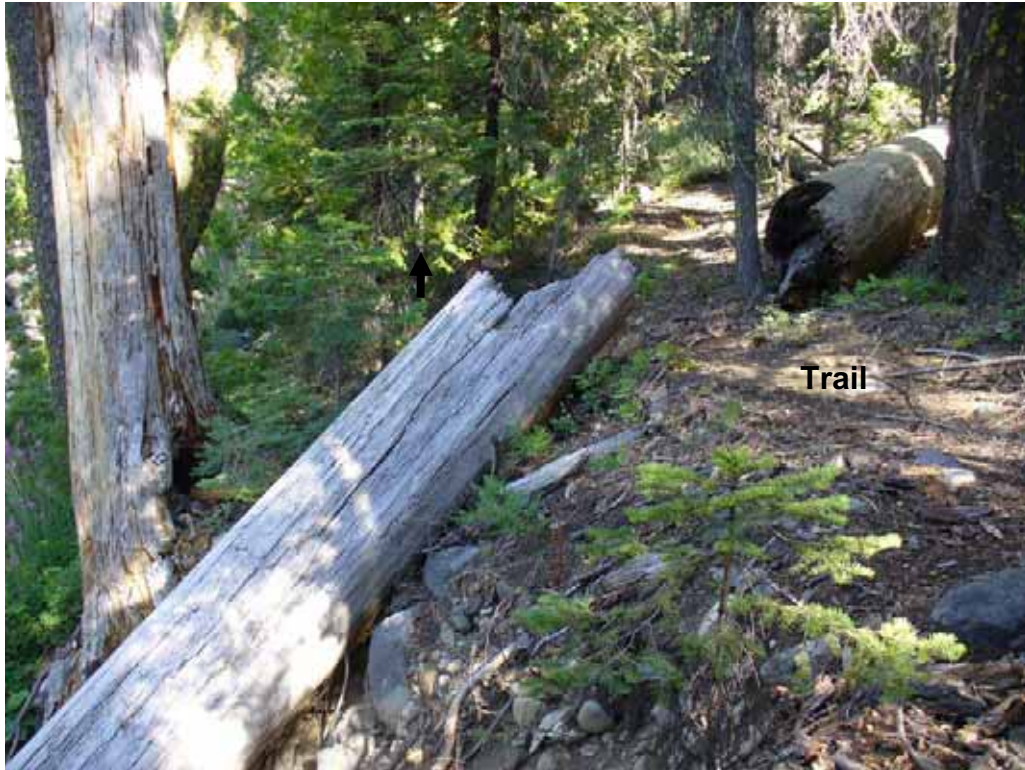
Photo L-2-23. Trail to Sites 11 and 12. (7/24/08)

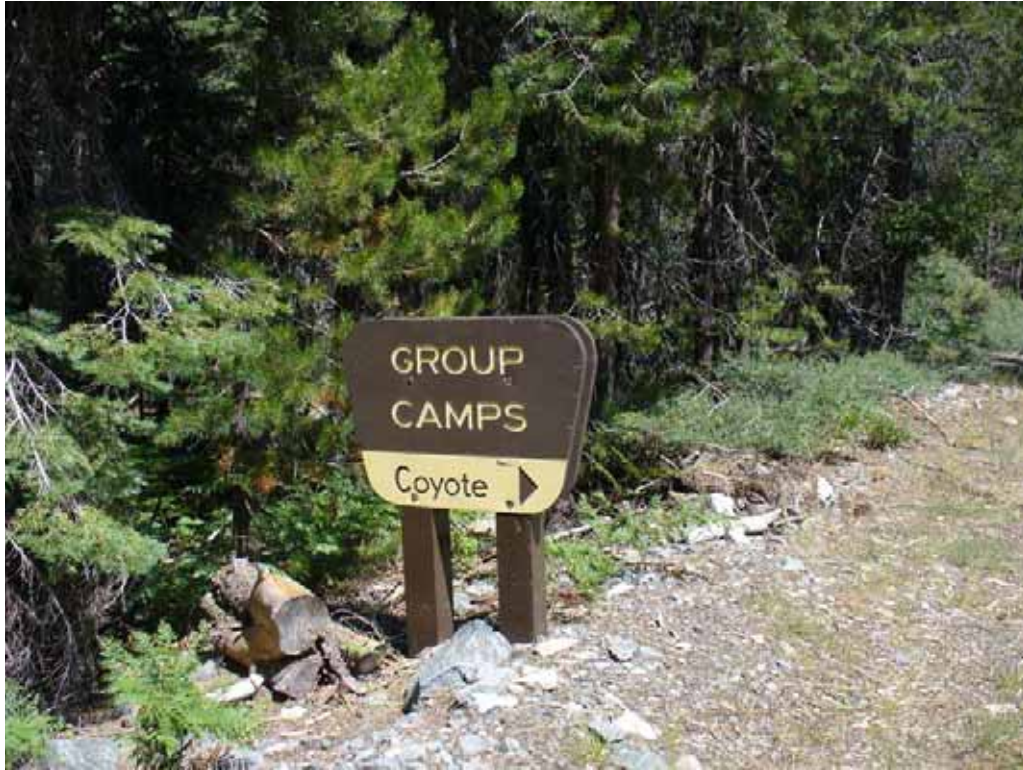
Photo M-2-1. Site identification sign located on FR 96 across. (7/24/08)

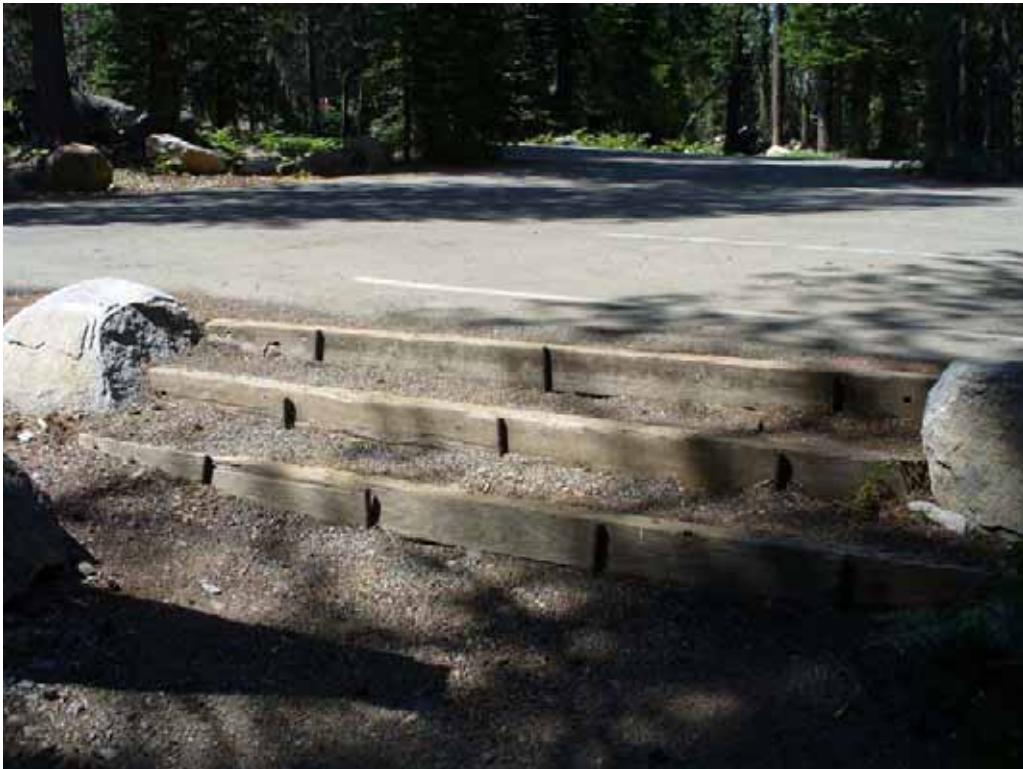
Photo M-2-4. Steps between parking area and Little Wolf.

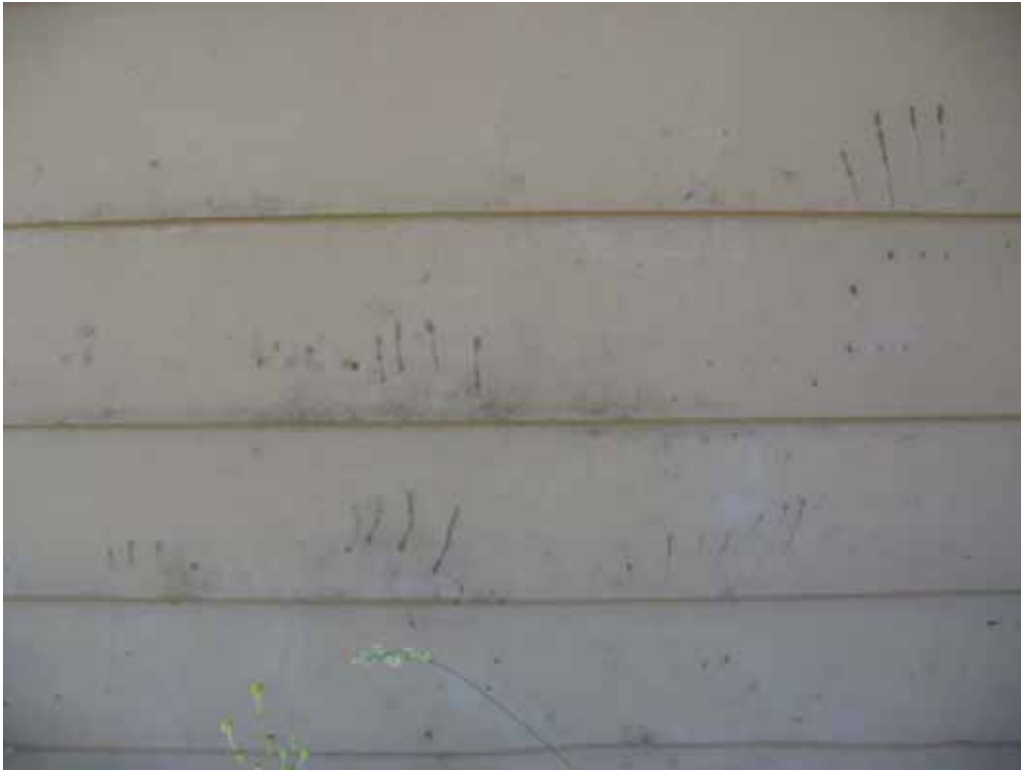
Photo M-2-21. Bear scratches on bathroom at Black Bear. (7/24/08)

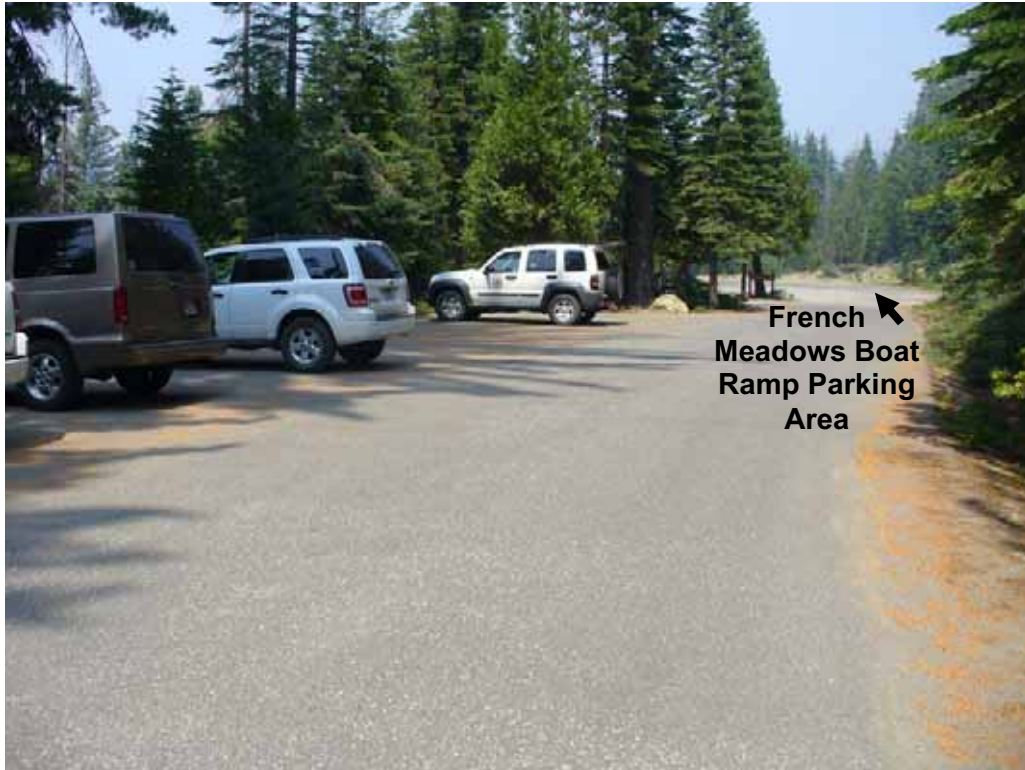
Photo O-2-13. French Meadows Picnic Area Parking. Parking and roadway surfaces are in good condition. Note Boat Ramp Parking Area in background. (7/23/08)

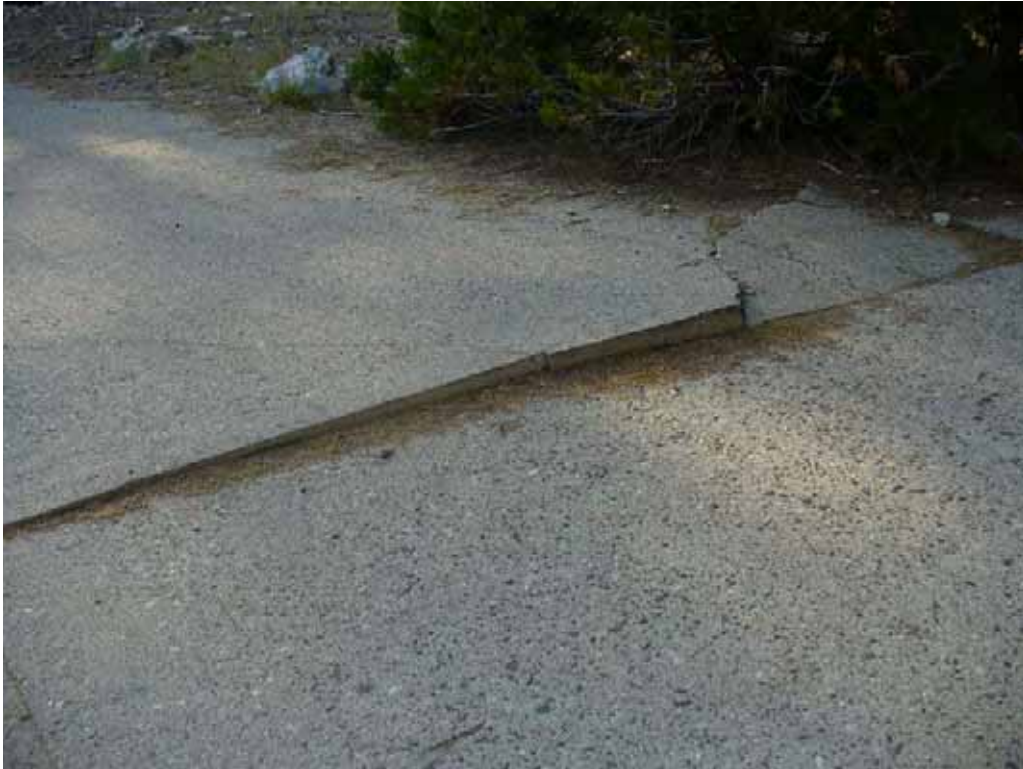
Photo P-2-4. Uplifted concrete at edge of high water turn-around area. (7/23/08)

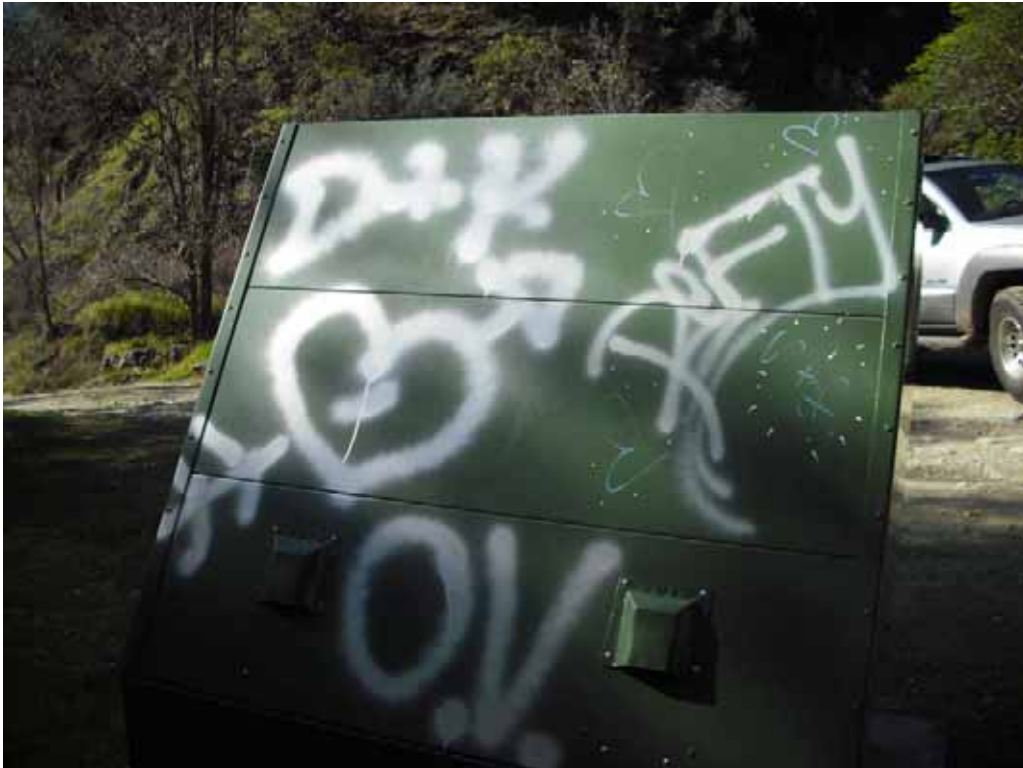
Photo V-2-31. Graffiti on back of bear-proof garbage container. (3/12/09)
